Validation Workshop on Roads To The Rescue Khajuriya (LGED SubPolder)

BUET and MetaMeta
15th November 2017

Objectives

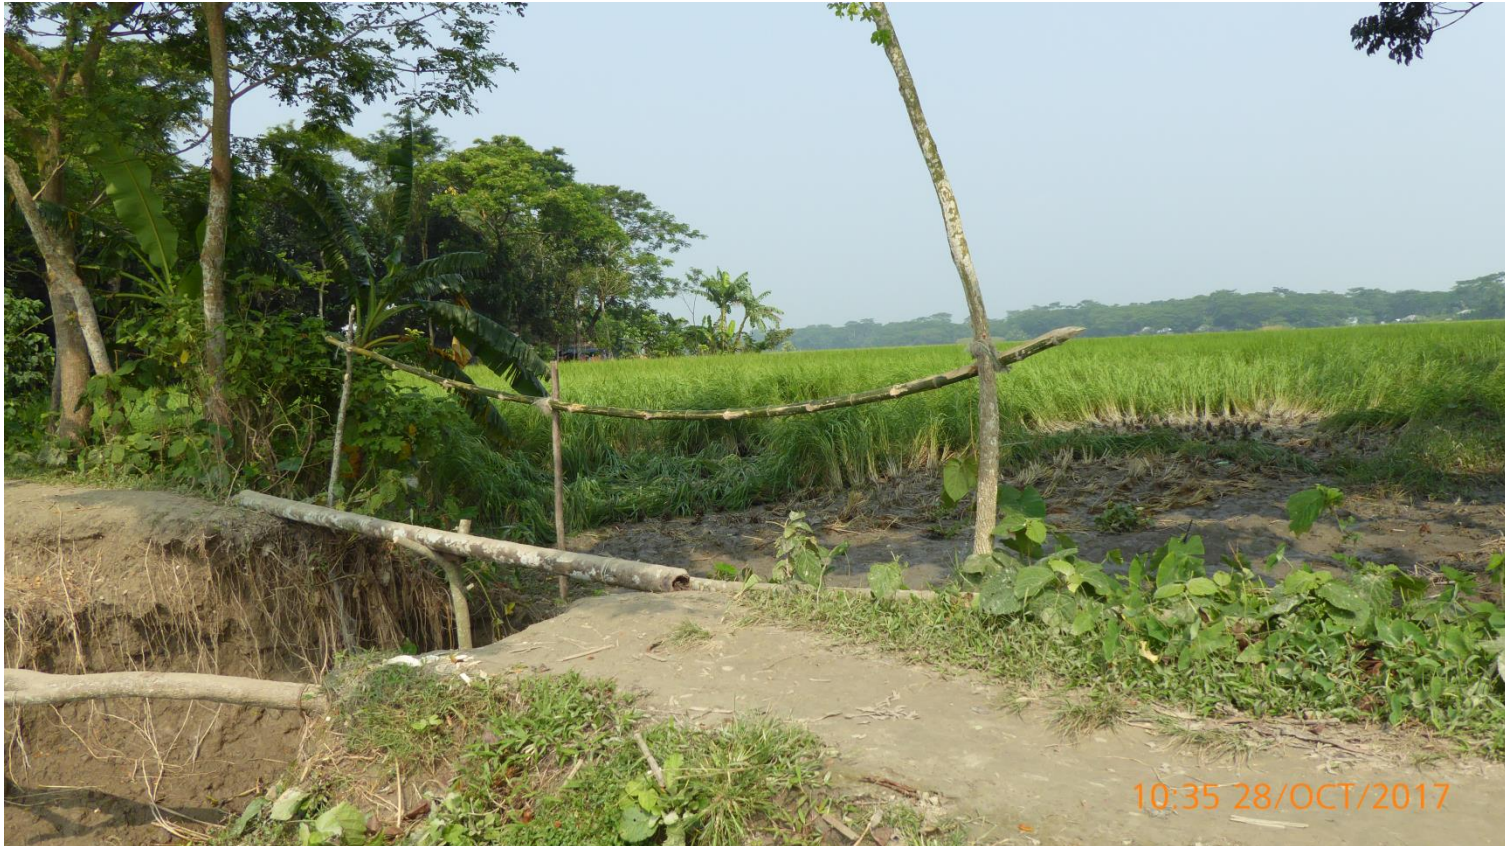
Effects of Damaged/Breached Embankments

Damage to cultivated areas

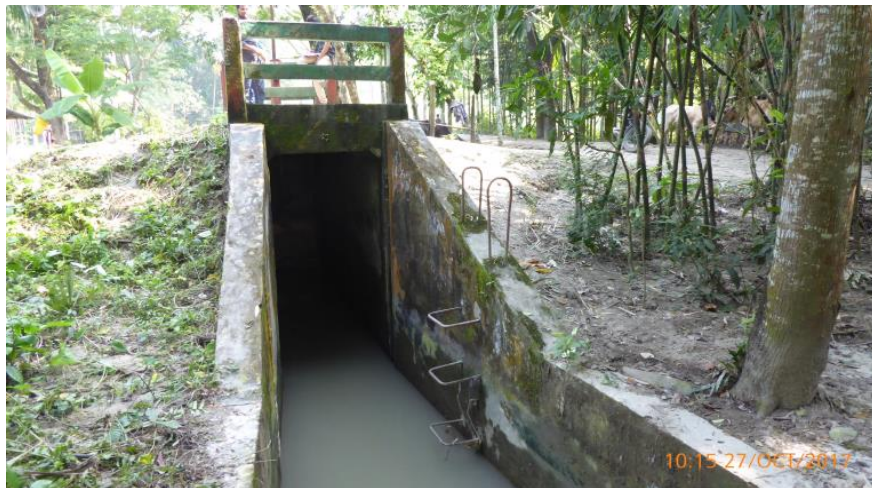
Partially damaged structures

1V sluice gate

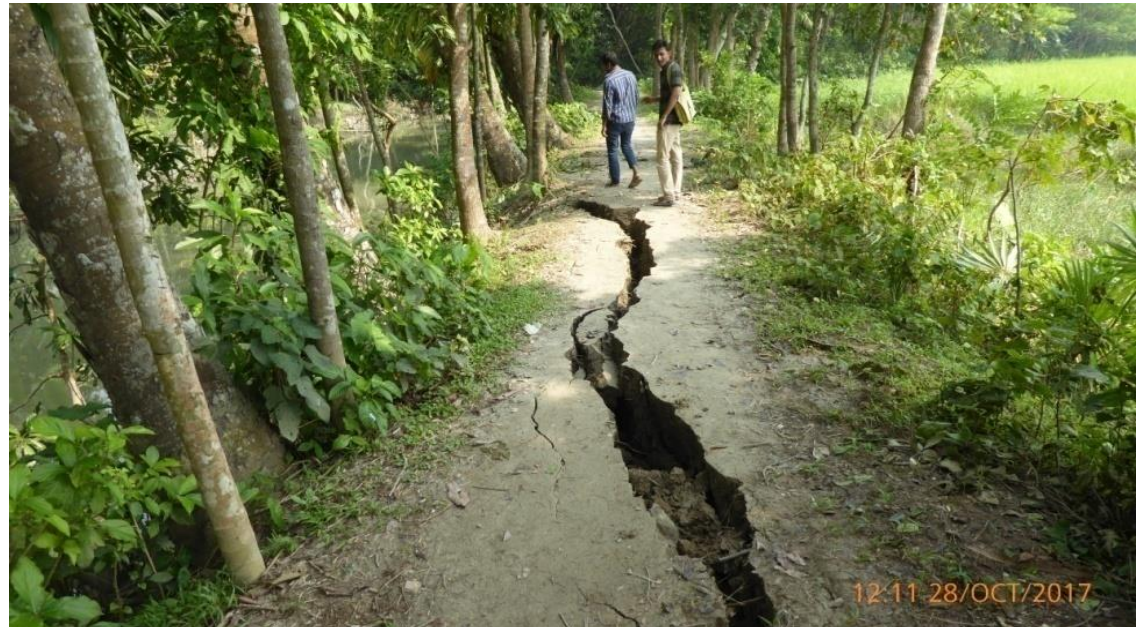
Road damage

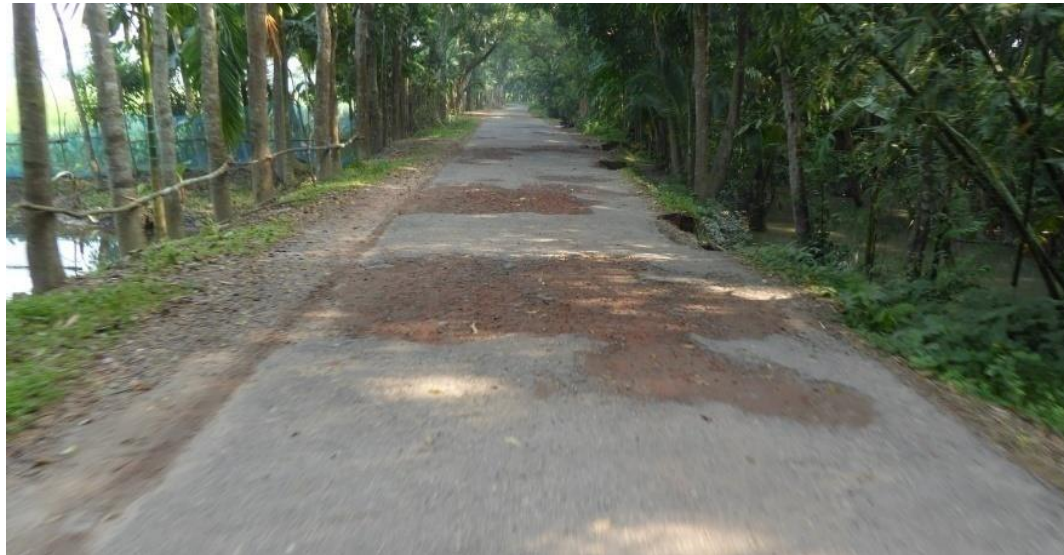
Broken sections of the road due to water erosion

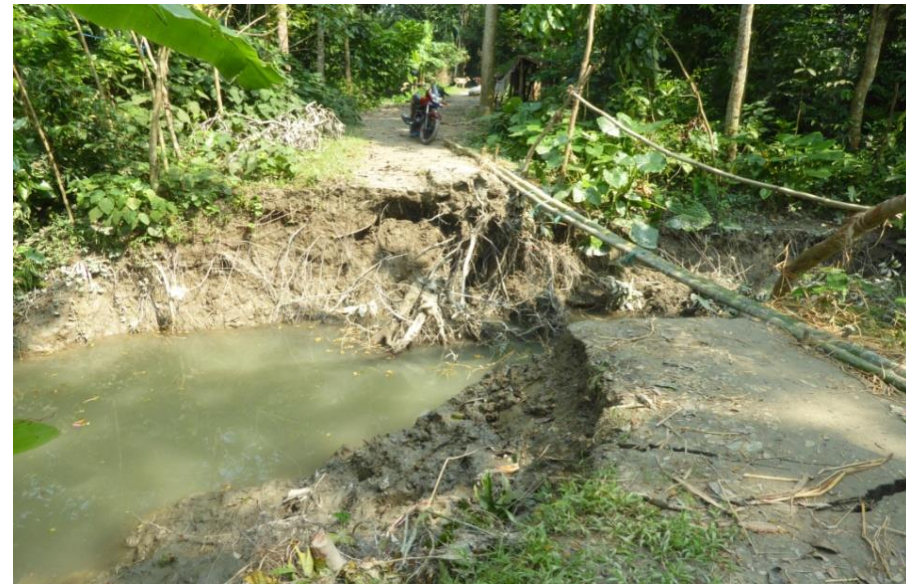
Road collapse, NO maintenance since 17 years

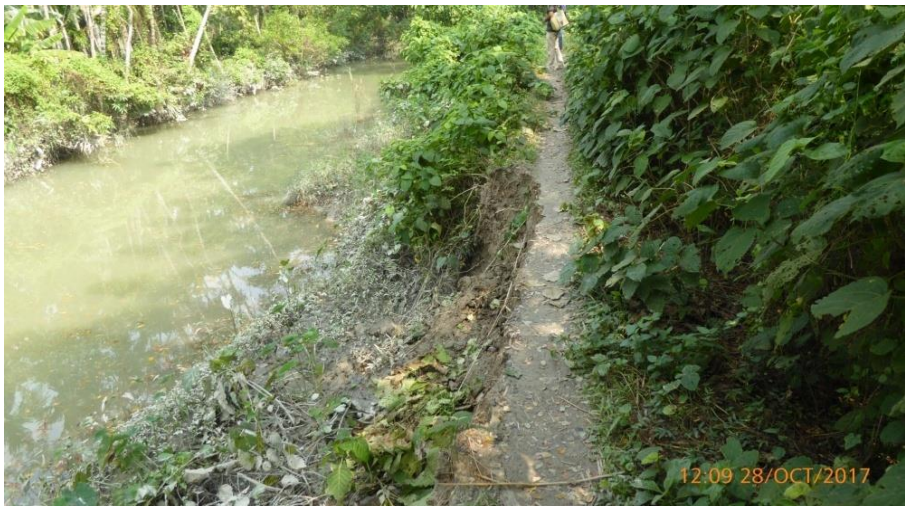
Road collapse, NO access

Narrow and low roads

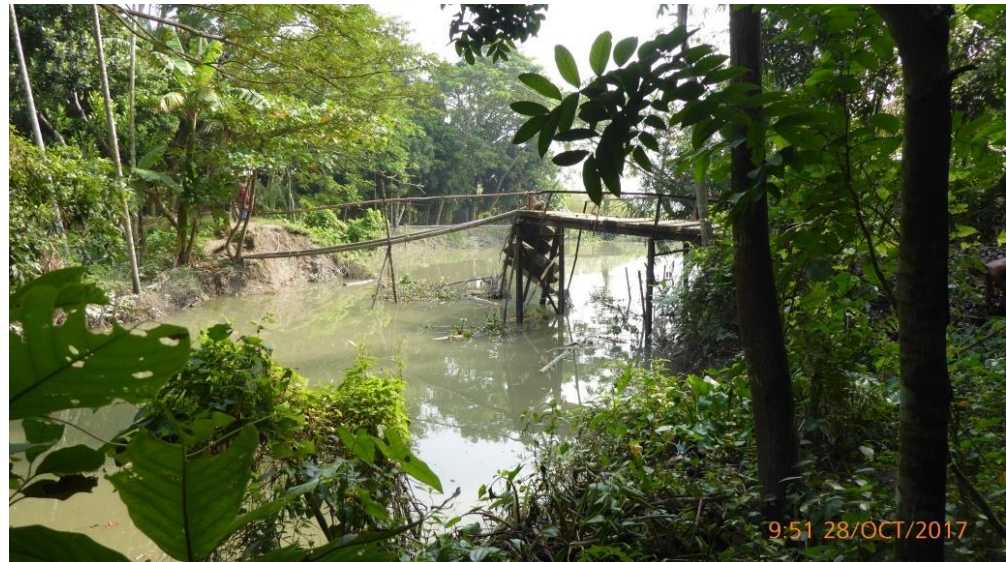
Old bridge needs repair/replacement
