Road Water Management for Resilience

Summary of field observation

by Wild beast group

February 26, 2017

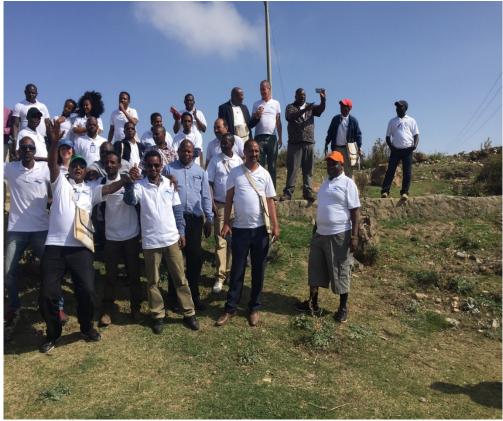
- First visit Enderta woreda, Felegeselam Kebele
 - At present around 40,699 ha land under area closure,
 - Barren land before 2011 with severe degradation,
 - As a baseline deep wells constructed in 1997 but low yield of wells observed,
 - After 6 years of treatment, ground water table raised and yield of wells improved,
 - Springs emerged and community began irrigation,
 - Road side plantation observed,
 - Plantation survival rate is 91% in the area enclosure,
 - Vision is to convert the area enclosure to forest land
- **Issues**: is grevillea tree species appropriate for a shallow soil depth?

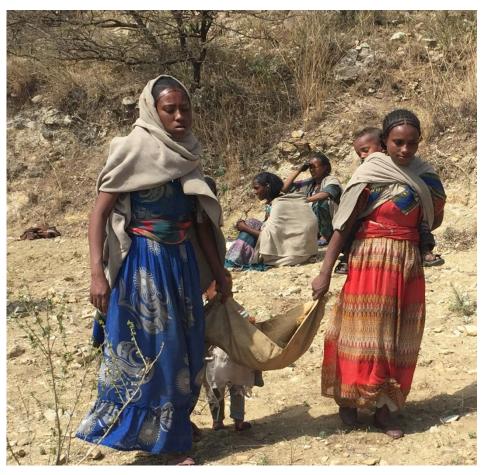
• Second site: Didiba kebele:

- Visited an irrigated land, and was learned that around 9000 ha of land is under irrigation in the kebele,
- Also visited a mass-labor mobilization and community working in the field,
- Community know that every year in February there is a mass labor mobilization,
- Discussed with community while they are constructing soil-faced stone bunds with trenches,
- Both men and women are actively working,

Women were working carrying children on their back – against the principles set out in the CBPWD guideline

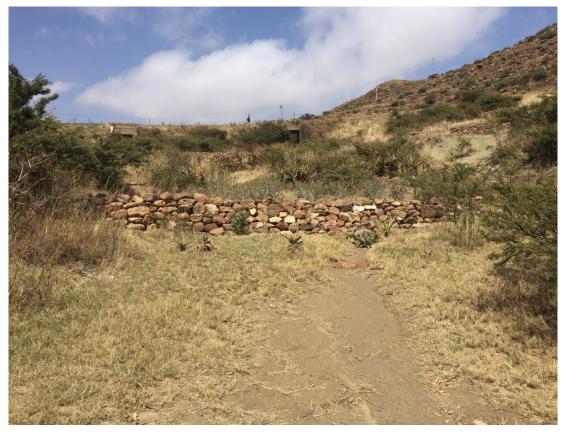
• Third site: Maikeyeh kebele:

- Visited a watershed treated less than one year,
- A culvert draining runoff to downslope, but intercepted by series of check dams and percolation pits,
- Very well rehabilitated despite short term intervention,
- Upstream of this area is under treatment with mass labor mobilization during the visit,
- Trenches constructed deep and wide,
- Effects down-stream is expected to be great in a short period of time

- Need to plant trees soon to complement the physical structure
- There are guards assigned to protect cattle entrance to the area would it be sustainable?

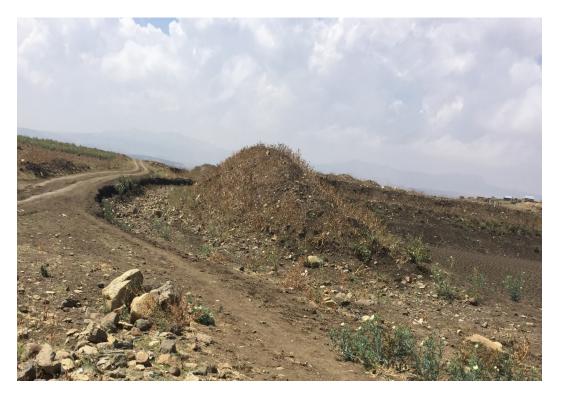
- Fourth site: Adigudom kebele:
 - Visited a large pond, dry at the moment,
 - A culvert draining runoff to a series of 3 ponds constructed by the community labor supported by machinery,
 - Ponds were used for supplementary irrigation,
 - A very good example of road water management

- The team observed poor design of the spillway, which has an eroding effect on the community road?
- No plantation around the pond for better protection and stabilization,
- Water storage may not last long due to percolation, and requires compaction,

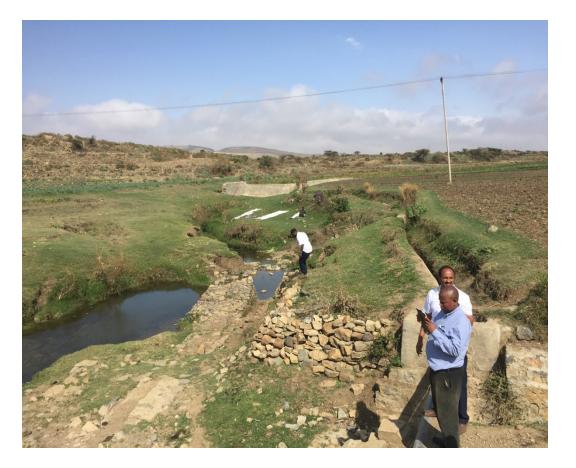
- Fifth site: Didiba mereb-meity kebele:
 - Visited a diversion weir,
 - Currently the lined canal after the diversion weir is dry
 - Farmers are pumping water to irrigate their farm from a seepage from the dam upstream of the weir,
 - Youth rented land from the owners and produce cash crops using irrigation
- Issues:
 - Water shortage as compared to demand

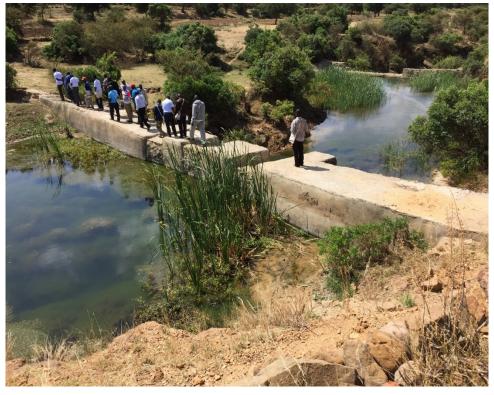
- First site: mai-weyini watershed in Abreha Weatsbeha kebele:
 - Abahawi (Kebele Chairperson) provided briefing and guided us throughout the field visit,
 - Upstream watershed well treated,
 - Deep well drilled 130m depth with no yield in the beginning, but after treatment artesian well with 28lit/sec emerged,
 - Observed series of water retaining structures along the originally deep (8m) gully,
 - Upslope we noted sandwich check dams and down slope check dams changed to masonry dams with gabion, spillways provided alternately
 - Down the gully observed water harvested as a result of watershed treatment up stream and used for irrigation,
- Issues:
 - Check dams damage observed, which require routine maintenance,
 - Mulching required for fruit trees planted in the park

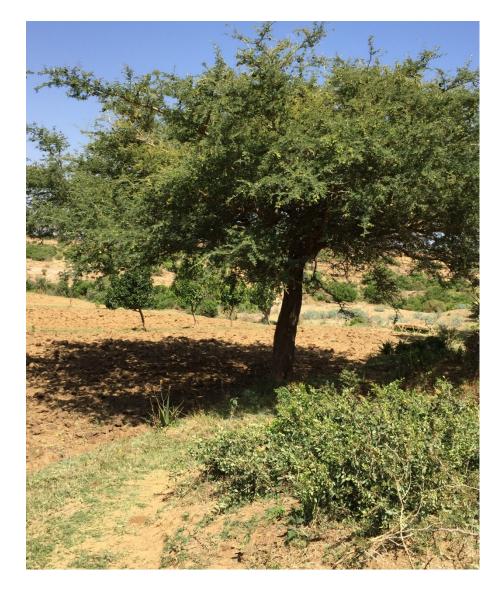
- First site: mai-weyini Abreha Weeatsbeha kebele:
 - Observed irrigated plots with "momona" tree – acacia spp which is used for land fertility,
 - Free grazing is prohibited in the kebele "even cattle know this",
 - Climate around the kebele improved as a result visitors advised to take enough oxygen for a year!

- Noted they are planning to raise the dams which might affect stability – instead, desilt routinely to maintain acceptable water level,
- Fish farming can be introduced in the ponds,

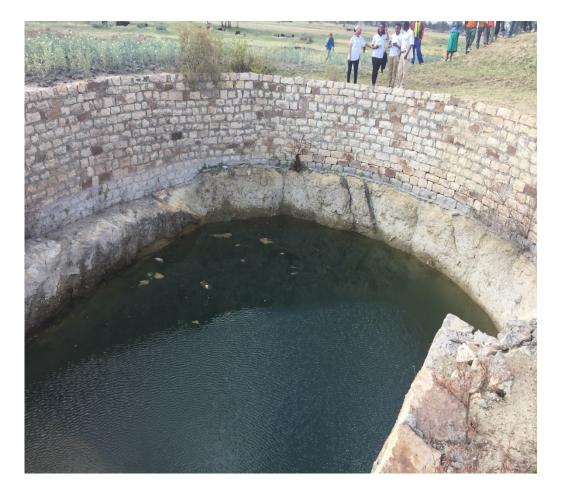
- Second site: Giraras kebele in Hawzen woreda:
 - Shallow hand-dug wells enriched as a result of deep trenches,
 - Deep trenches sustain wells,

• Use of irrigation type (furrow, drip,...) should be considered in view of the water quality and soil characteristics

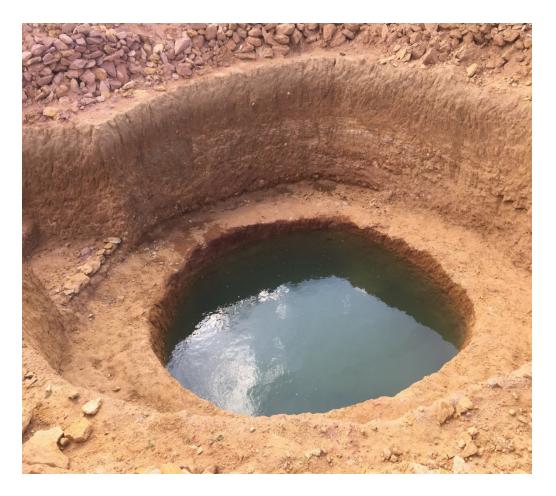
- Third site: Giraras kebele in Hawzen kebele:
 - Pond from roadside run-off followed by hand-dug well to improve water quality,

- under construction, but good to speed up the construction of retaining wall,
- Protection around the ponds and wells to enhance safety

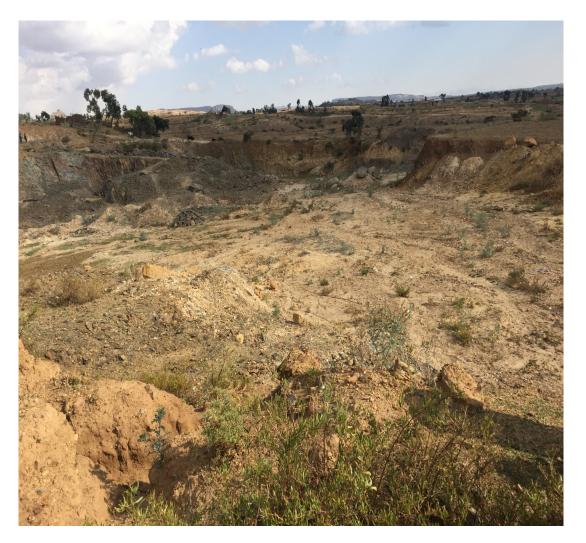
- Fourth site: around Fireweiny town:
 - Borrow pit and drainage from town
 - Down slope community protected from flood as a result,
- Issues:
 - Borrow pit too close to the road,
 - Health issues from the drainage from town, hygiene training to the community, integration with health sector
 - Channel requires maintenance
