Short Report on the field visit to Freweign (Sinkata)-Hawzien, and Abreha Weatsbeha-Hawzien Roads

(By: Kifle Woldearegay)

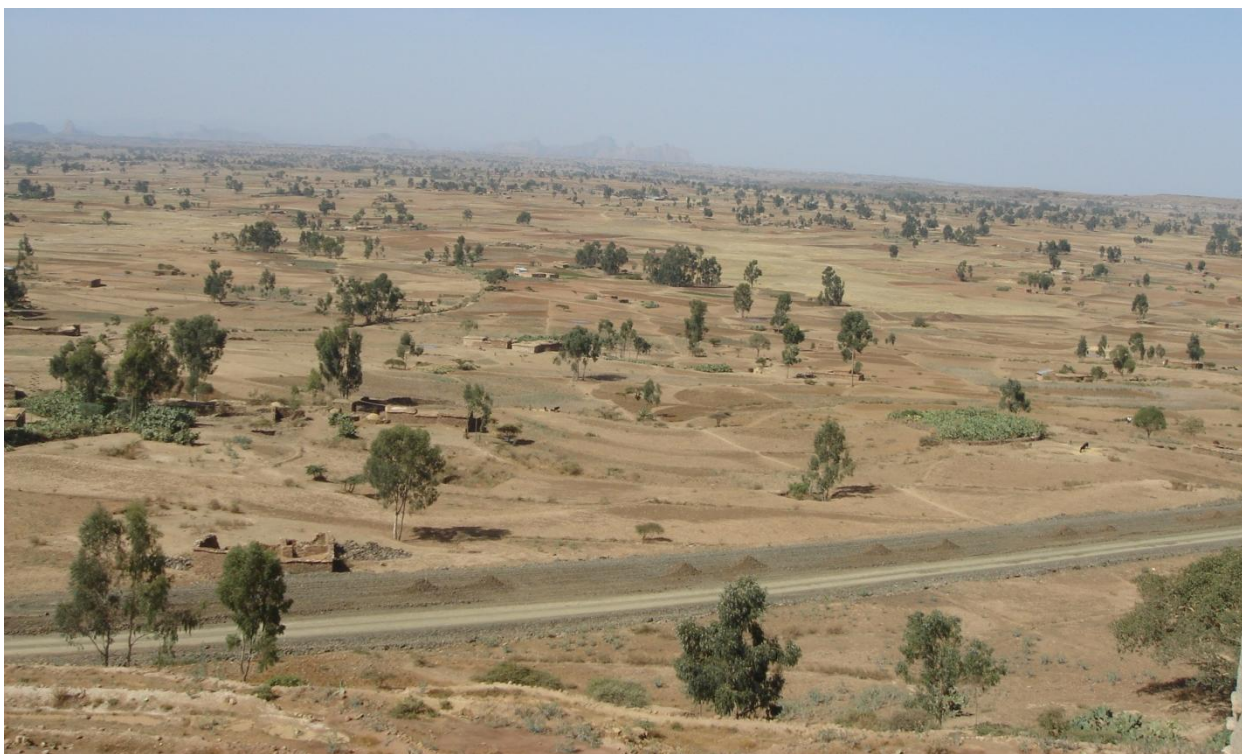
Plate 1: View of the plains at Freweign area which the road under construction passes through. The communities at down side of the road are endangered by the flood from culverts.

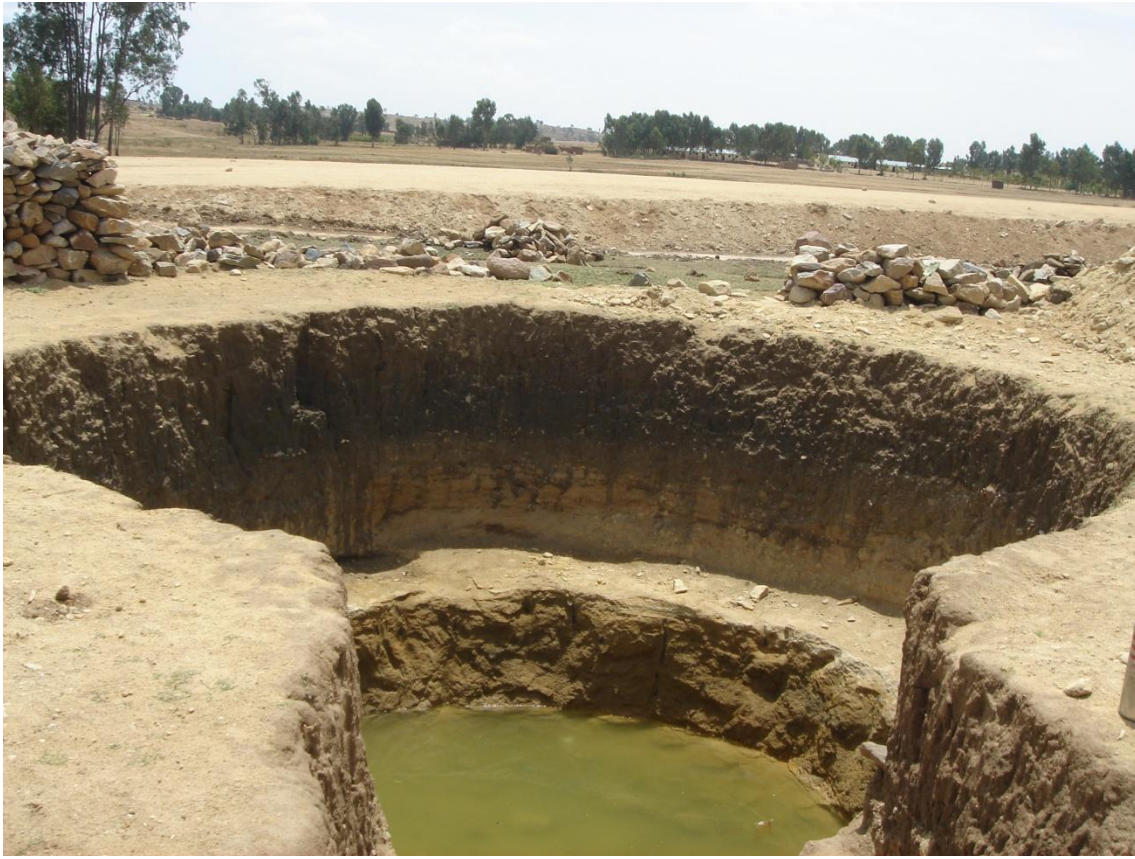
Plate 2a: A road passing close to an existing hand-dug well which is used for small-scale irrigation along the Freweign-Hawzien road.

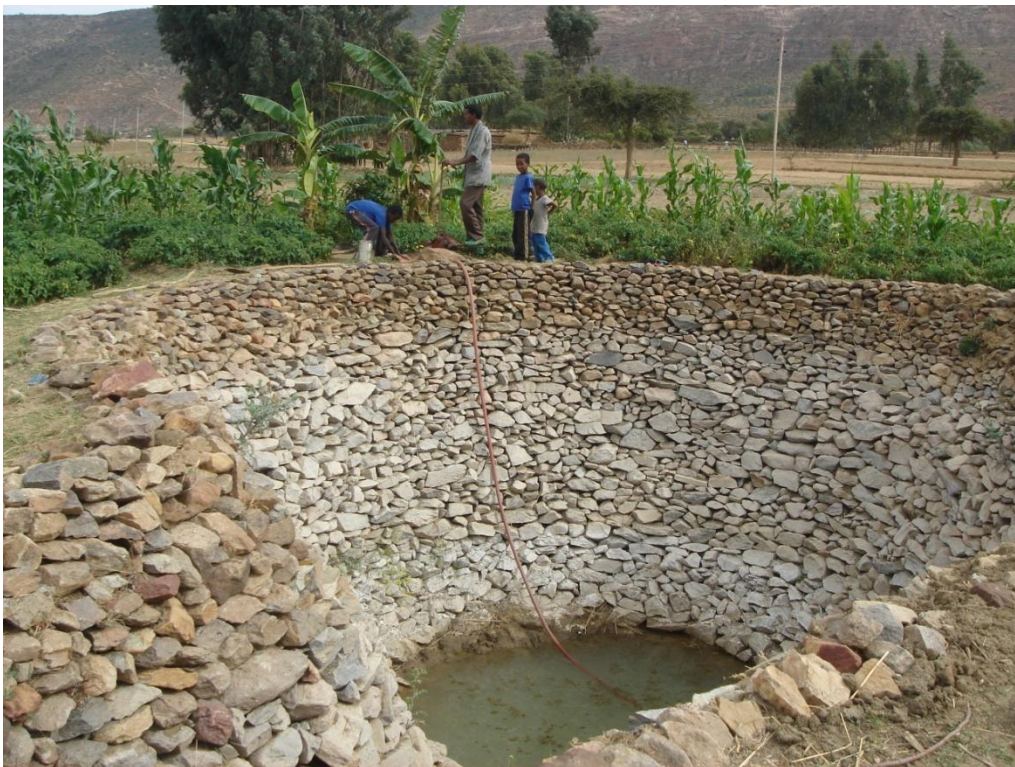
Plate 2b. Hand-dug well for small-scale irrigation along the Abreha Westbeha-Hawzien road.

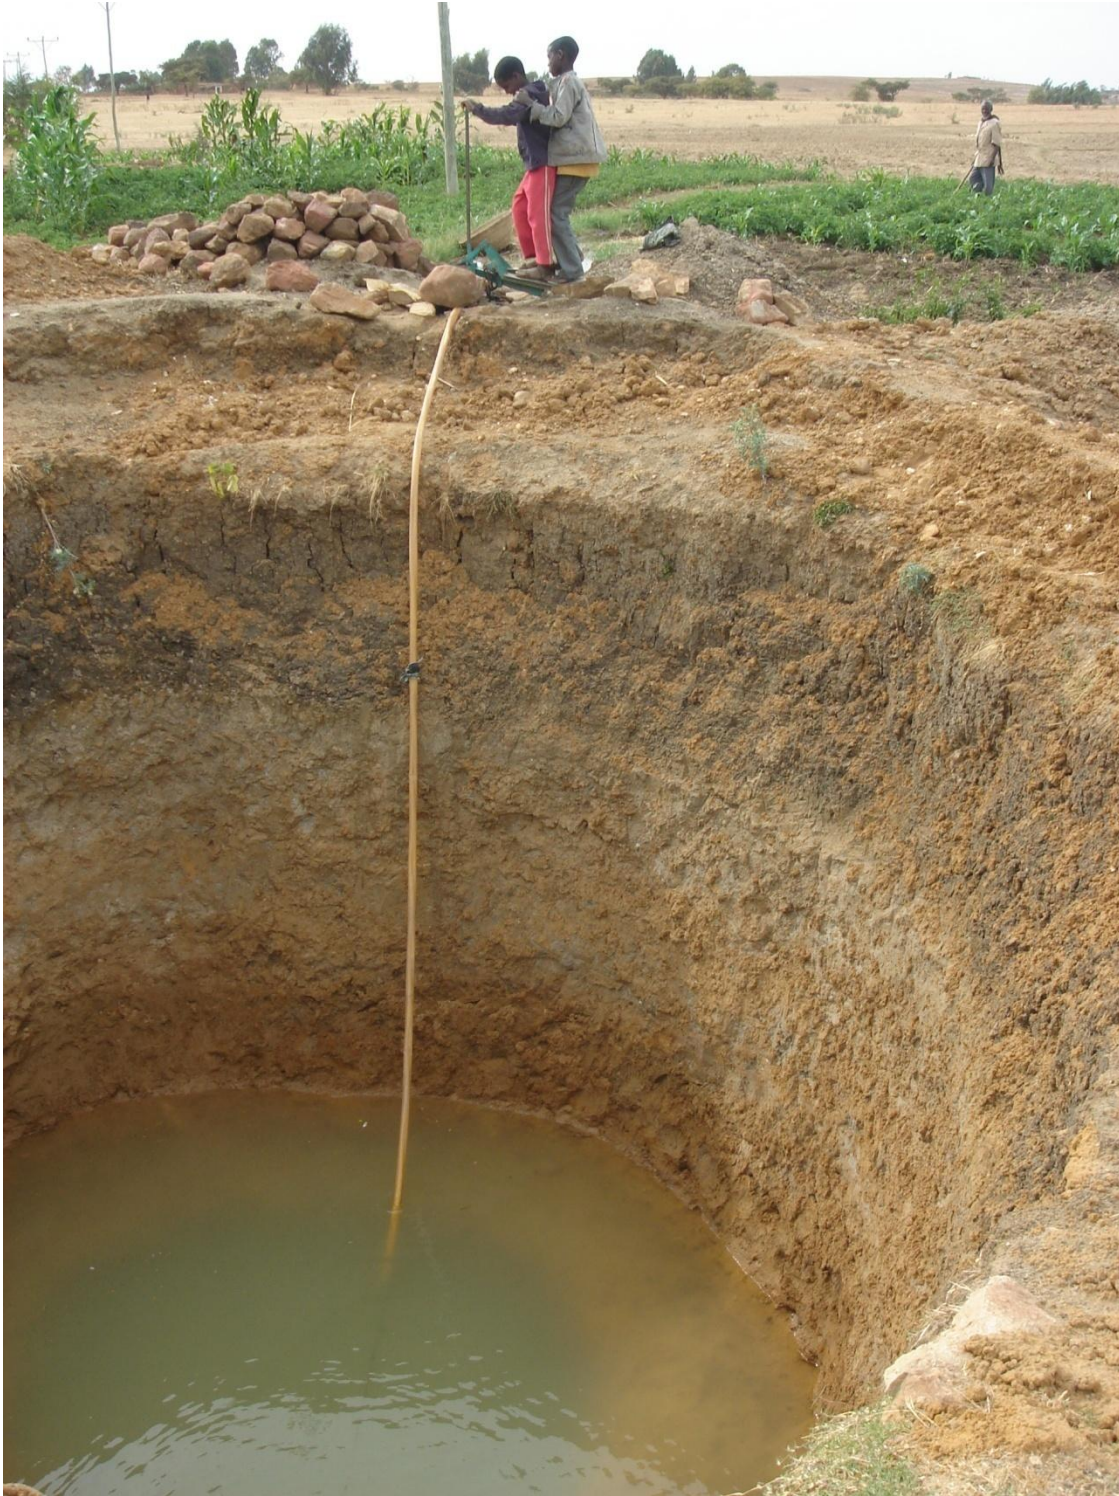
Plate 2c: Hand-dug wells used for small-scale irrigation along the Abreha Wetsbehawzien road.

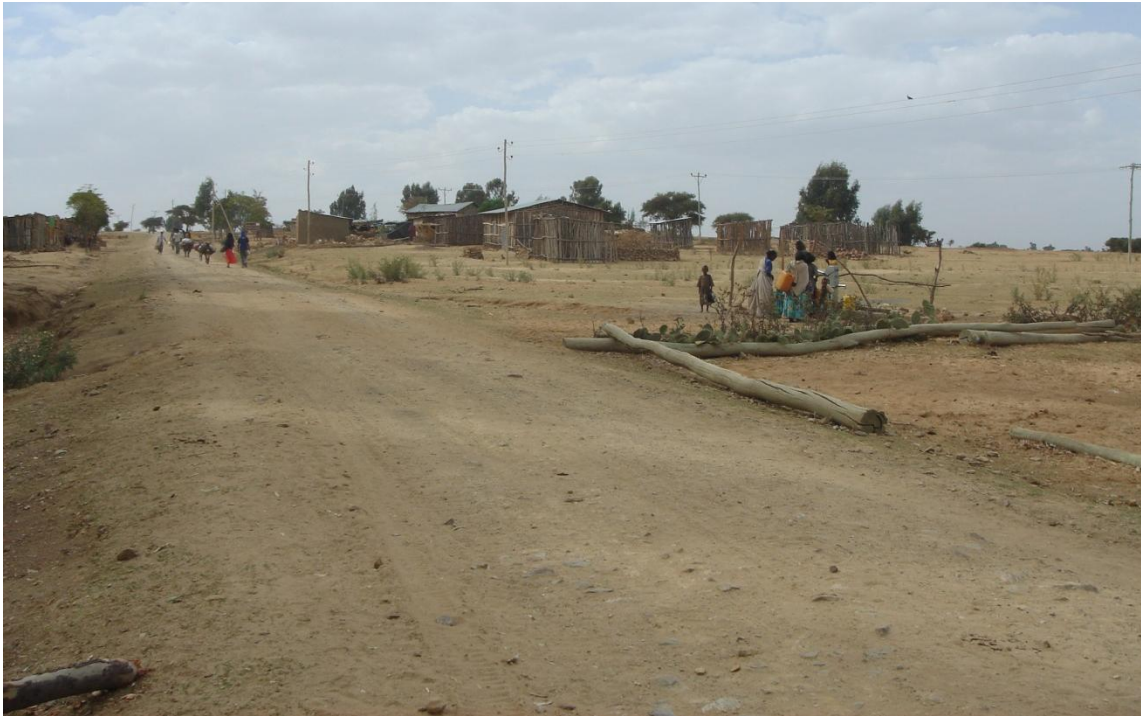
Plate 2d: Shallow well (for water supply) at the road side of the Abreha Wetsbeha-Hawzien road. Well was developed after the road construction but there is a plan to upgrade the road to an asphalt.

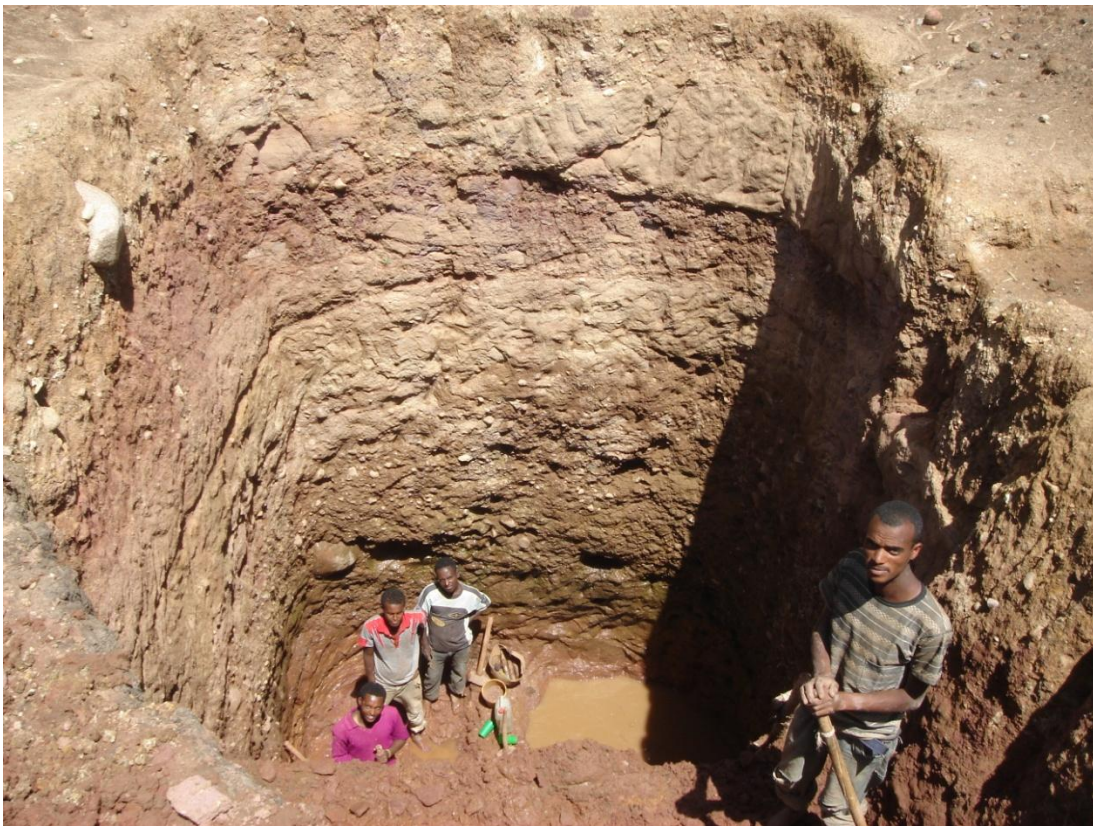
Plate 3: Hand-dug well which is under construction in Freweign (Sinkata) area .

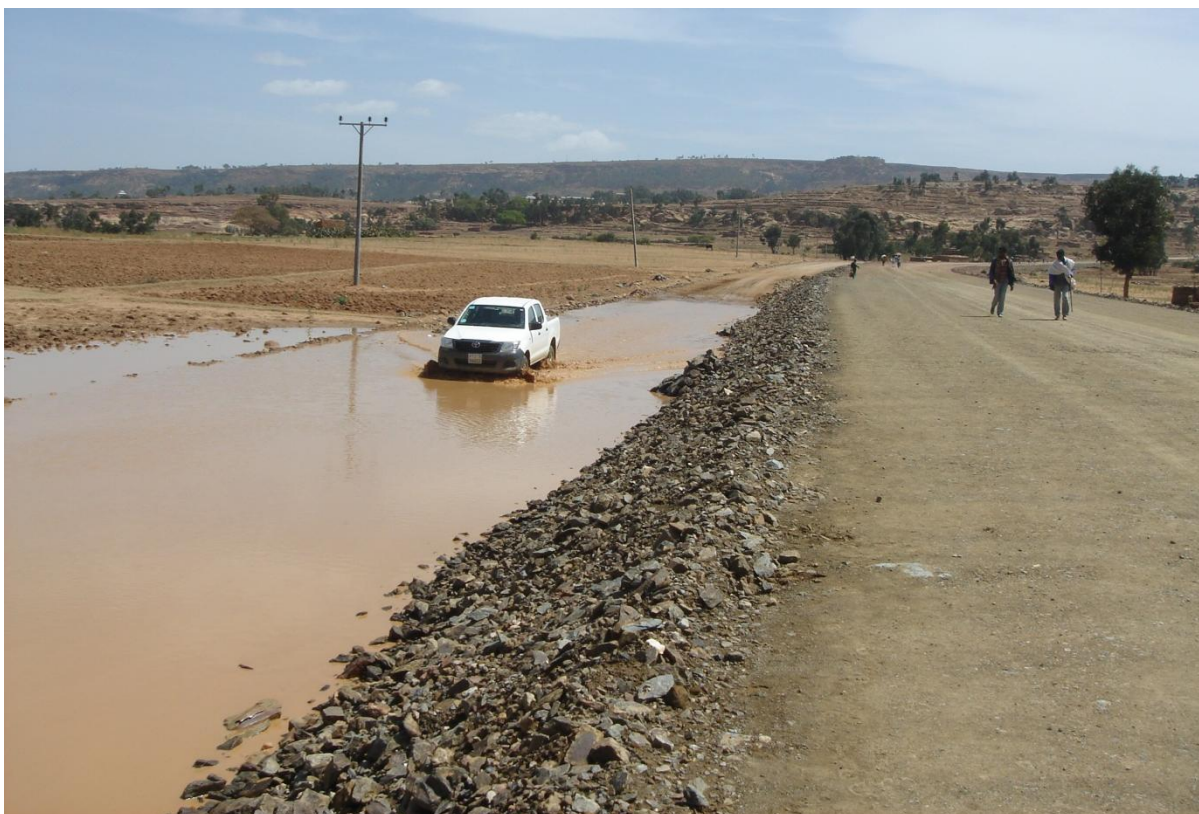
At different sections of the road which is under construction, ponding of water was observed (Plate 4) which could be guided for enhanced recharge of the shallow groundwater system of the area. It is important to mention that several hand-dug wells exist at the down sides of the roads. The communities have good experience of small-scale irrigation but they complain that many of the wells dry-up in the late months of the dry season.

Plate 4: Ponding of water at the road side of the Freweign-Hawzien road.

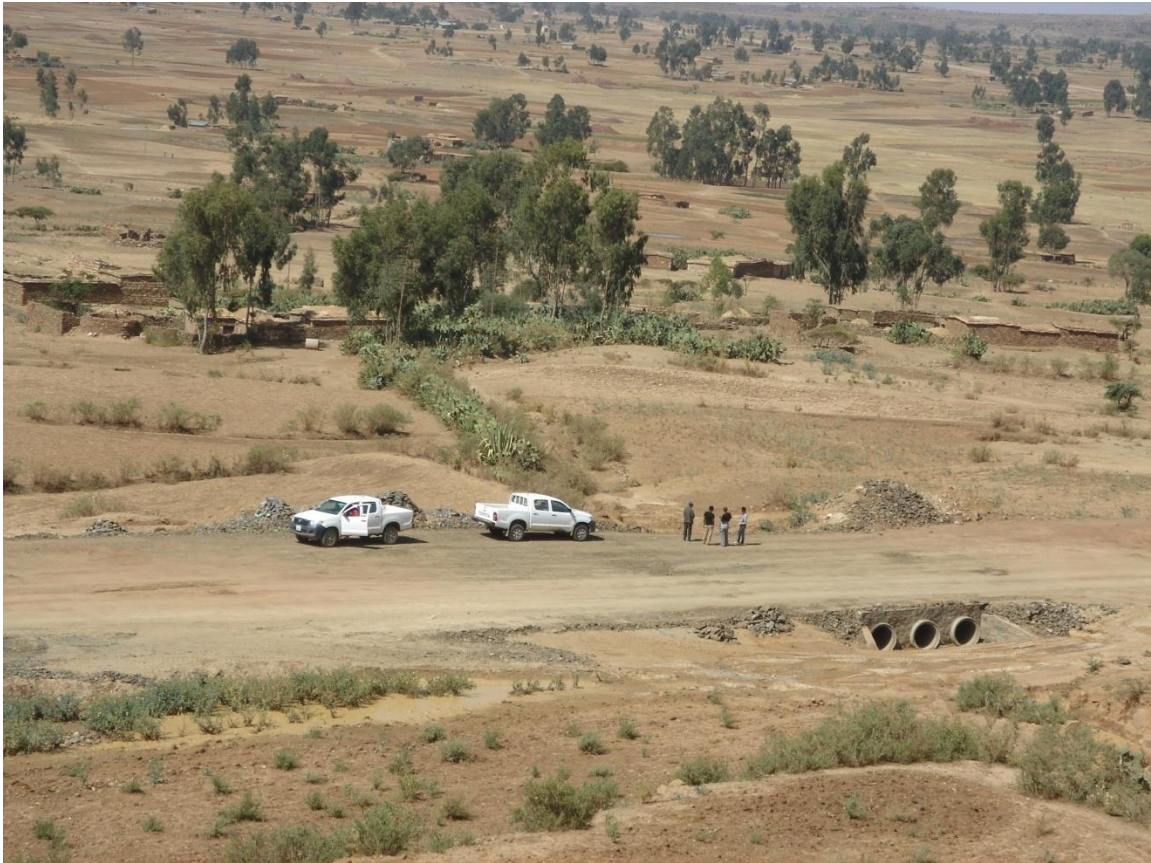
Due to the change in the hydrology of the areas, runoff from road sides and upslope is affecting communities (Plate 5). The communities are made complaints that their farm land and dwelling houses is affected by the flood (Plate 6). Some of the surface reservoirs (Horeye) is also filled with flood water (silting-up the reservoirs) as a result of the road construction (Plate 7).

Plate 5: Ponding of water at the road side and endangered dwelling houses from floods from culverts. The consultant of the road plans to channel the flow from culverts down up to 1km from the road.

- The consultant's as well as the client's concern of channeling the water from roads to several Kms distance could be solved by trying to recharge the groundwater system.

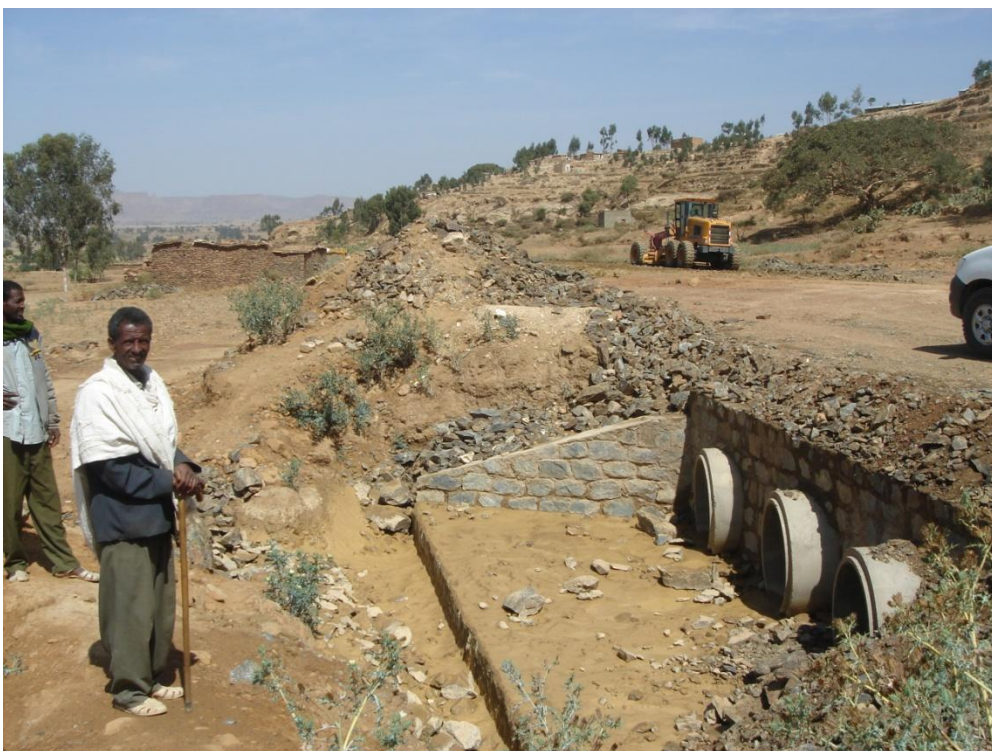
Plate 6: Representative of the communities affected by the flood explaining the issue at Freweign-Hawzien road.

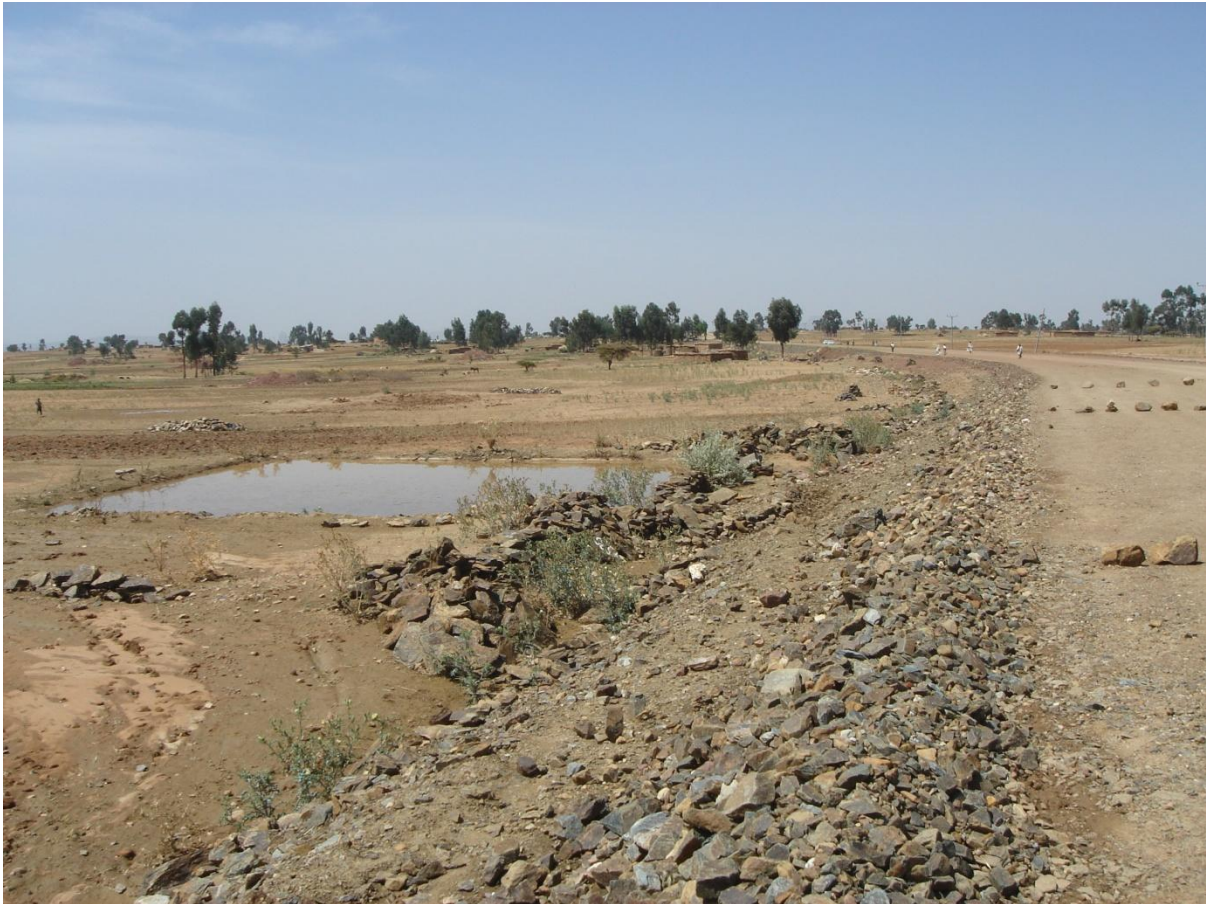
Plate 7: A 3m deep surface reservoir (Horeye) filled with flood water from road sides at the Freweign-Hawzien road.
