# Water Harvesting from Roads in Tigray, Northern Ethiopia: In Figures

***Kifle Woldearegay (Mekelle University, Ethiopia)***

***Frank Van Steengergen (MetaMeta, The Netherlands)***

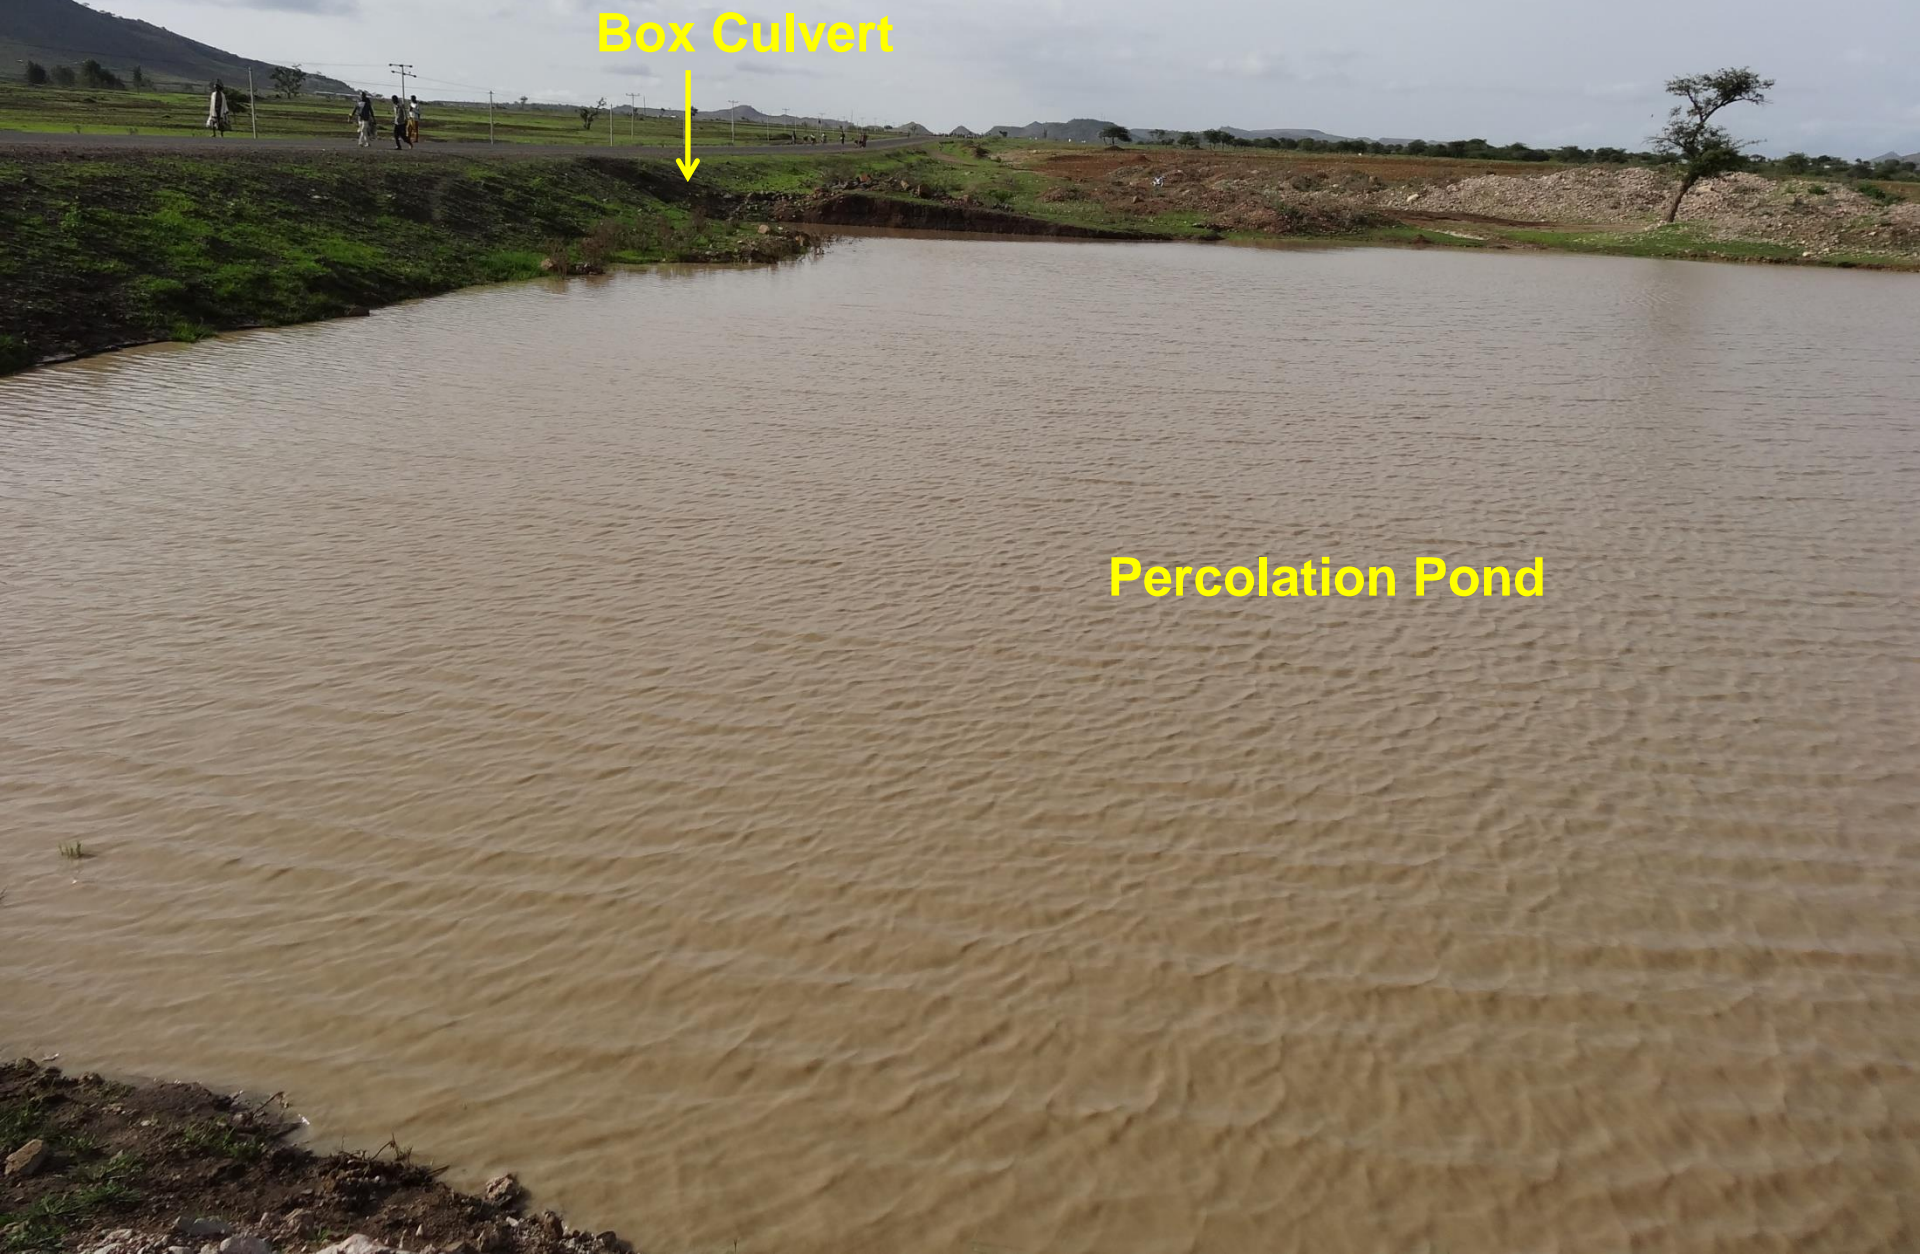
# Plate 1: Water from a box culvert is channeled into a percolation pond for groundwater recharge in Tigray, Northern Ethiopia

**Box Culvert**

**Percolation Pond**

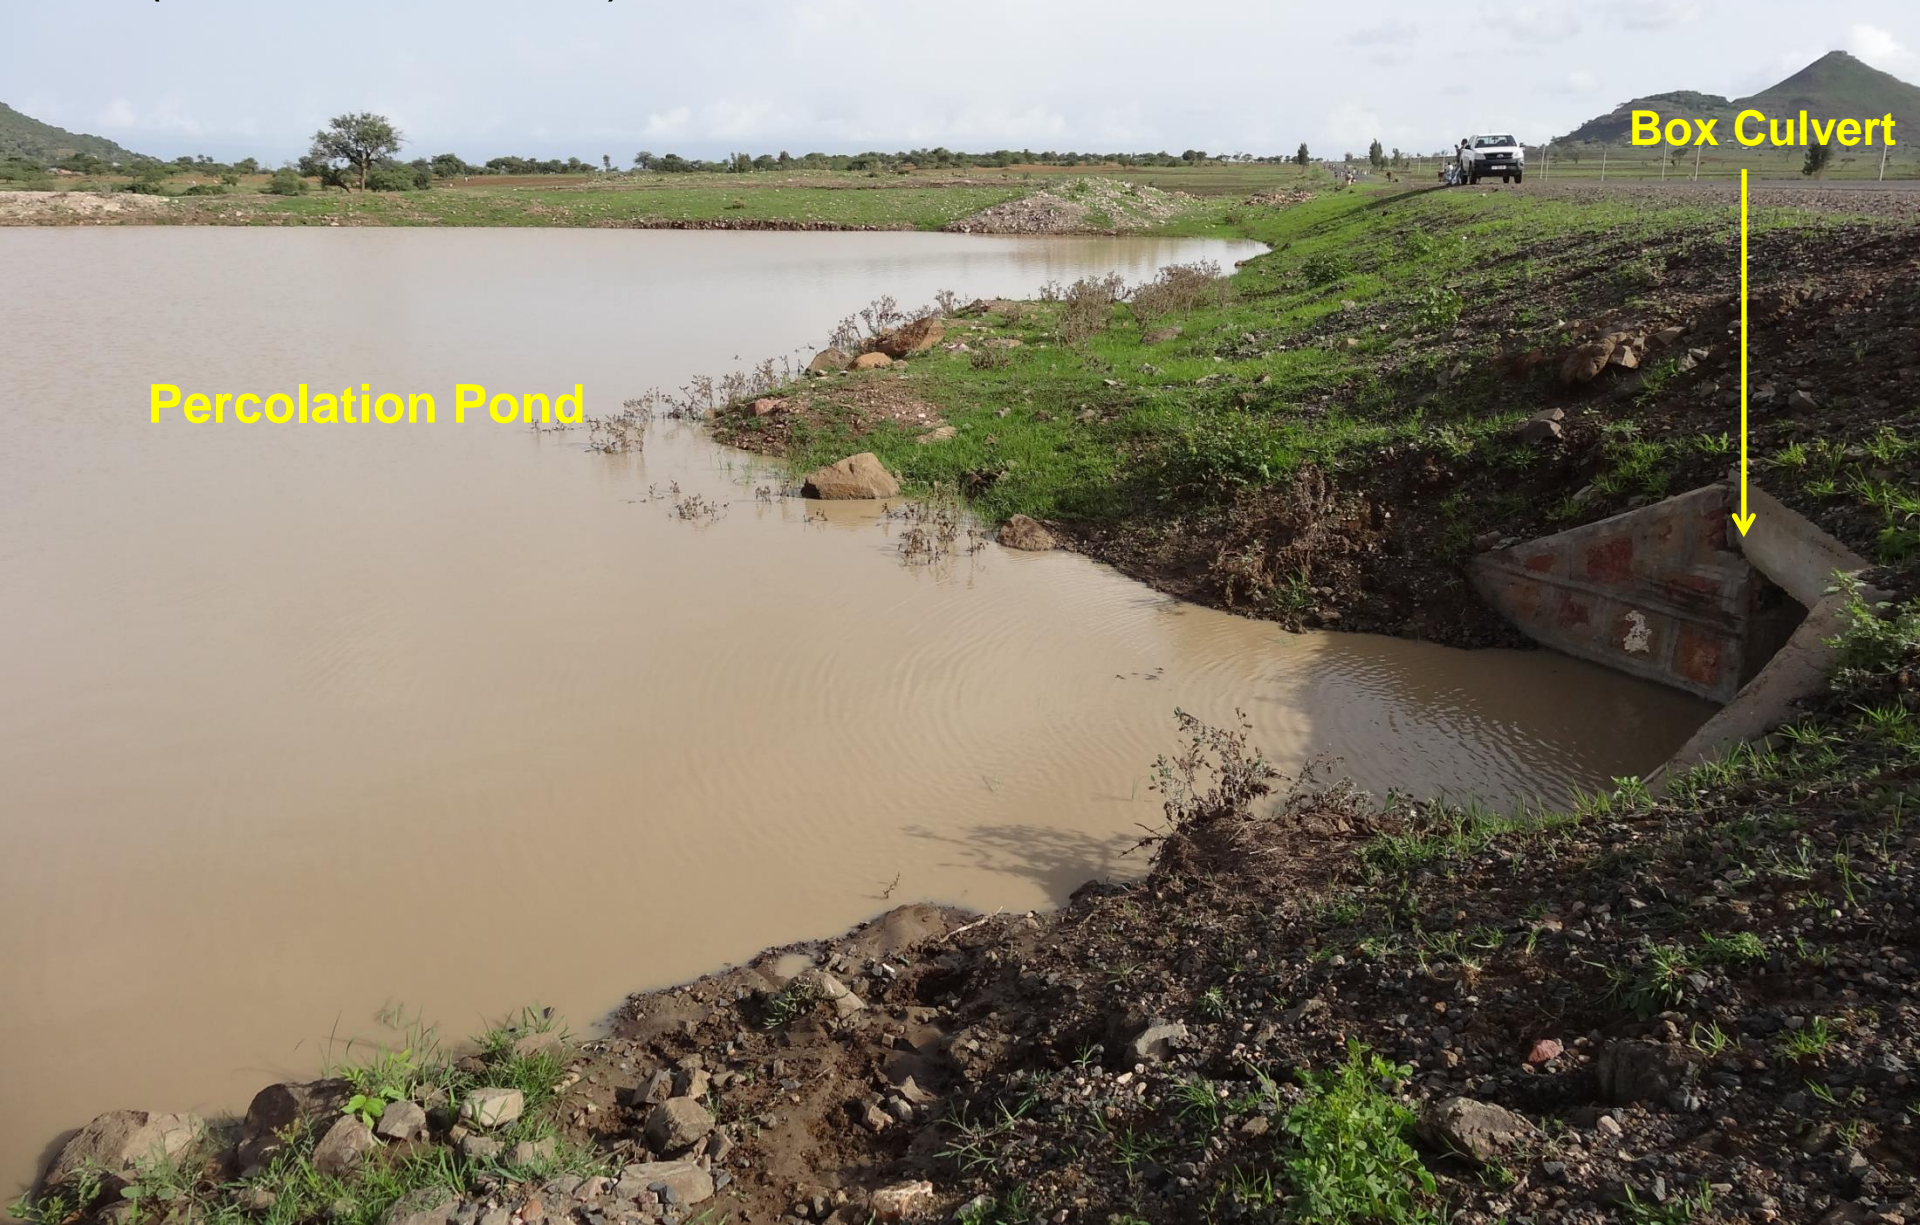
**Plate 2: Water from a box culvert is channeled into a percolation pond for groundwater recharge in Tigray, Northern Ethiopia**  
*(side view of Plate 1)*

**Percolation Pond**

**Box Culvert**

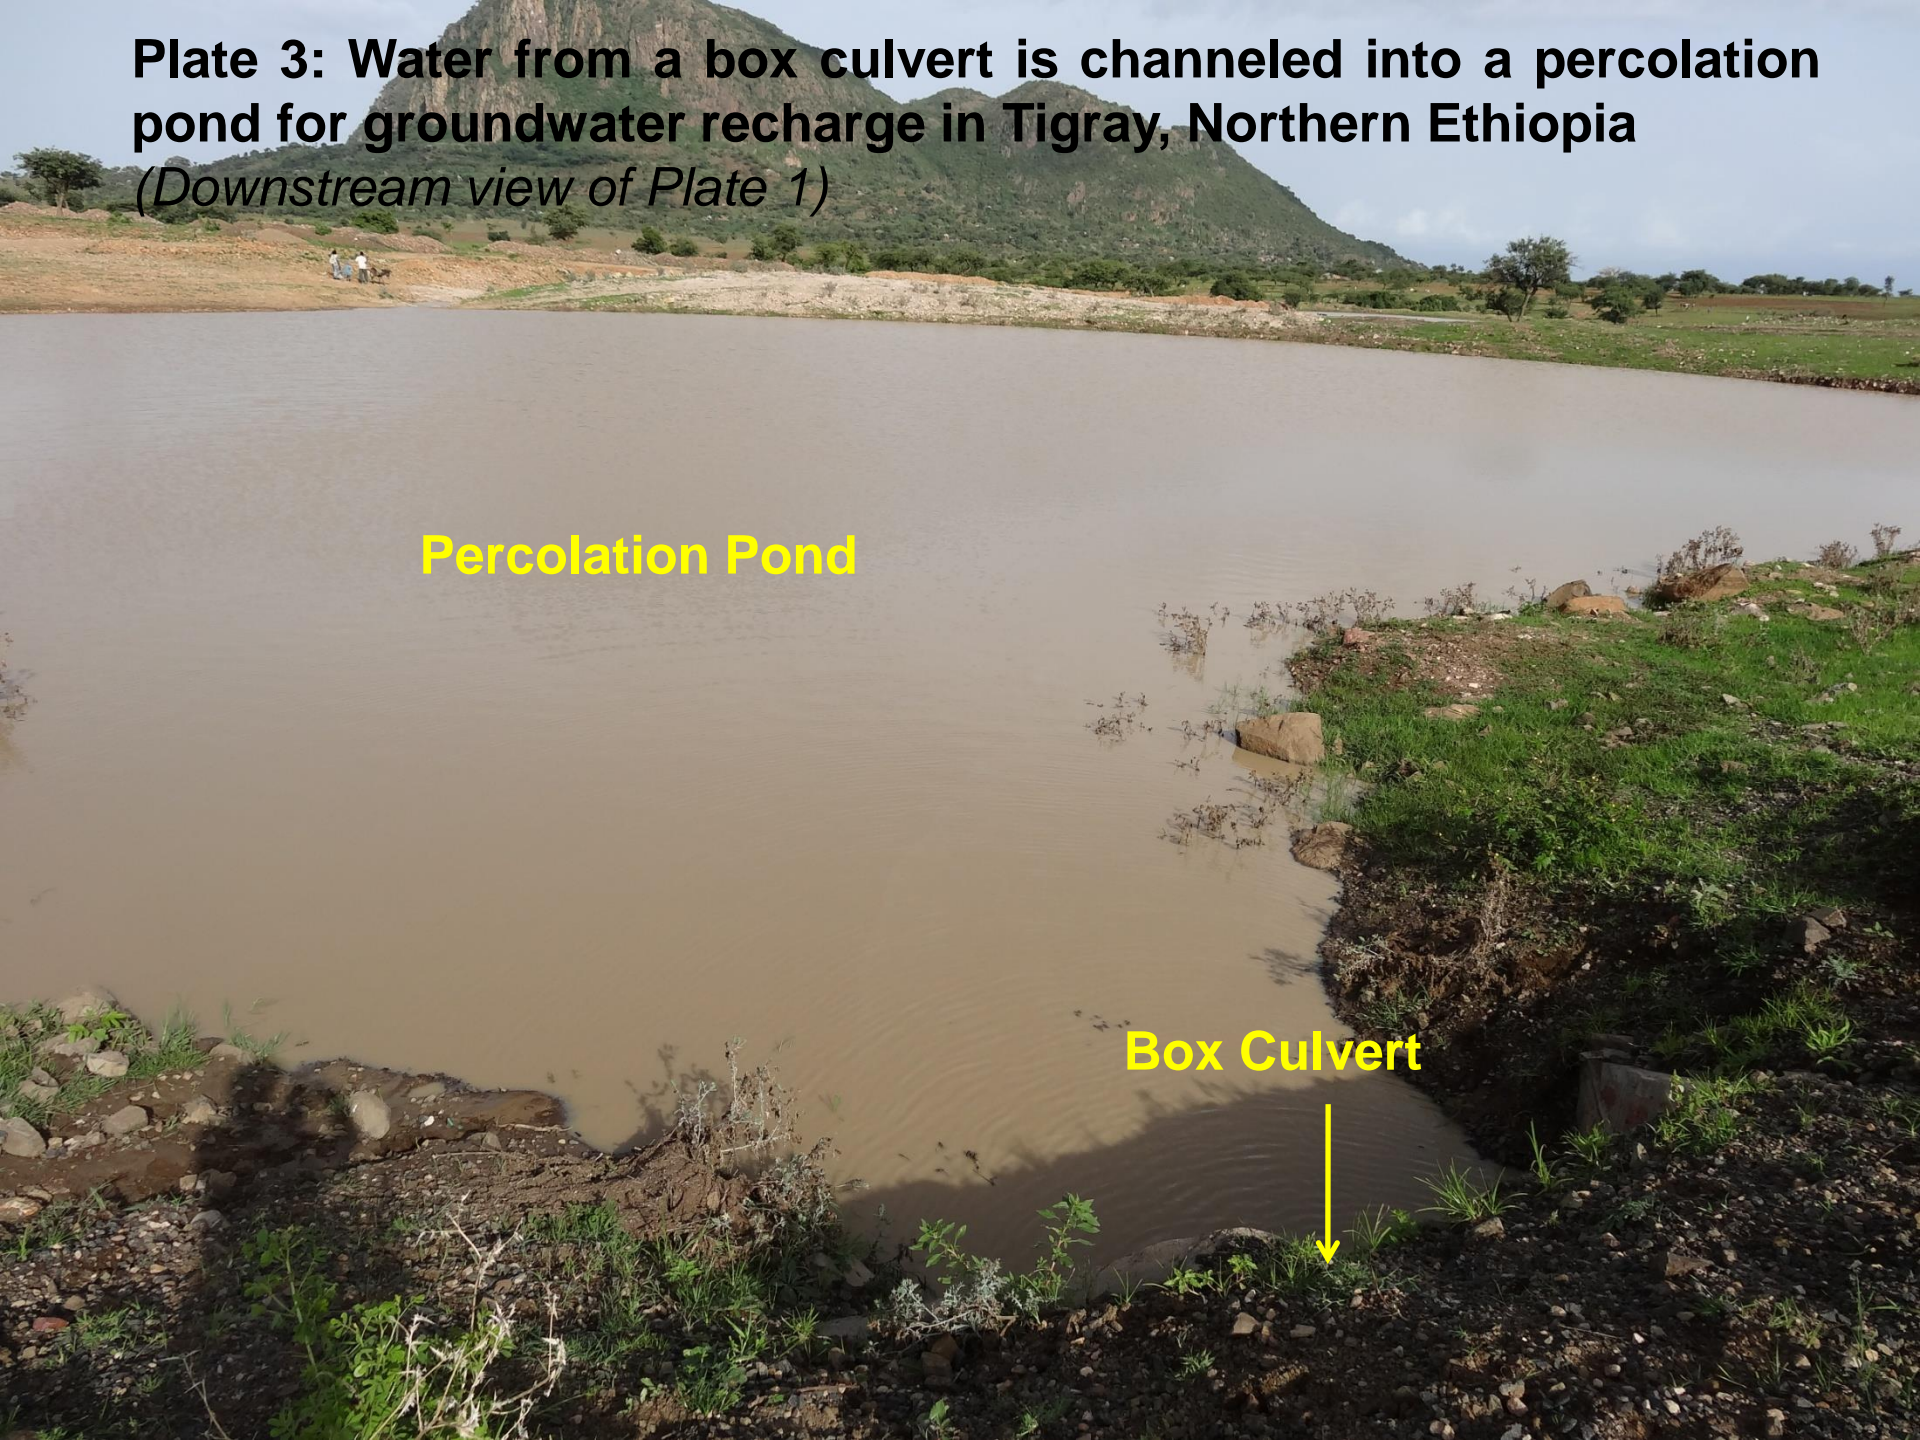
**Plate 3: Water from a box culvert is channeled into a percolation pond for groundwater recharge in Tigray, Northern Ethiopia**

*(Downstream view of Plate 1)*

**Percolation Pond**

**Box Culvert**

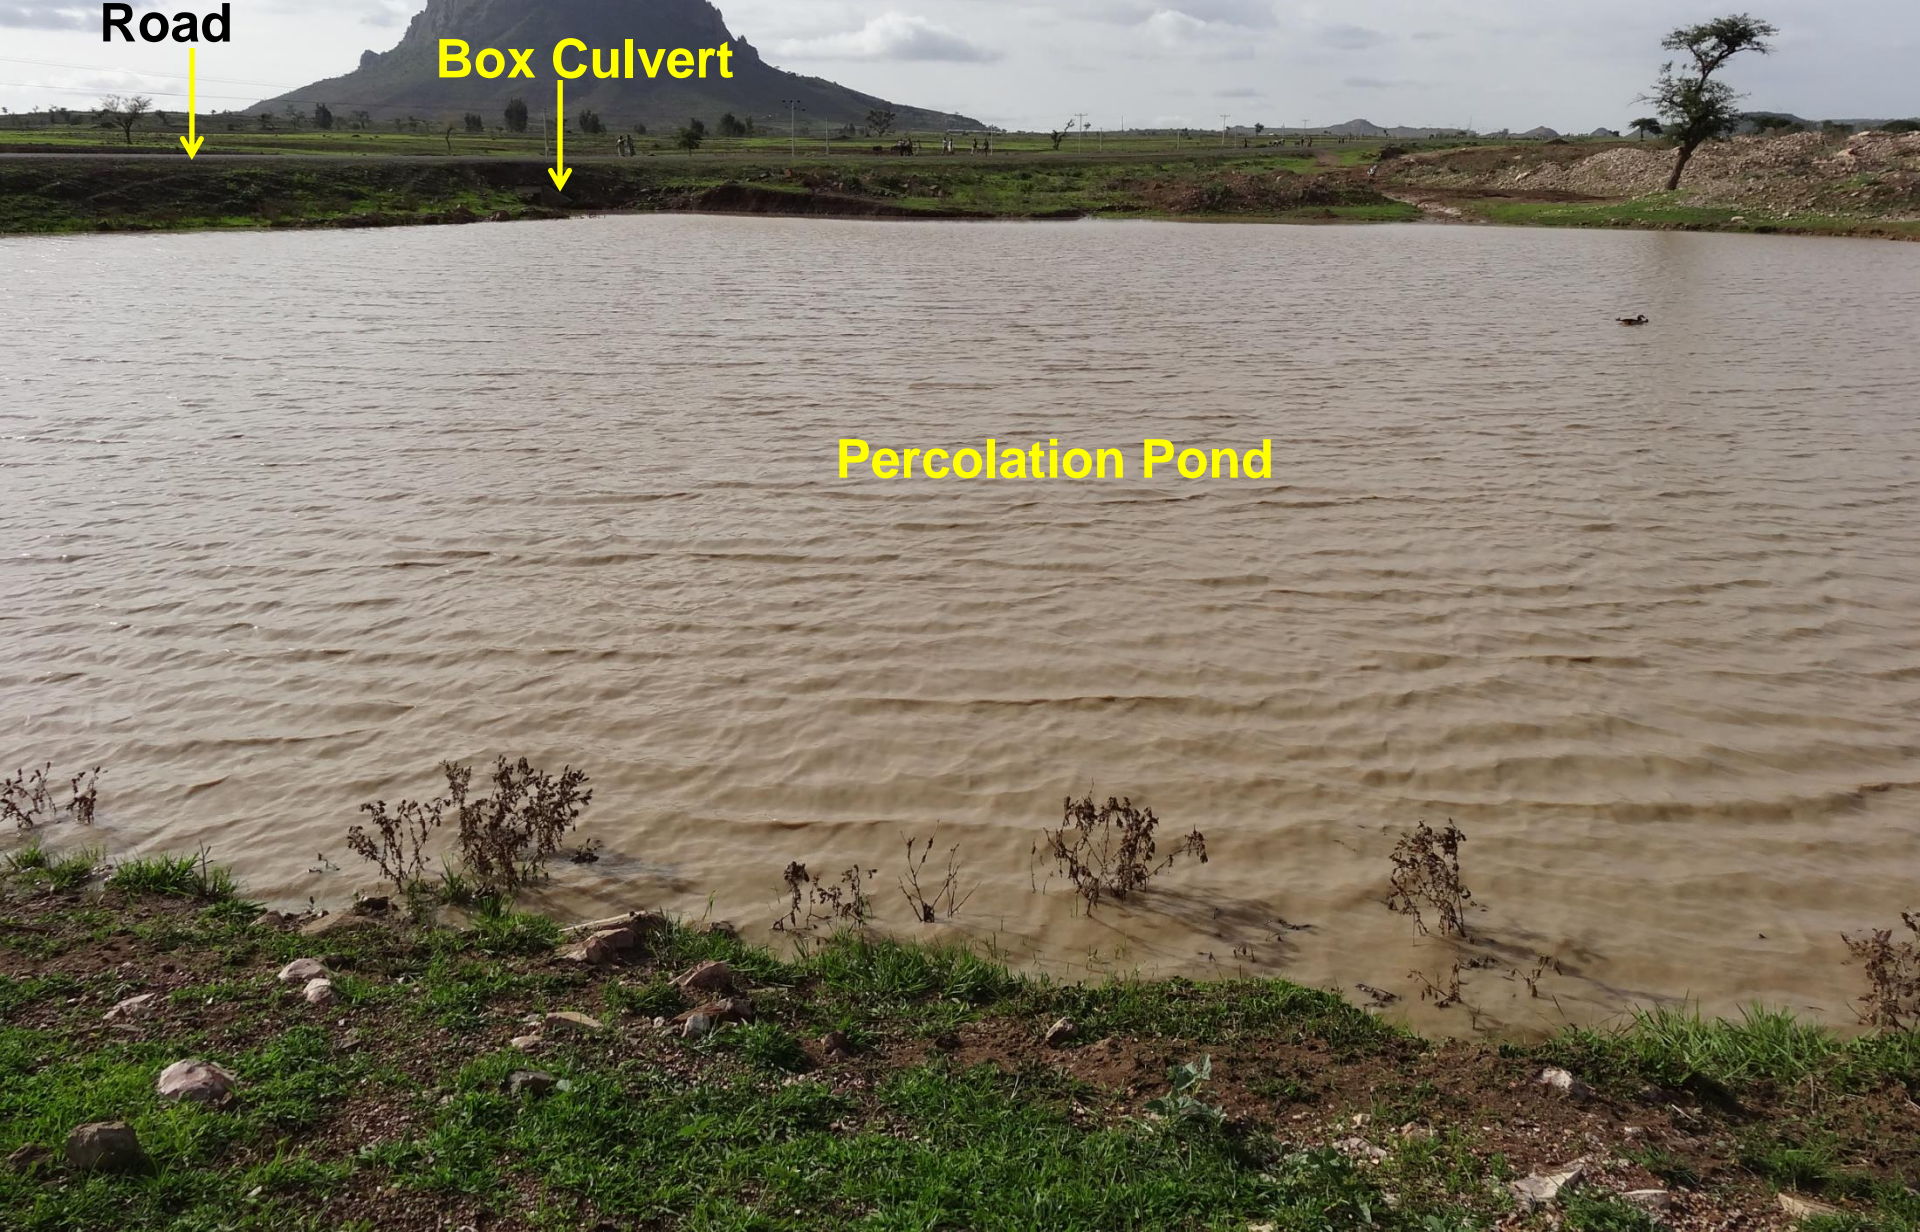
**Plate 4: Water from a box culvert is channeled into a percolation pond for groundwater recharge in Tigray, Northern Ethiopia (Upstream view of Plate 1)**

**Road**

**Box Culvert**

**Percolation Pond**

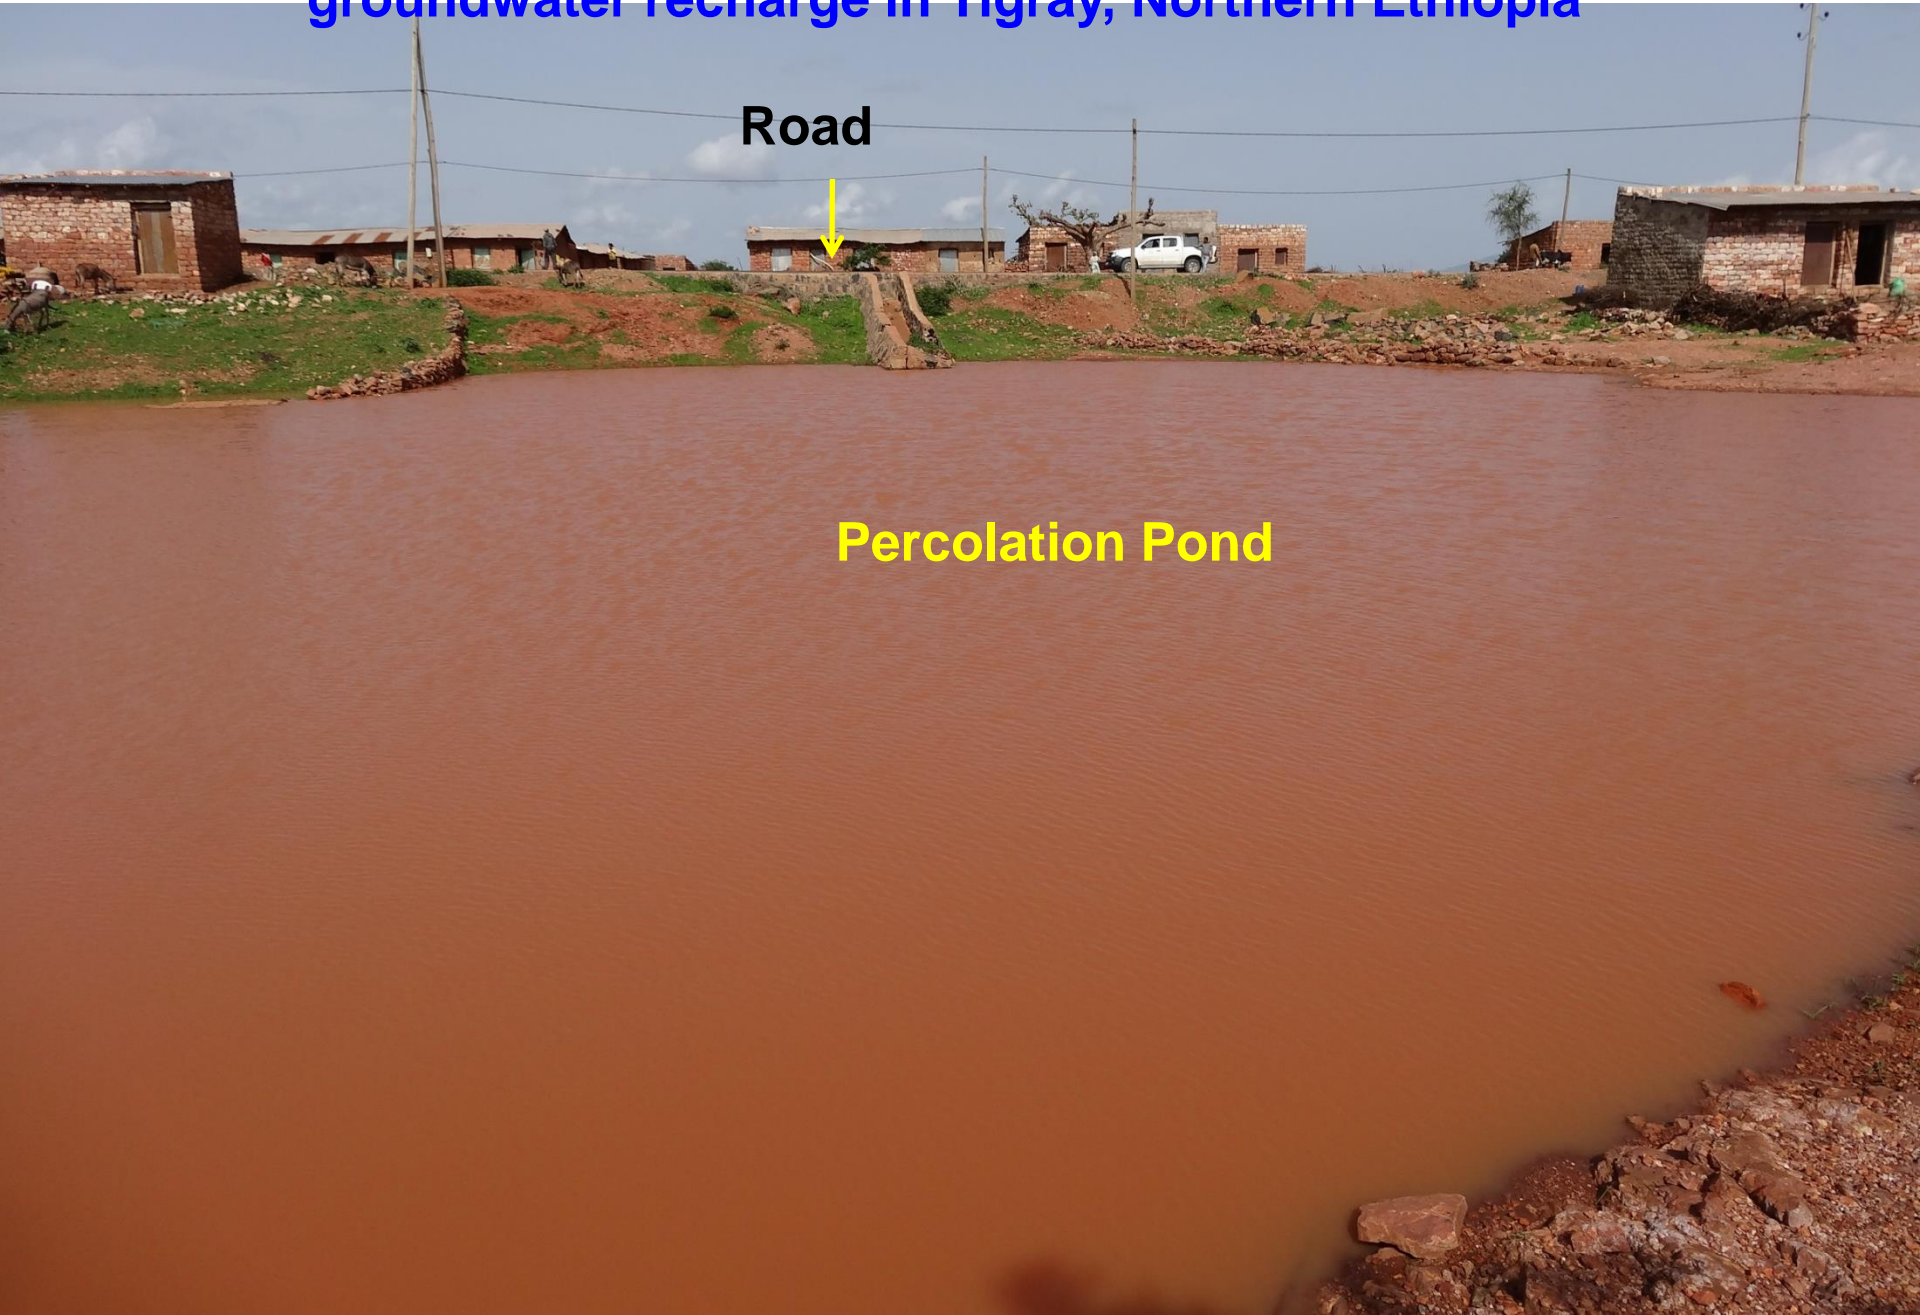
# Plate 5: Road side drainage channeled into percolation pond for groundwater recharge in Tigray, Northern Ethiopia

Road

Percolation Pond

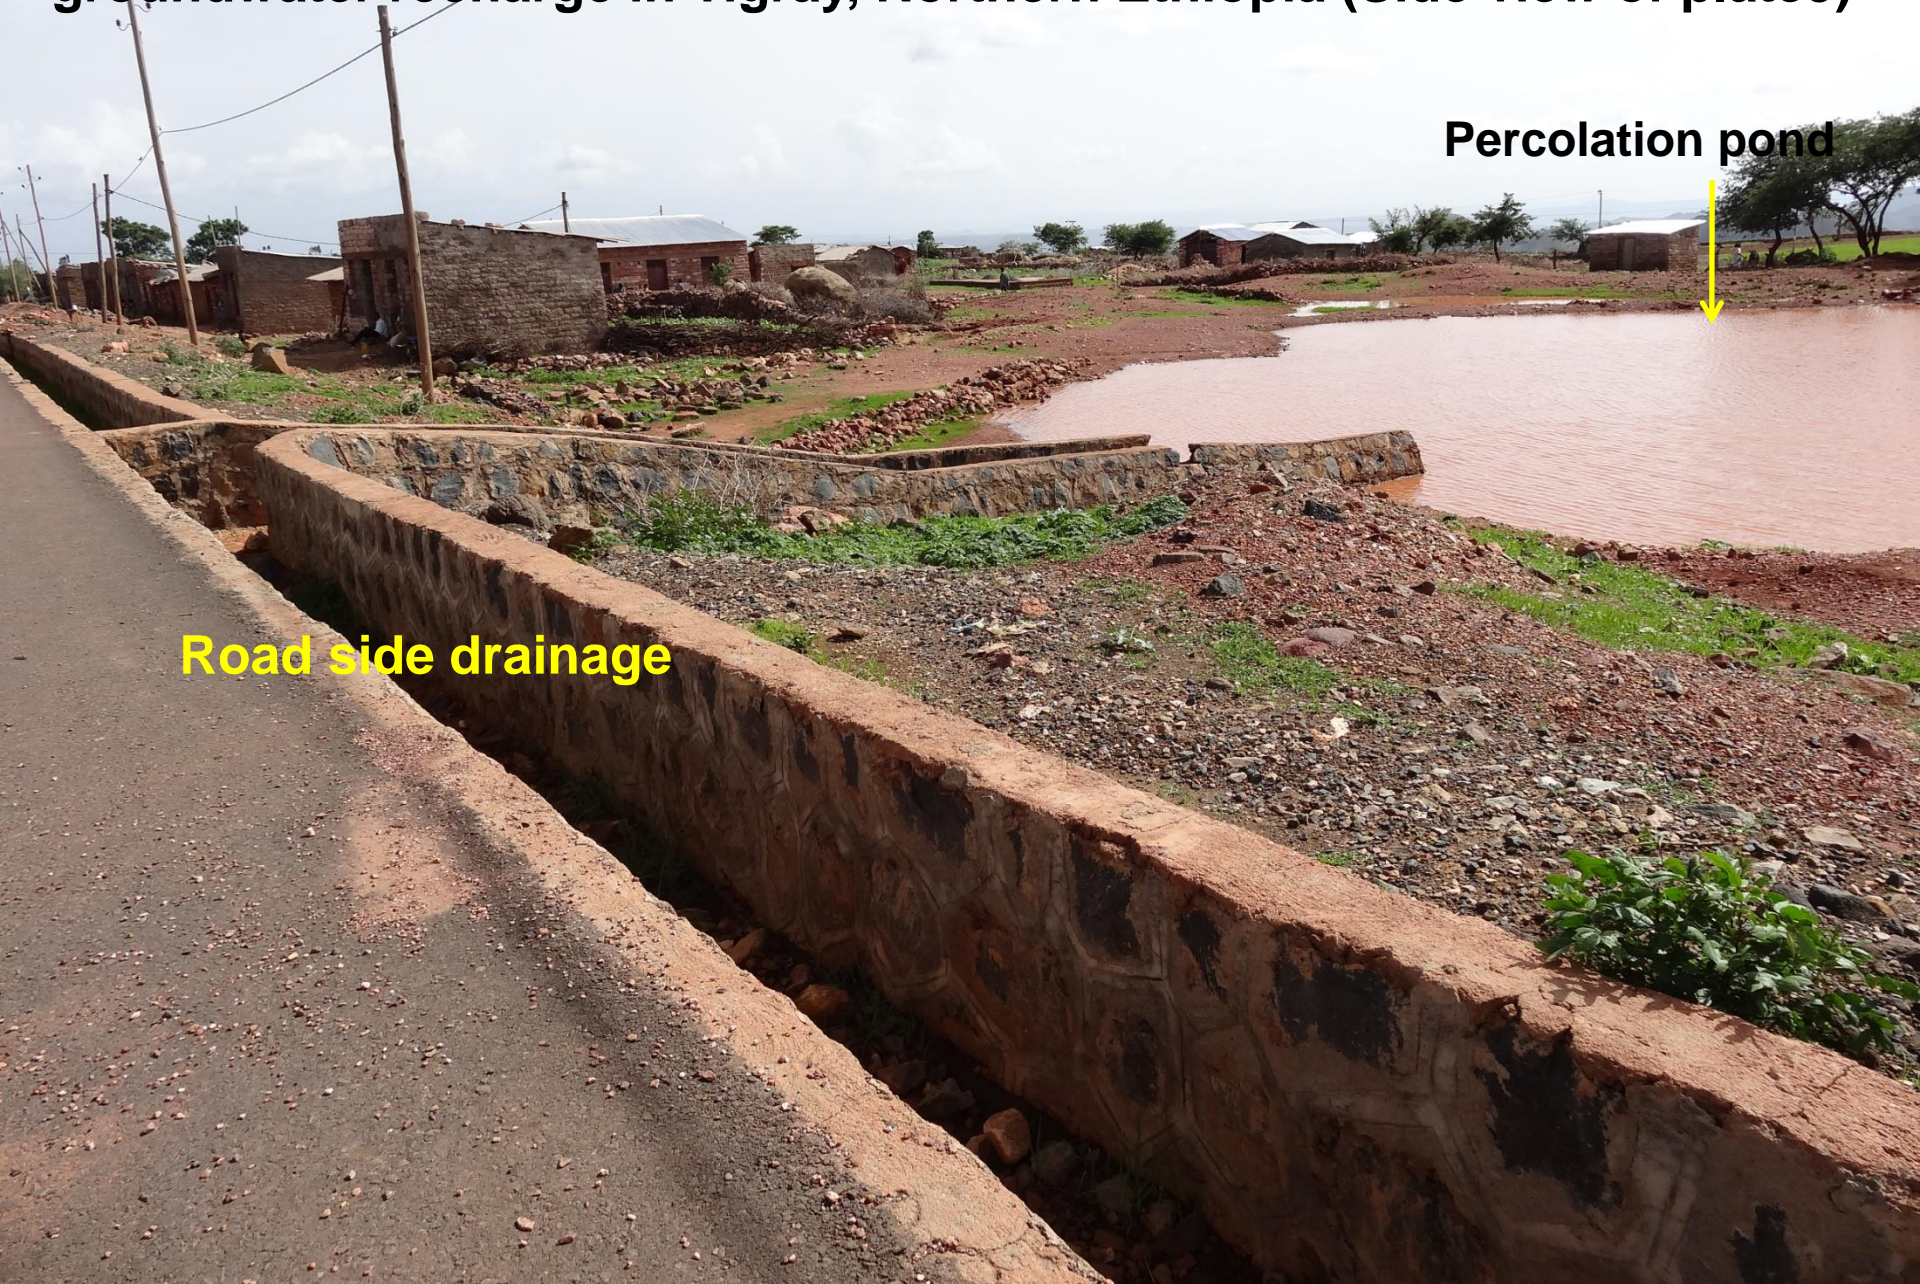
**Plate 6: Road side drainage connected to percolation pond for groundwater recharge in Tigray, Northern Ethiopia (Side view of plate5)**

**Percolation pond**

**Road side drainage**

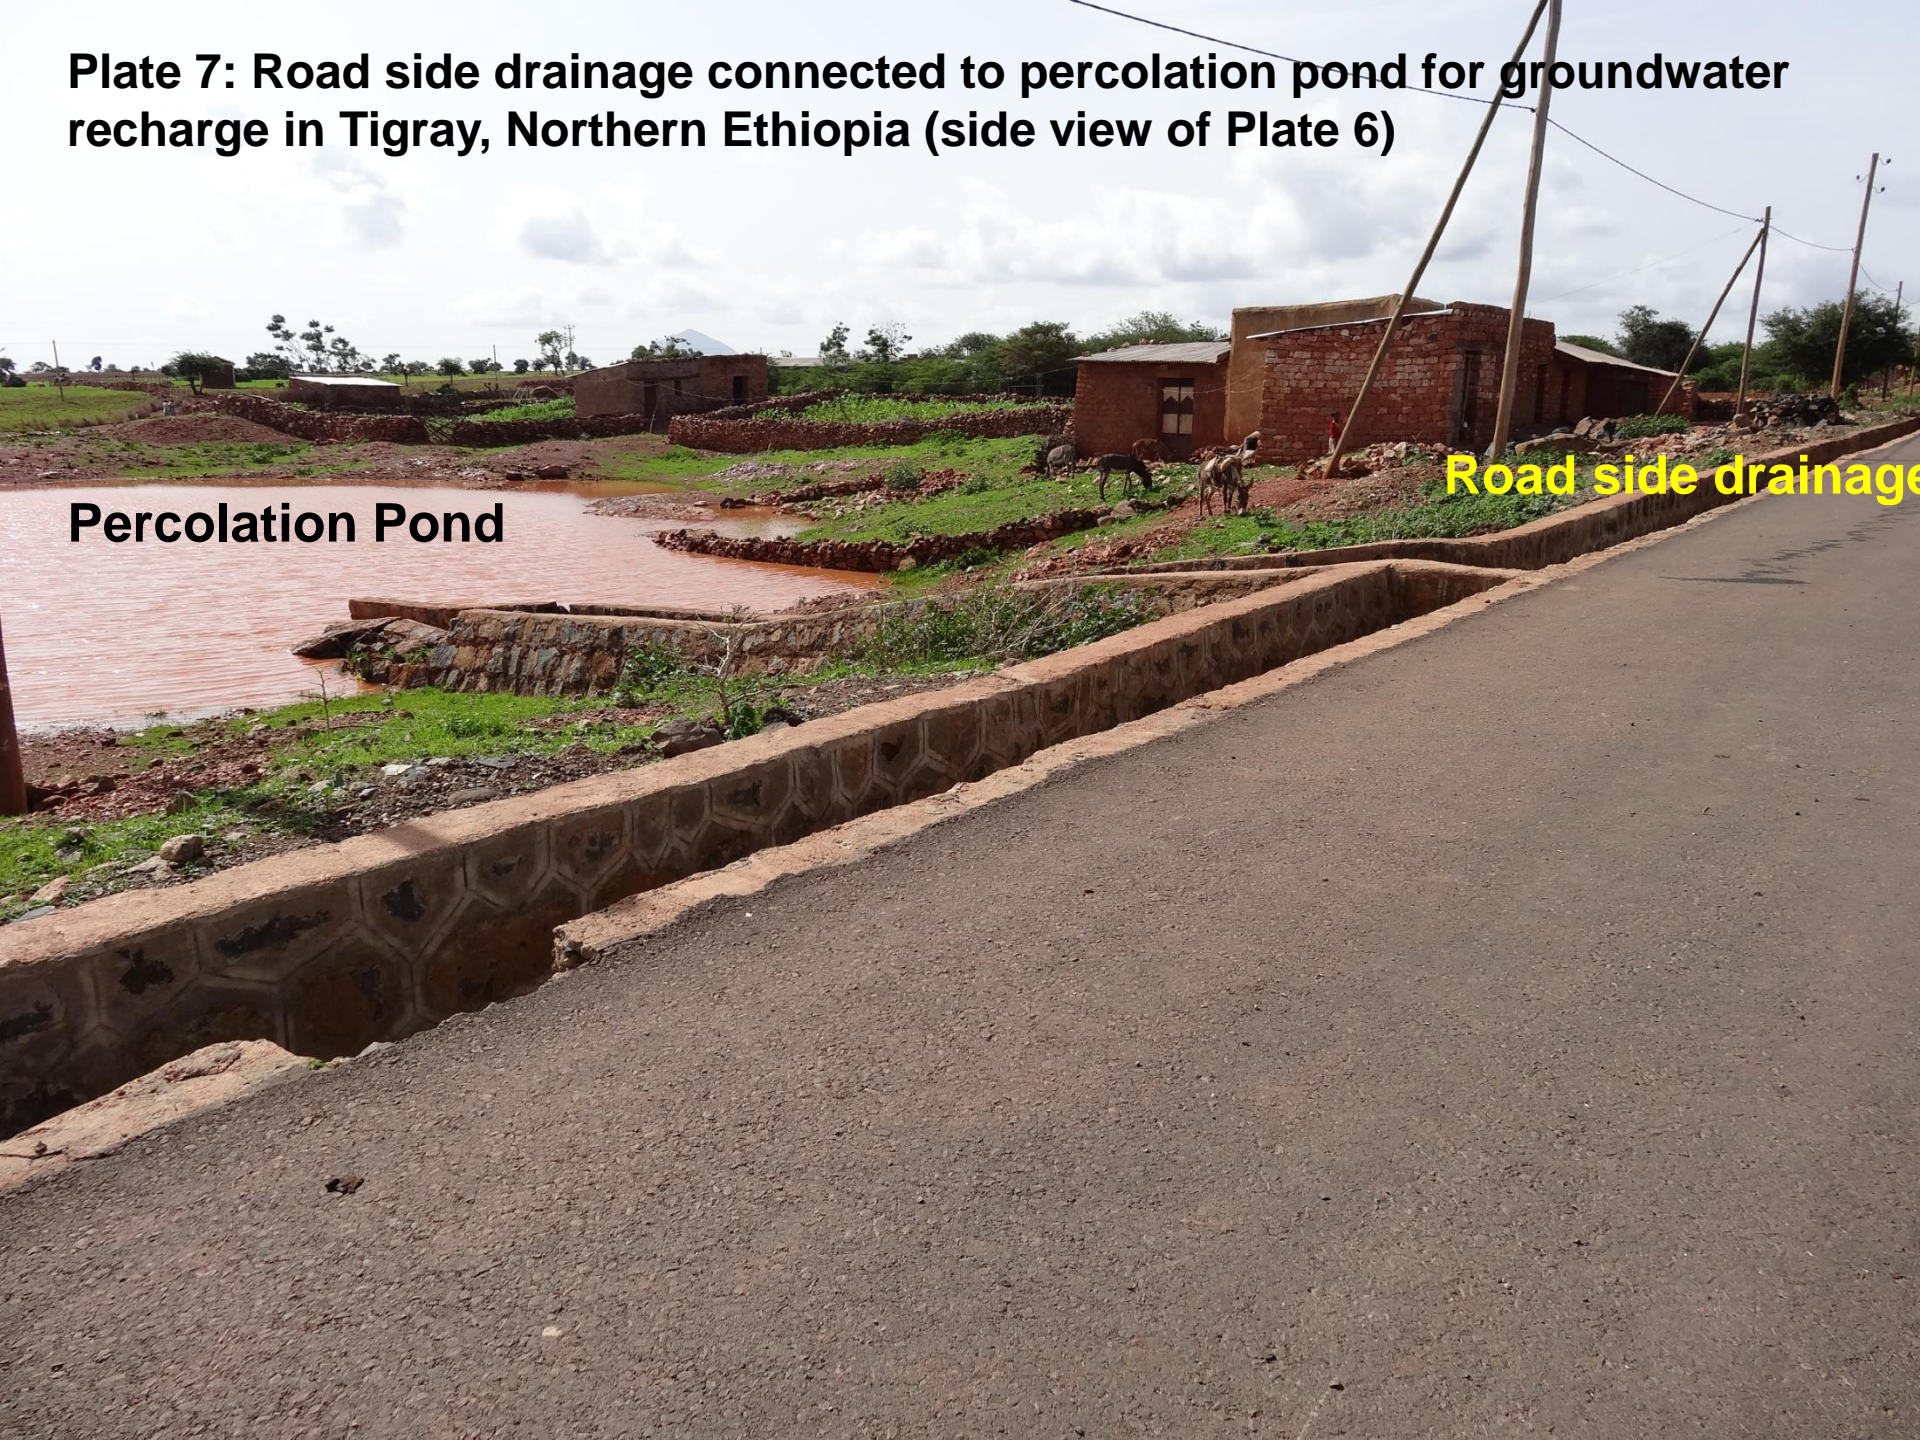
**Plate 7: Road side drainage connected to percolation pond for groundwater recharge in Tigray, Northern Ethiopia (side view of Plate 6)**

**Percolation Pond**

**Road side drainage**

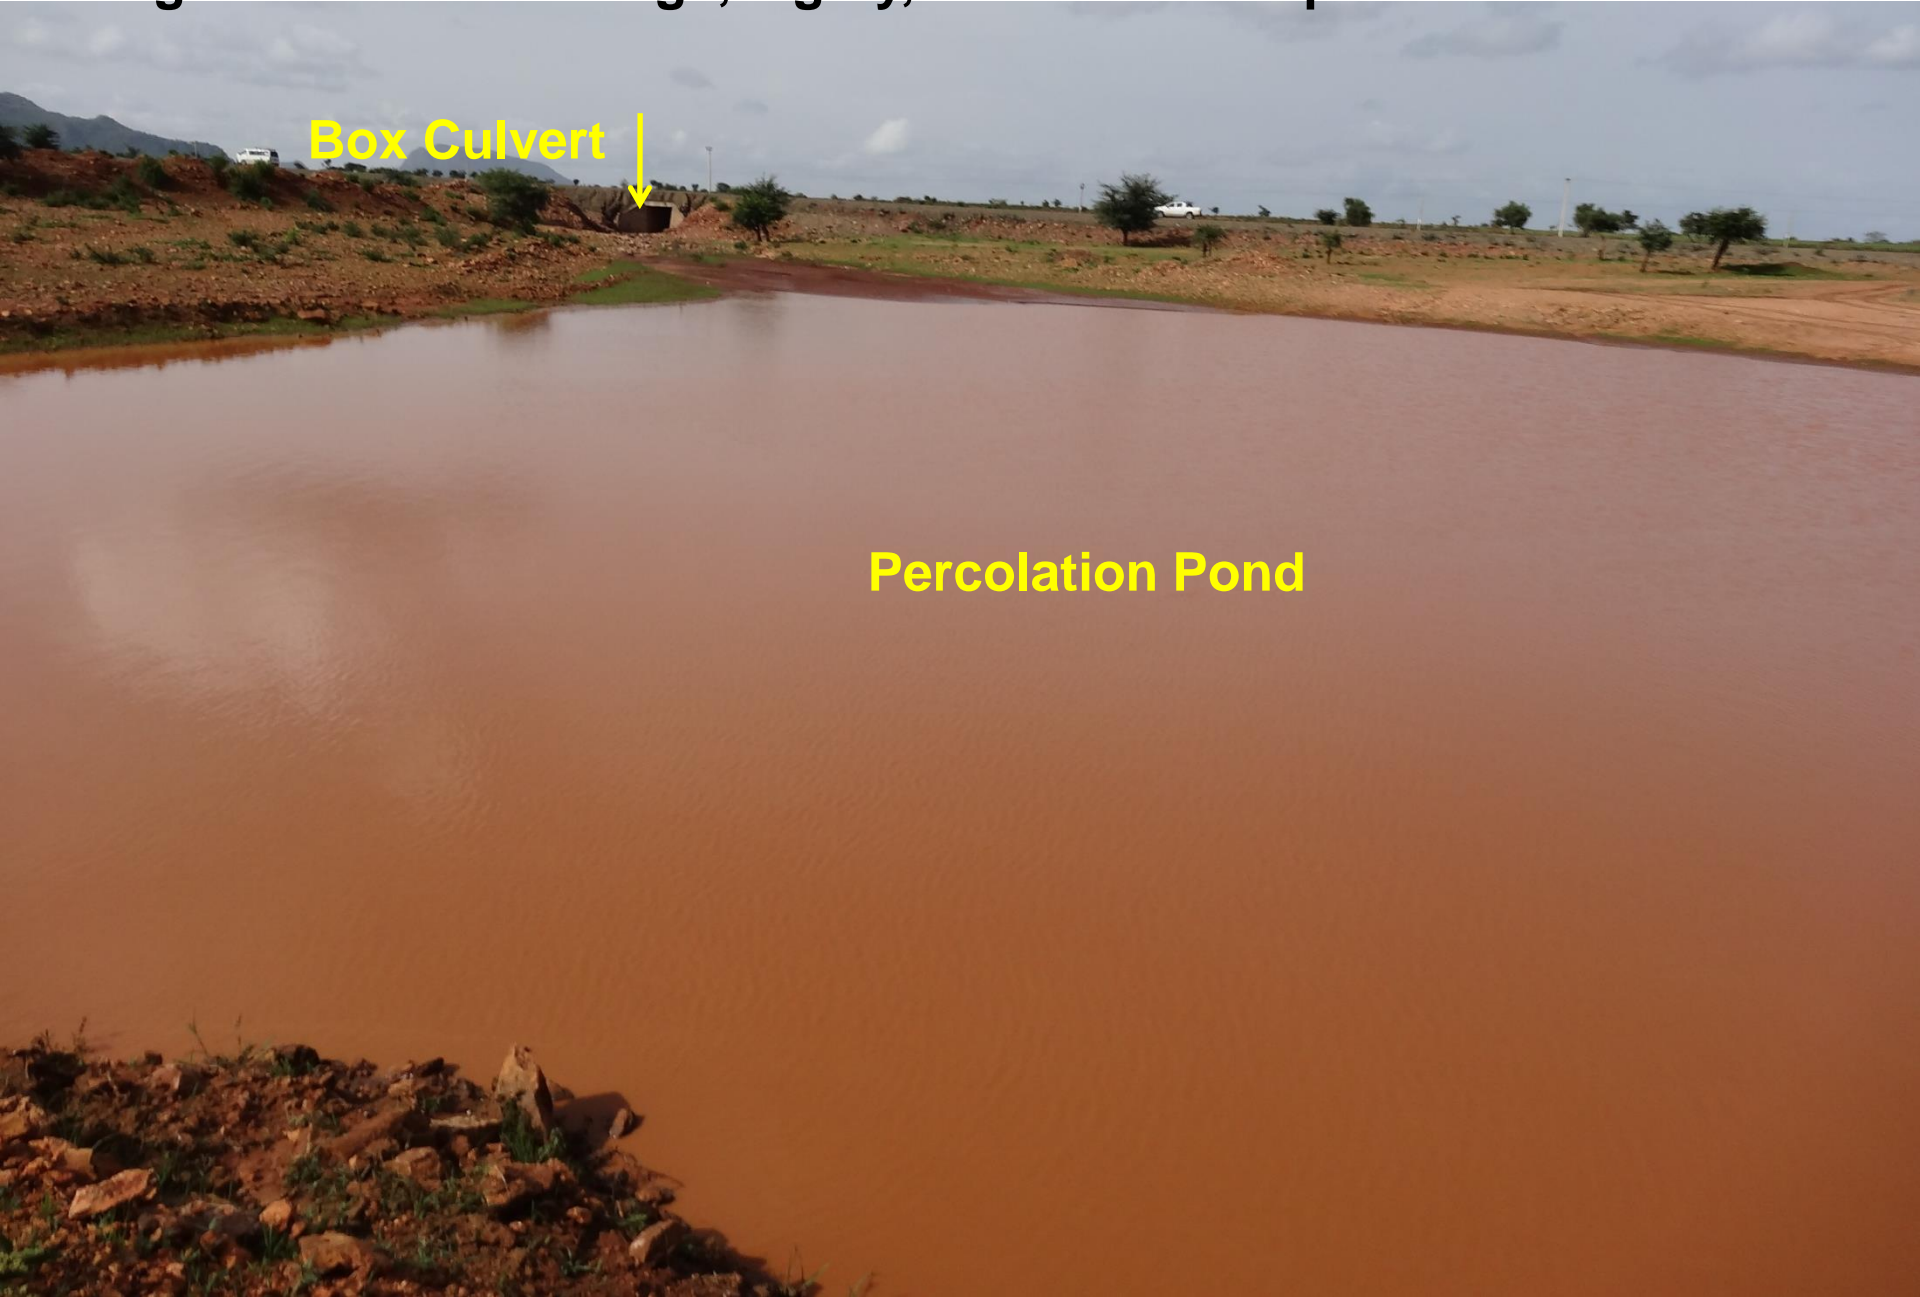
**Plate 8: Water from a box culvert is channeled into a percolation pond for groundwater recharge, Tigray, Northern Ethiopia**

**Box Culvert**

**Percolation Pond**

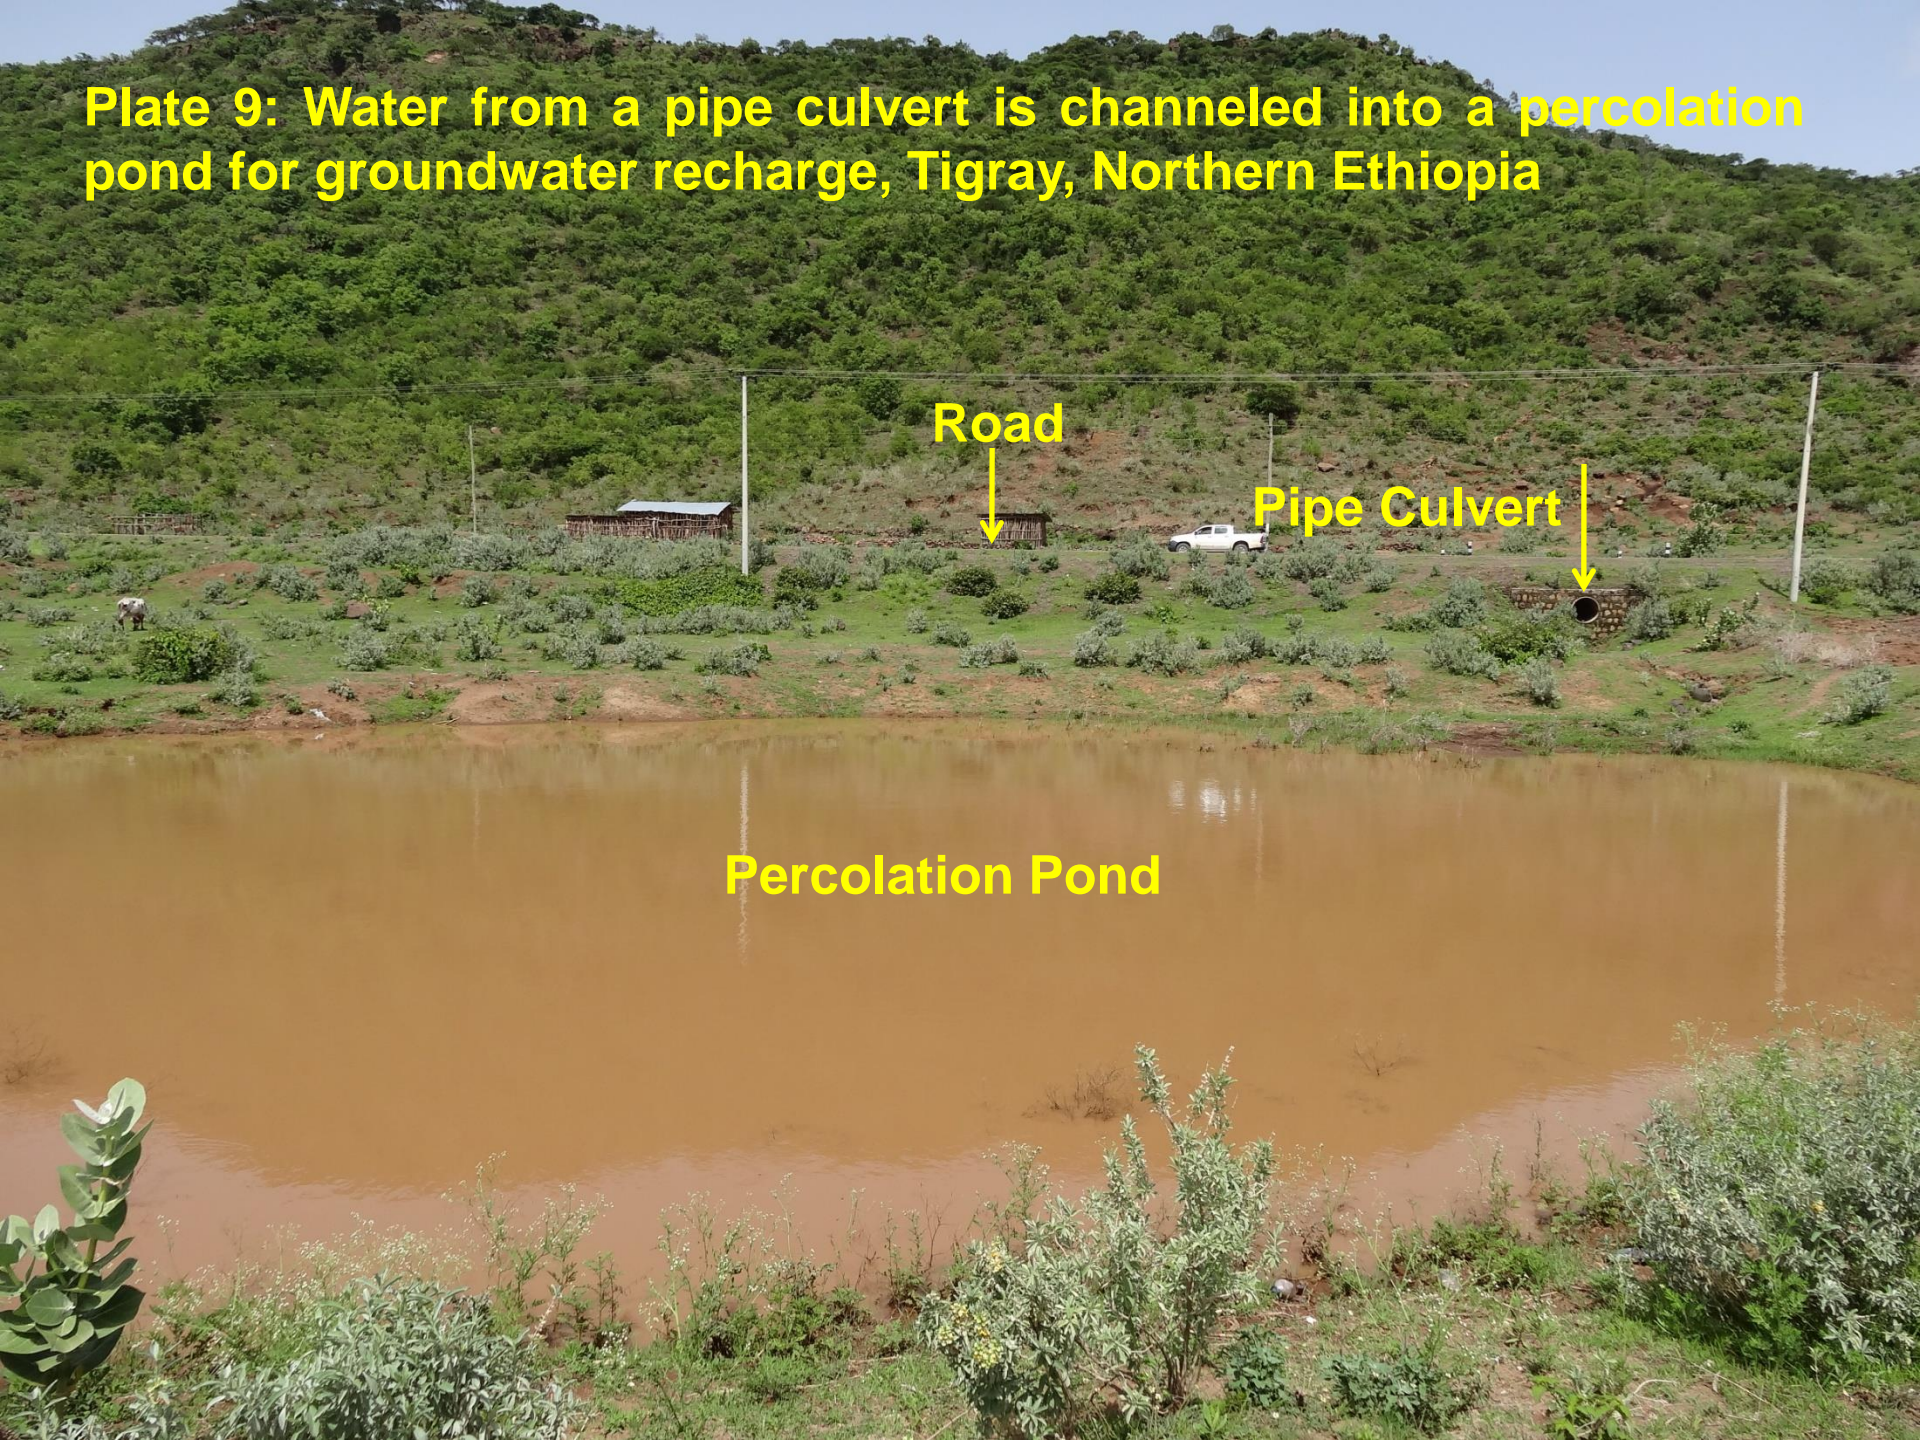
**Plate 9: Water from a pipe culvert is channeled into a percolation pond for groundwater recharge, Tigray, Northern Ethiopia**

**Road**

**Pipe Culvert**

**Percolation Pond**
