# Water Harvesting from Roads in Tigray, Northern Ethiopia: In Figures

***Kifle Woldearegay (Mekelle University, Ethiopia)***

***Frank Van Steengergen (MetaMeta, The Netherlands)***

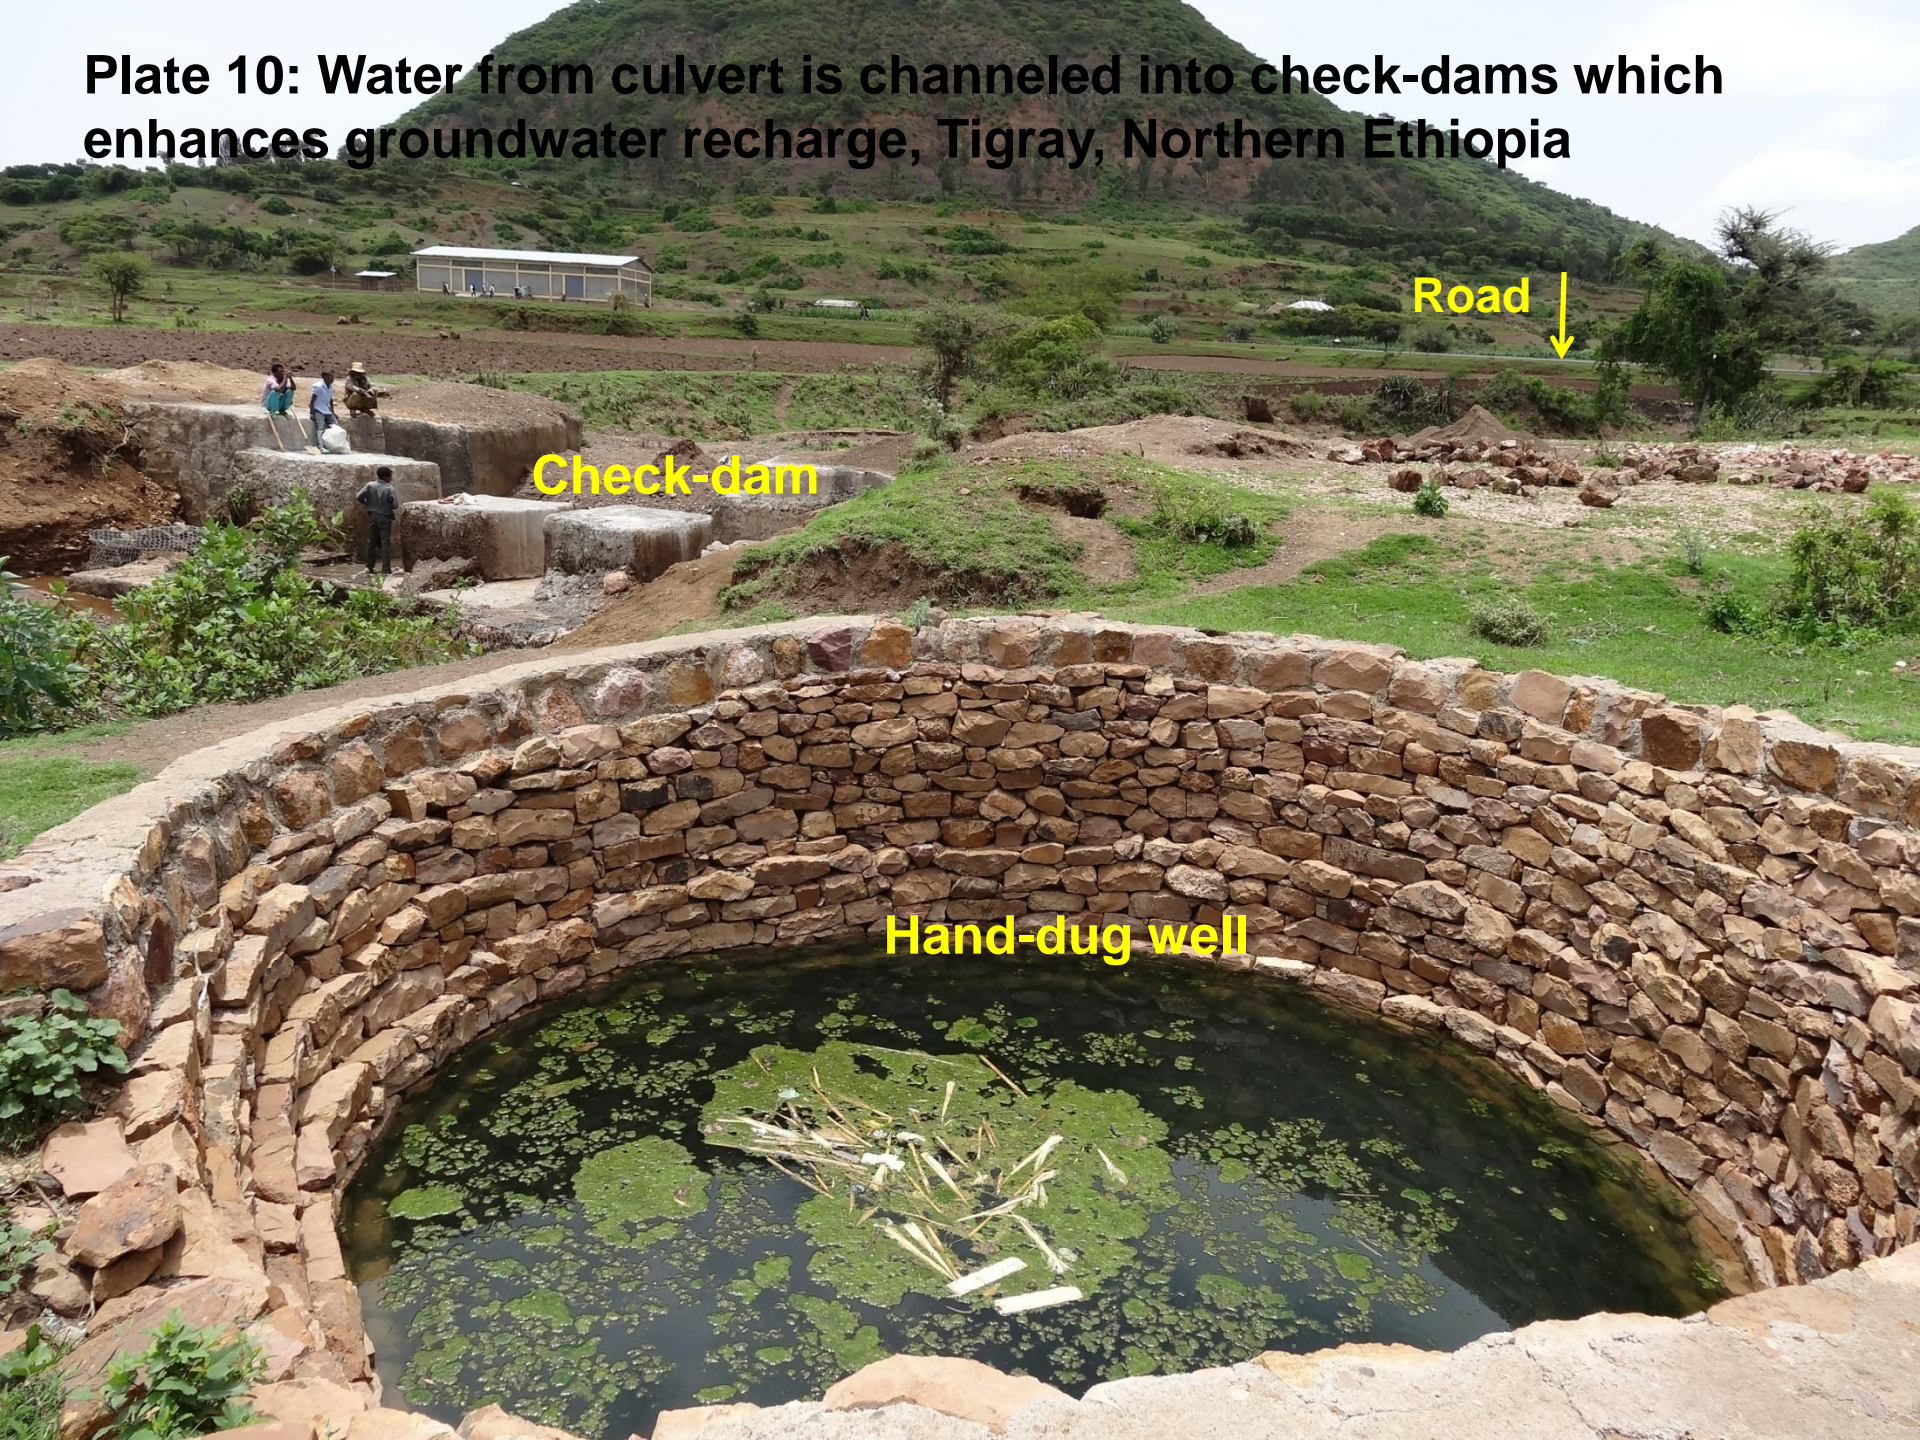
**Plate 10: Water from culvert is channeled into check-dams which enhances groundwater recharge, Tigray, Northern Ethiopia**

**Check-dam**

**Road**

**Hand-dug well**

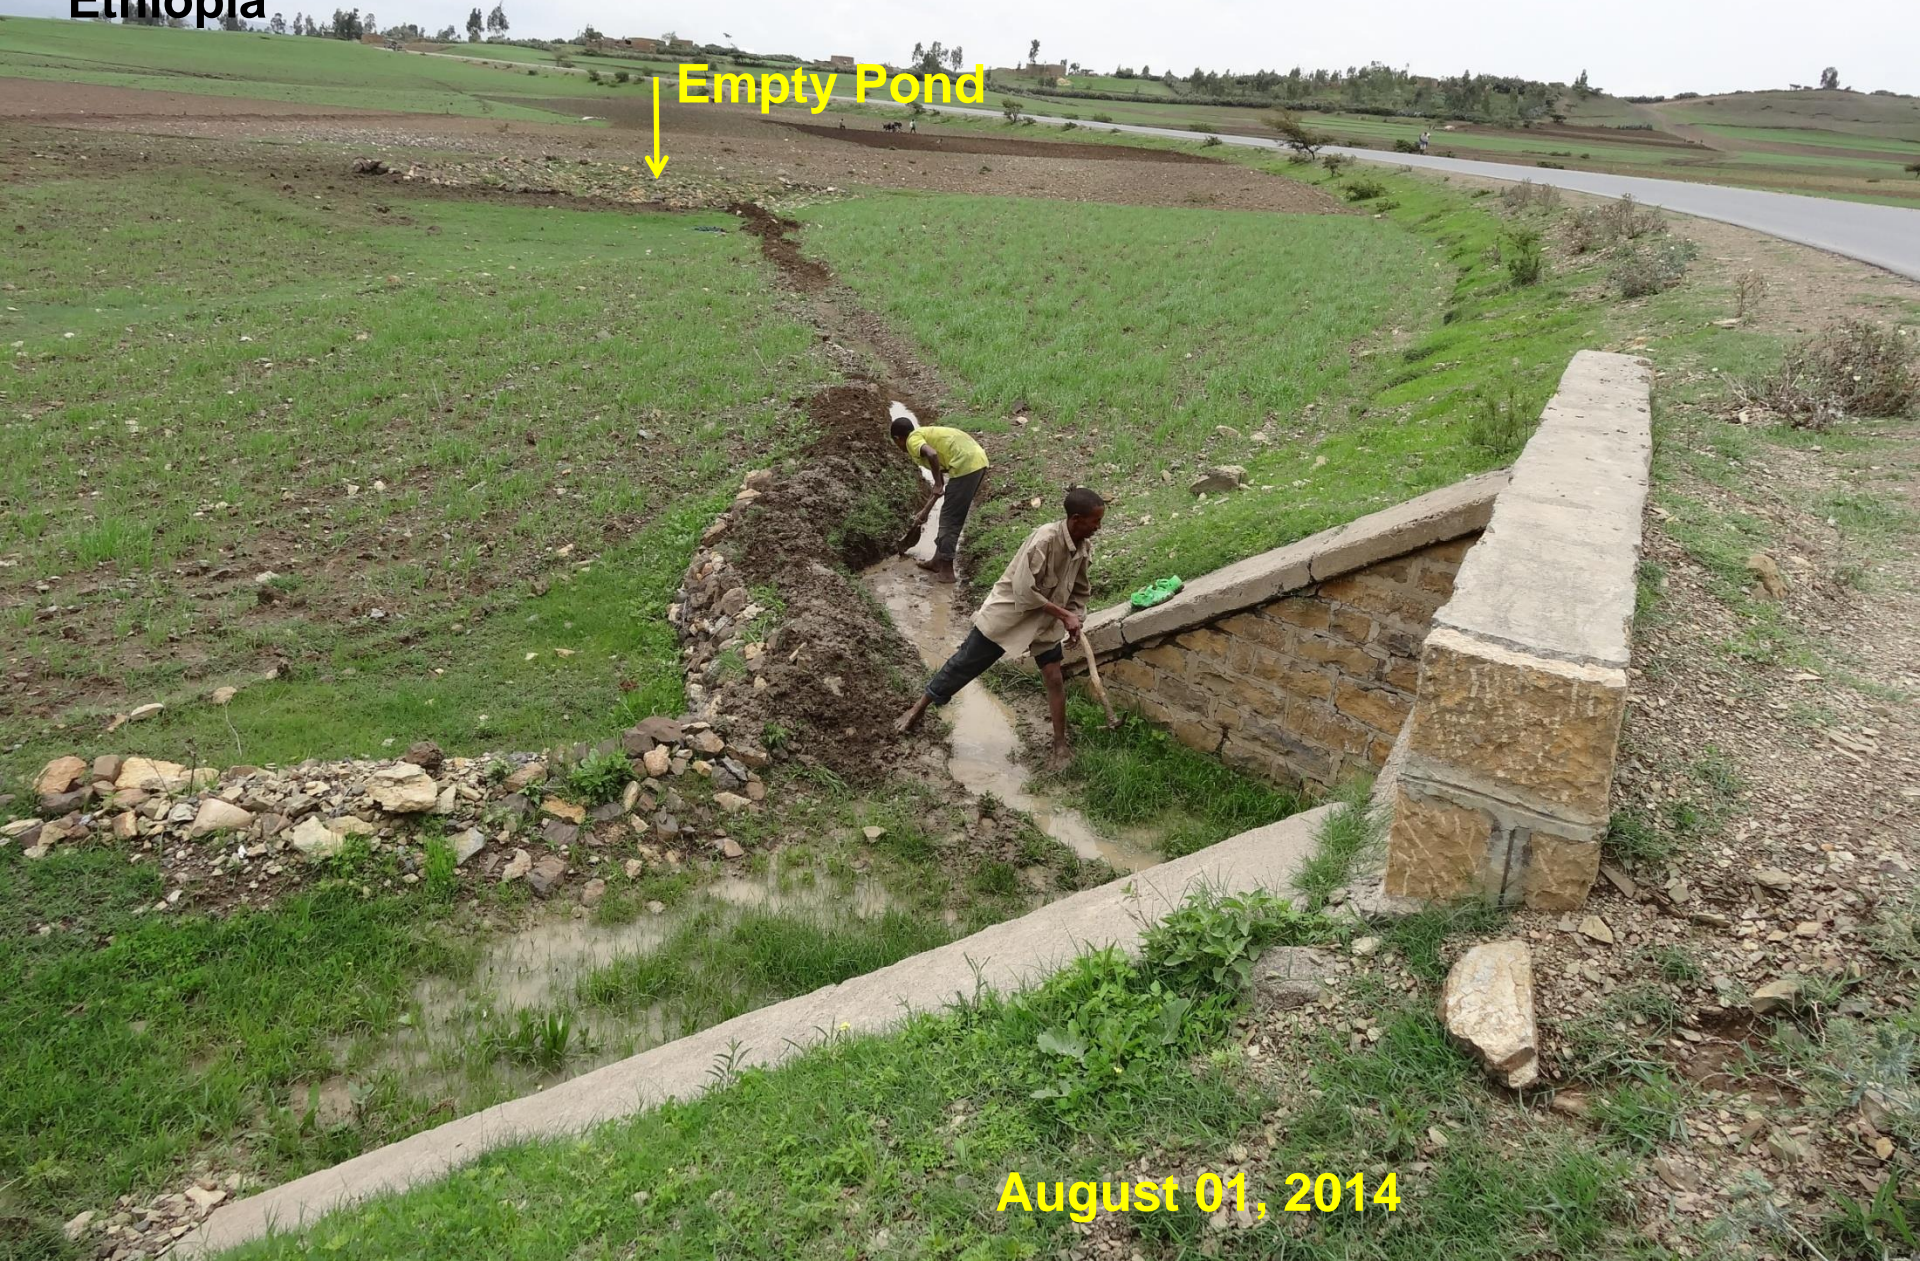
# Plate 11: Farmers diverting water from a culvert into a percolation pond for supplementary irrigation and groundwater recharge in Tigray, Ethiopia

Empty Pond

August 01, 2014

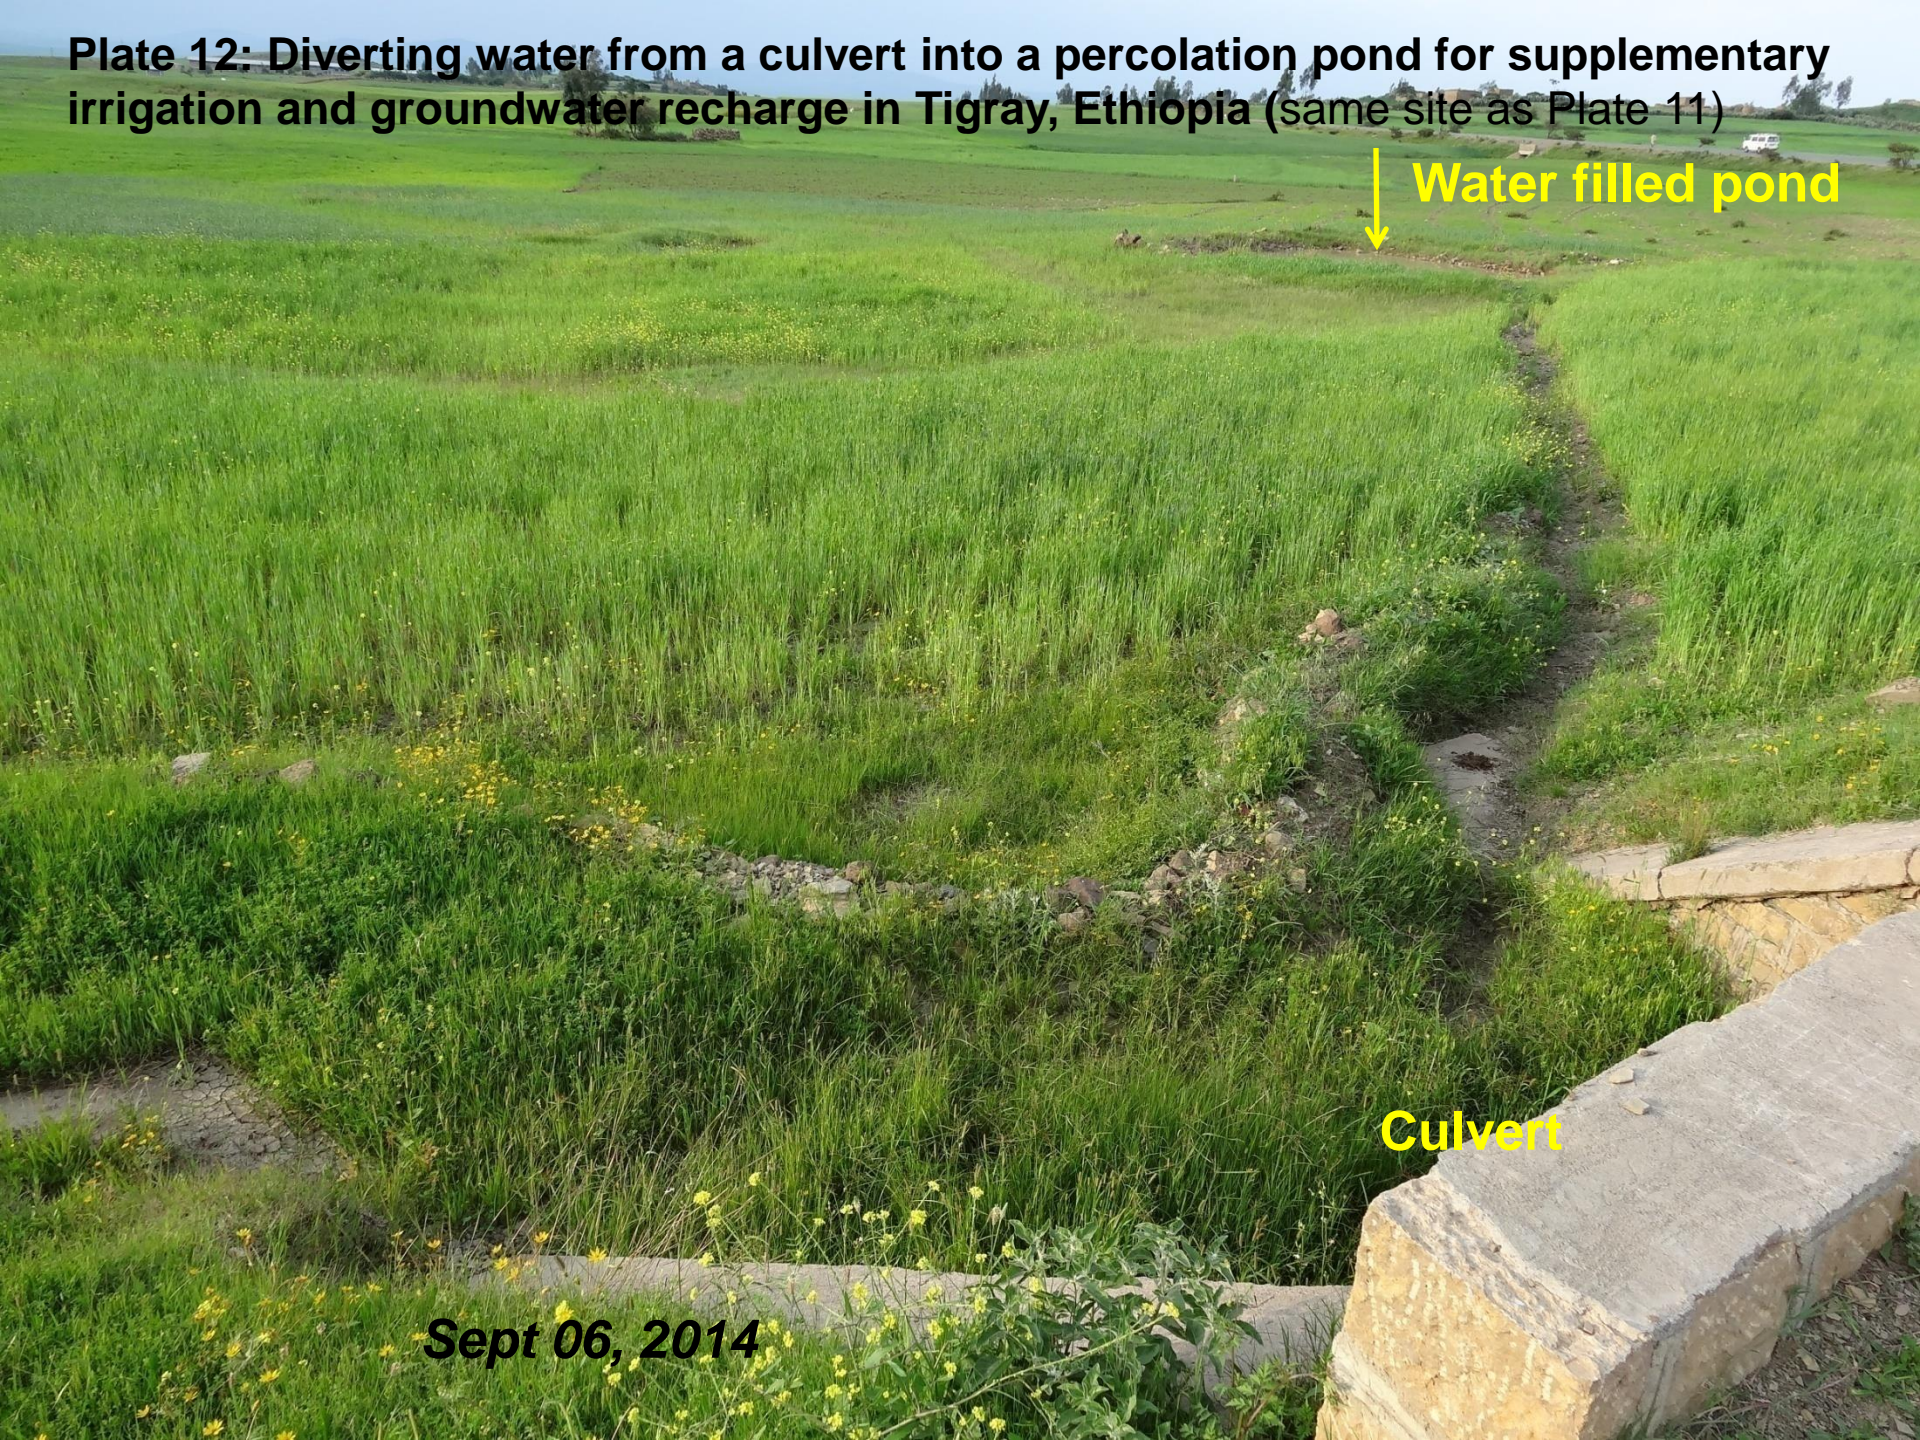
**Plate 12: Diverting water from a culvert into a percolation pond for supplementary irrigation and groundwater recharge in Tigray, Ethiopia (same site as Plate 11)**

**Water filled pond**

**Culvert**

**Sept 06, 2014**

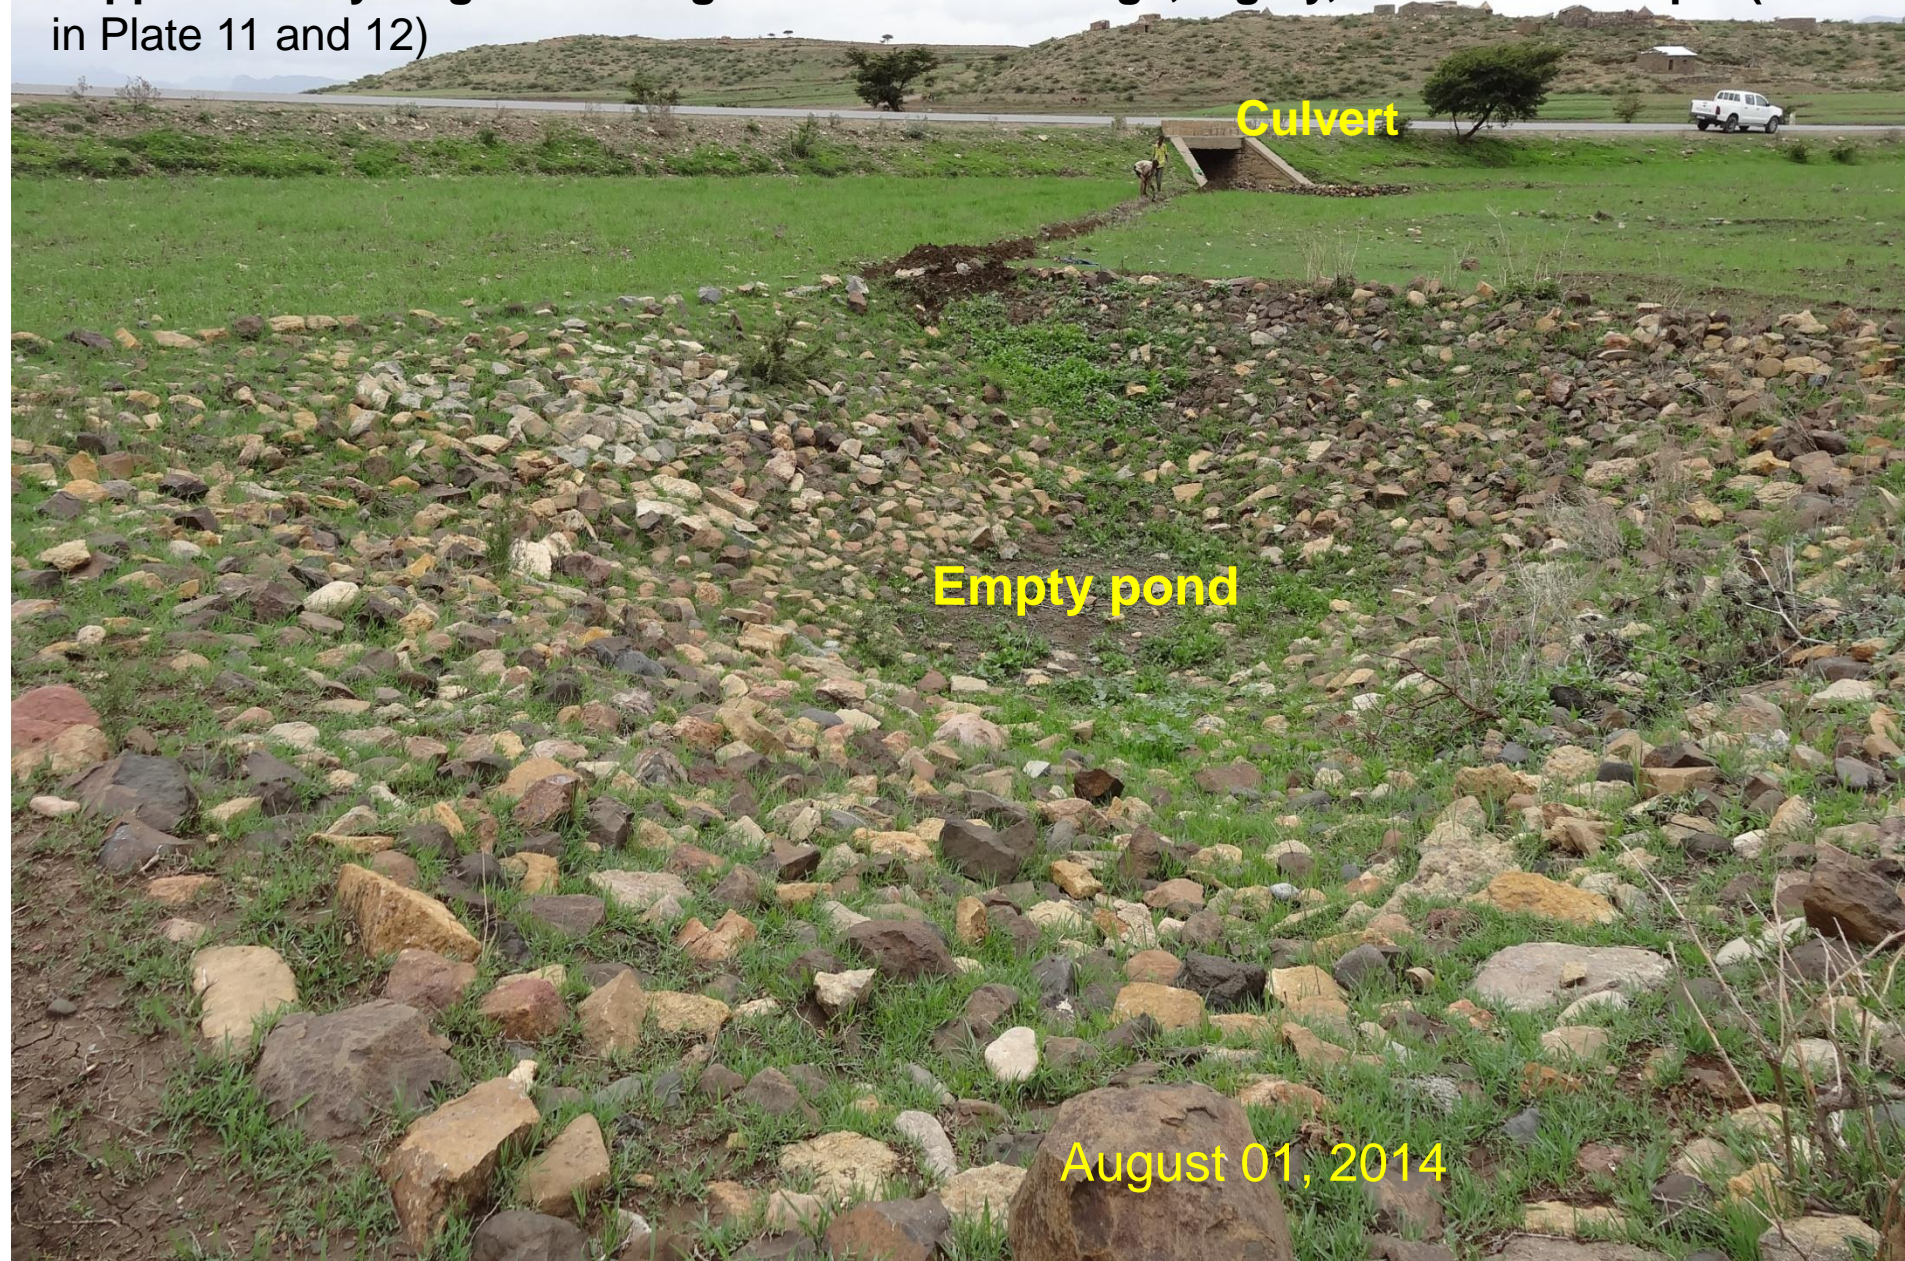
**Plate 13: Farmers preparing for diverting water from a culvert into a pond for supplementary irrigation and groundwater recharge, Tigray, Northern Ethiopia (Site in Plate 11 and 12)**

Culvert

Empty pond

August 01, 2014

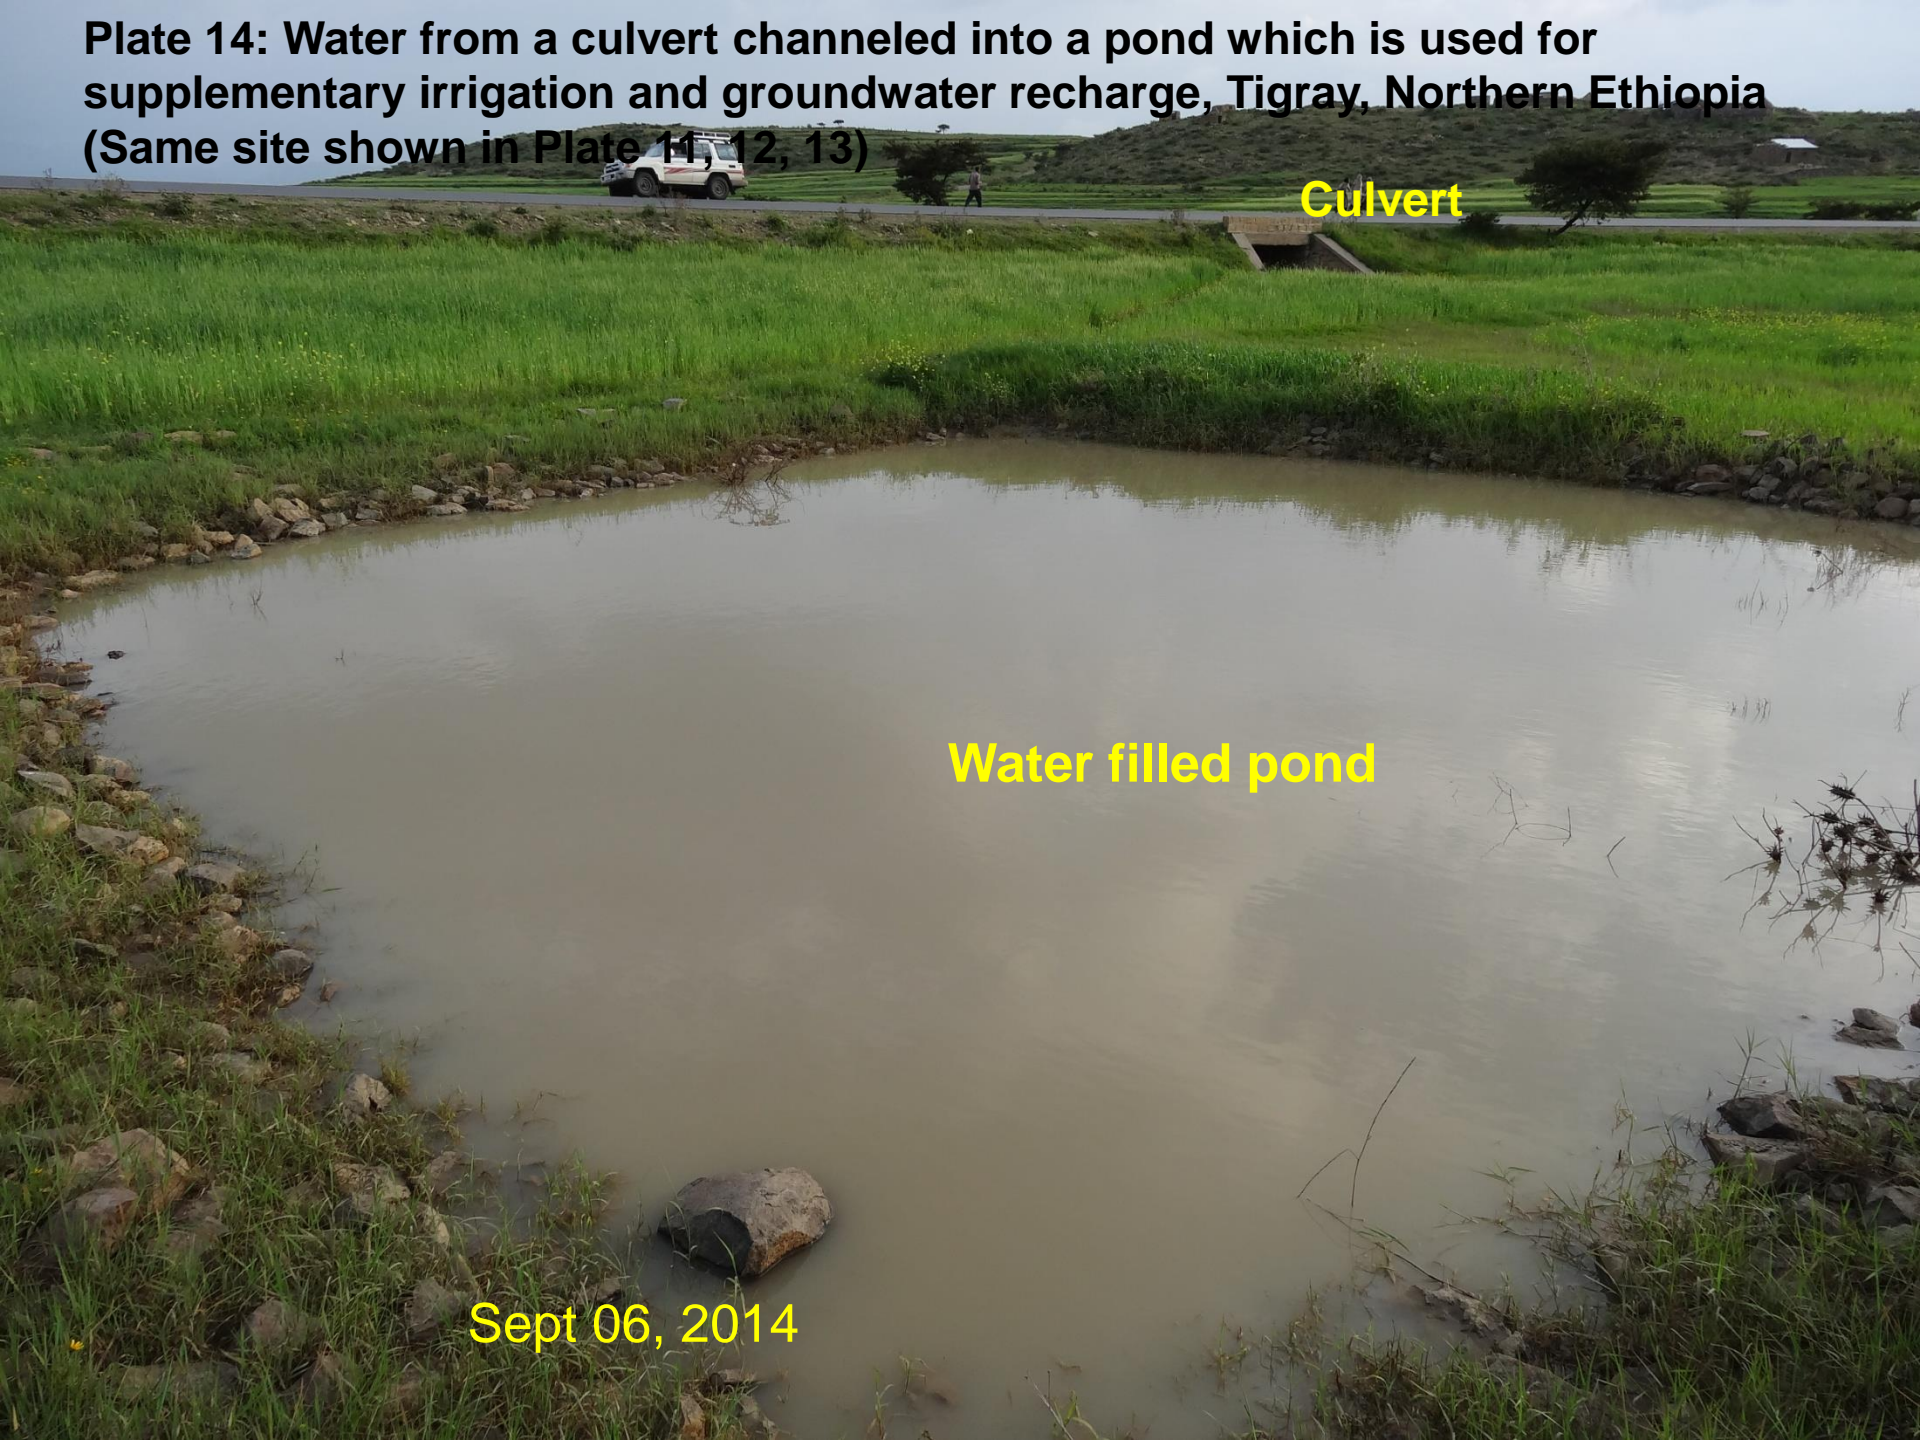
**Plate 14: Water from a culvert channeled into a pond which is used for supplementary irrigation and groundwater recharge, Tigray, Northern Ethiopia (Same site shown in Plate 11, 12, 13)**

**Culvert**

**Water filled pond**

**Sept 06, 2014**

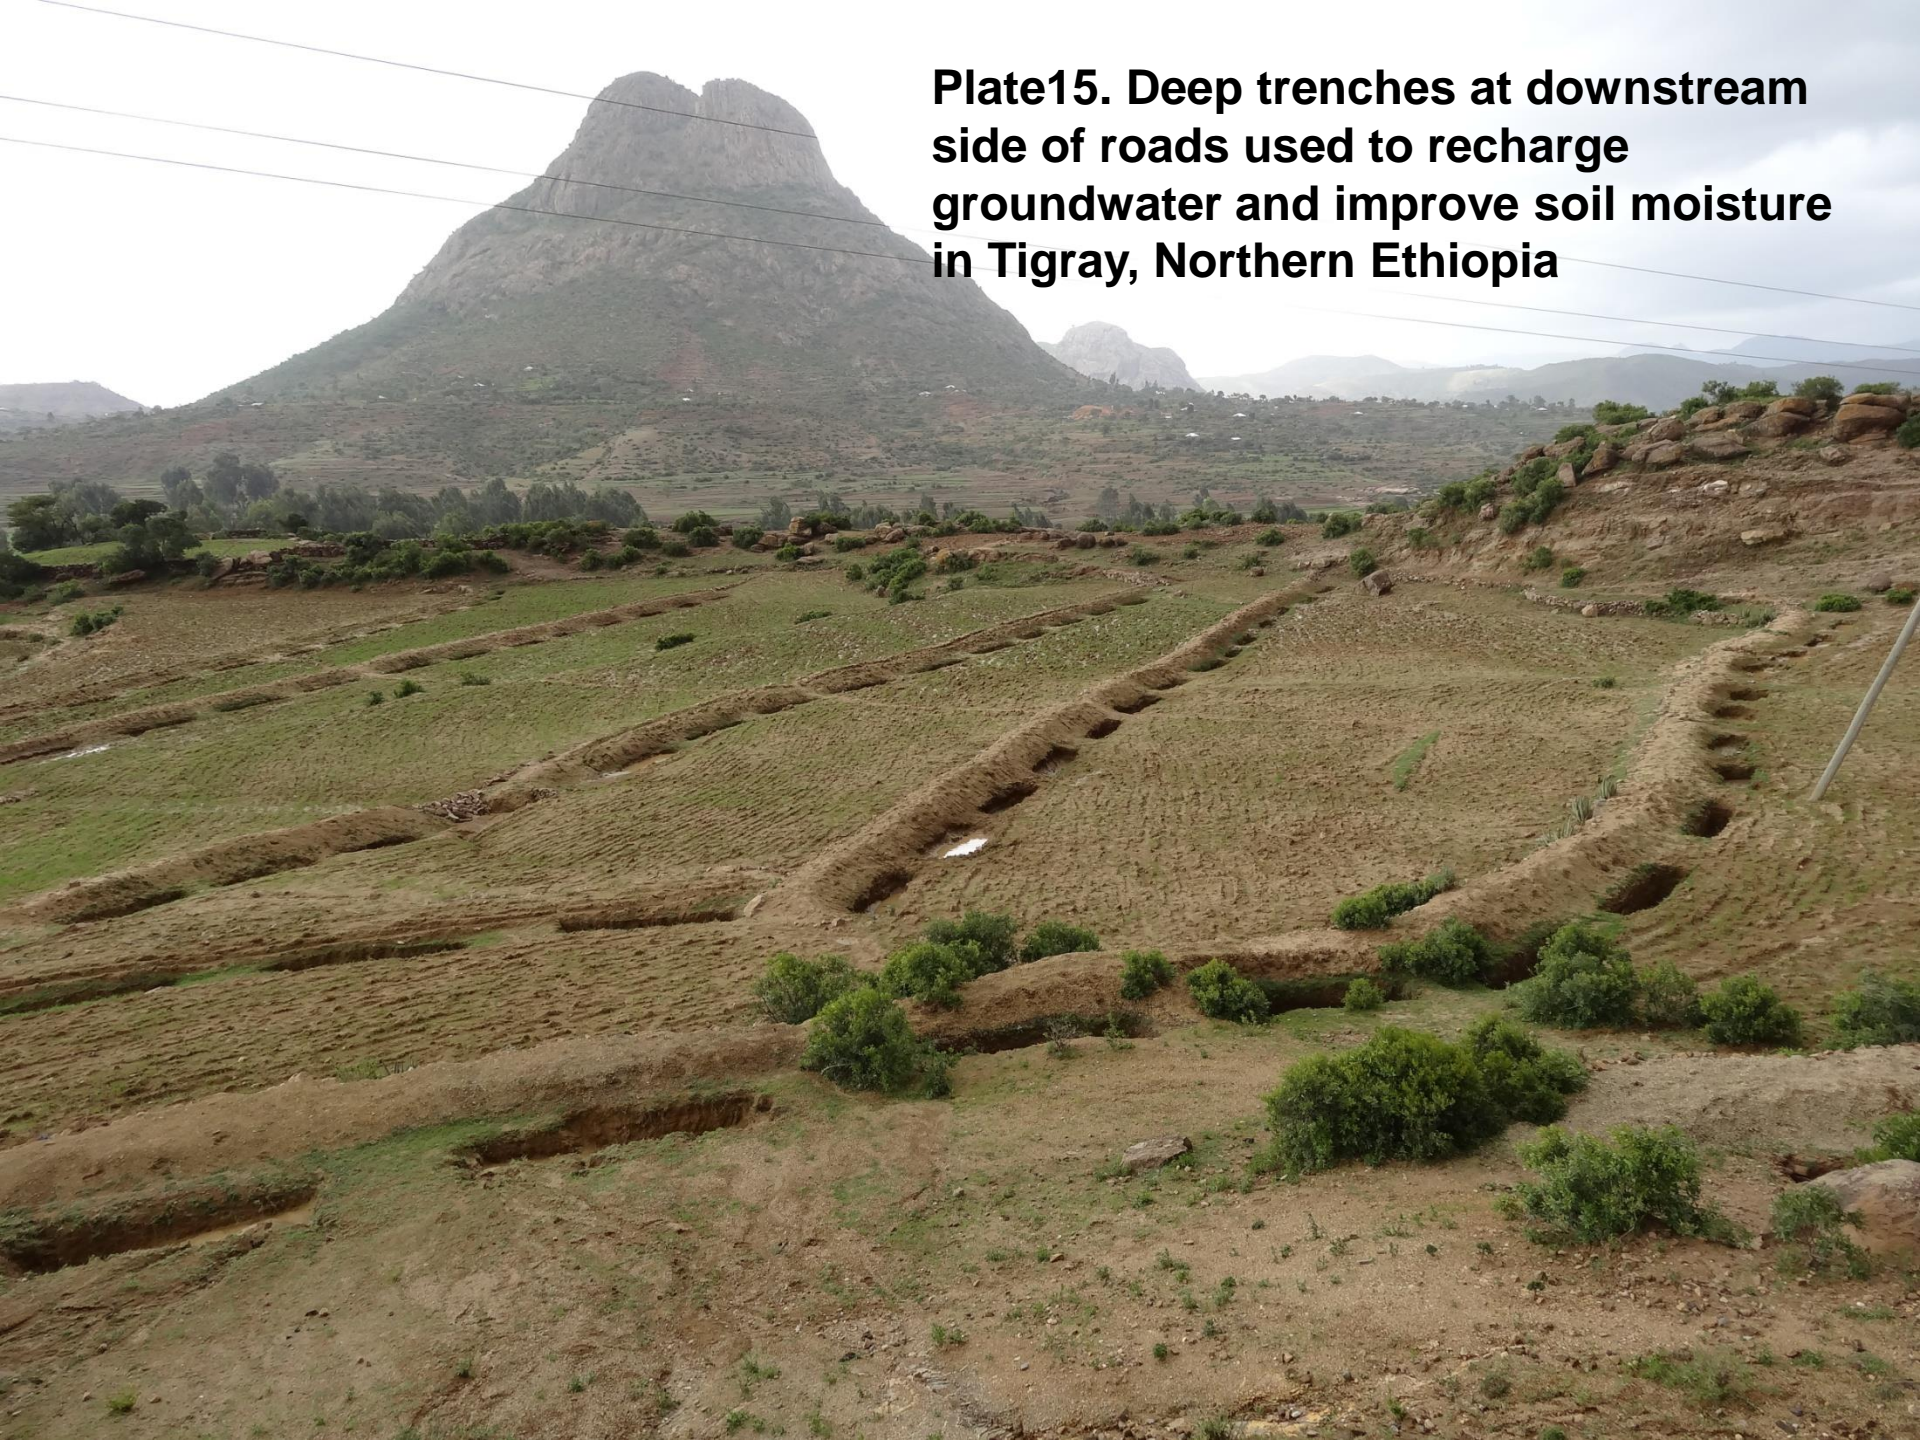
**Plate15. Deep trenches at downstream side of roads used to recharge groundwater and improve soil moisture in Tigray, Northern Ethiopia**

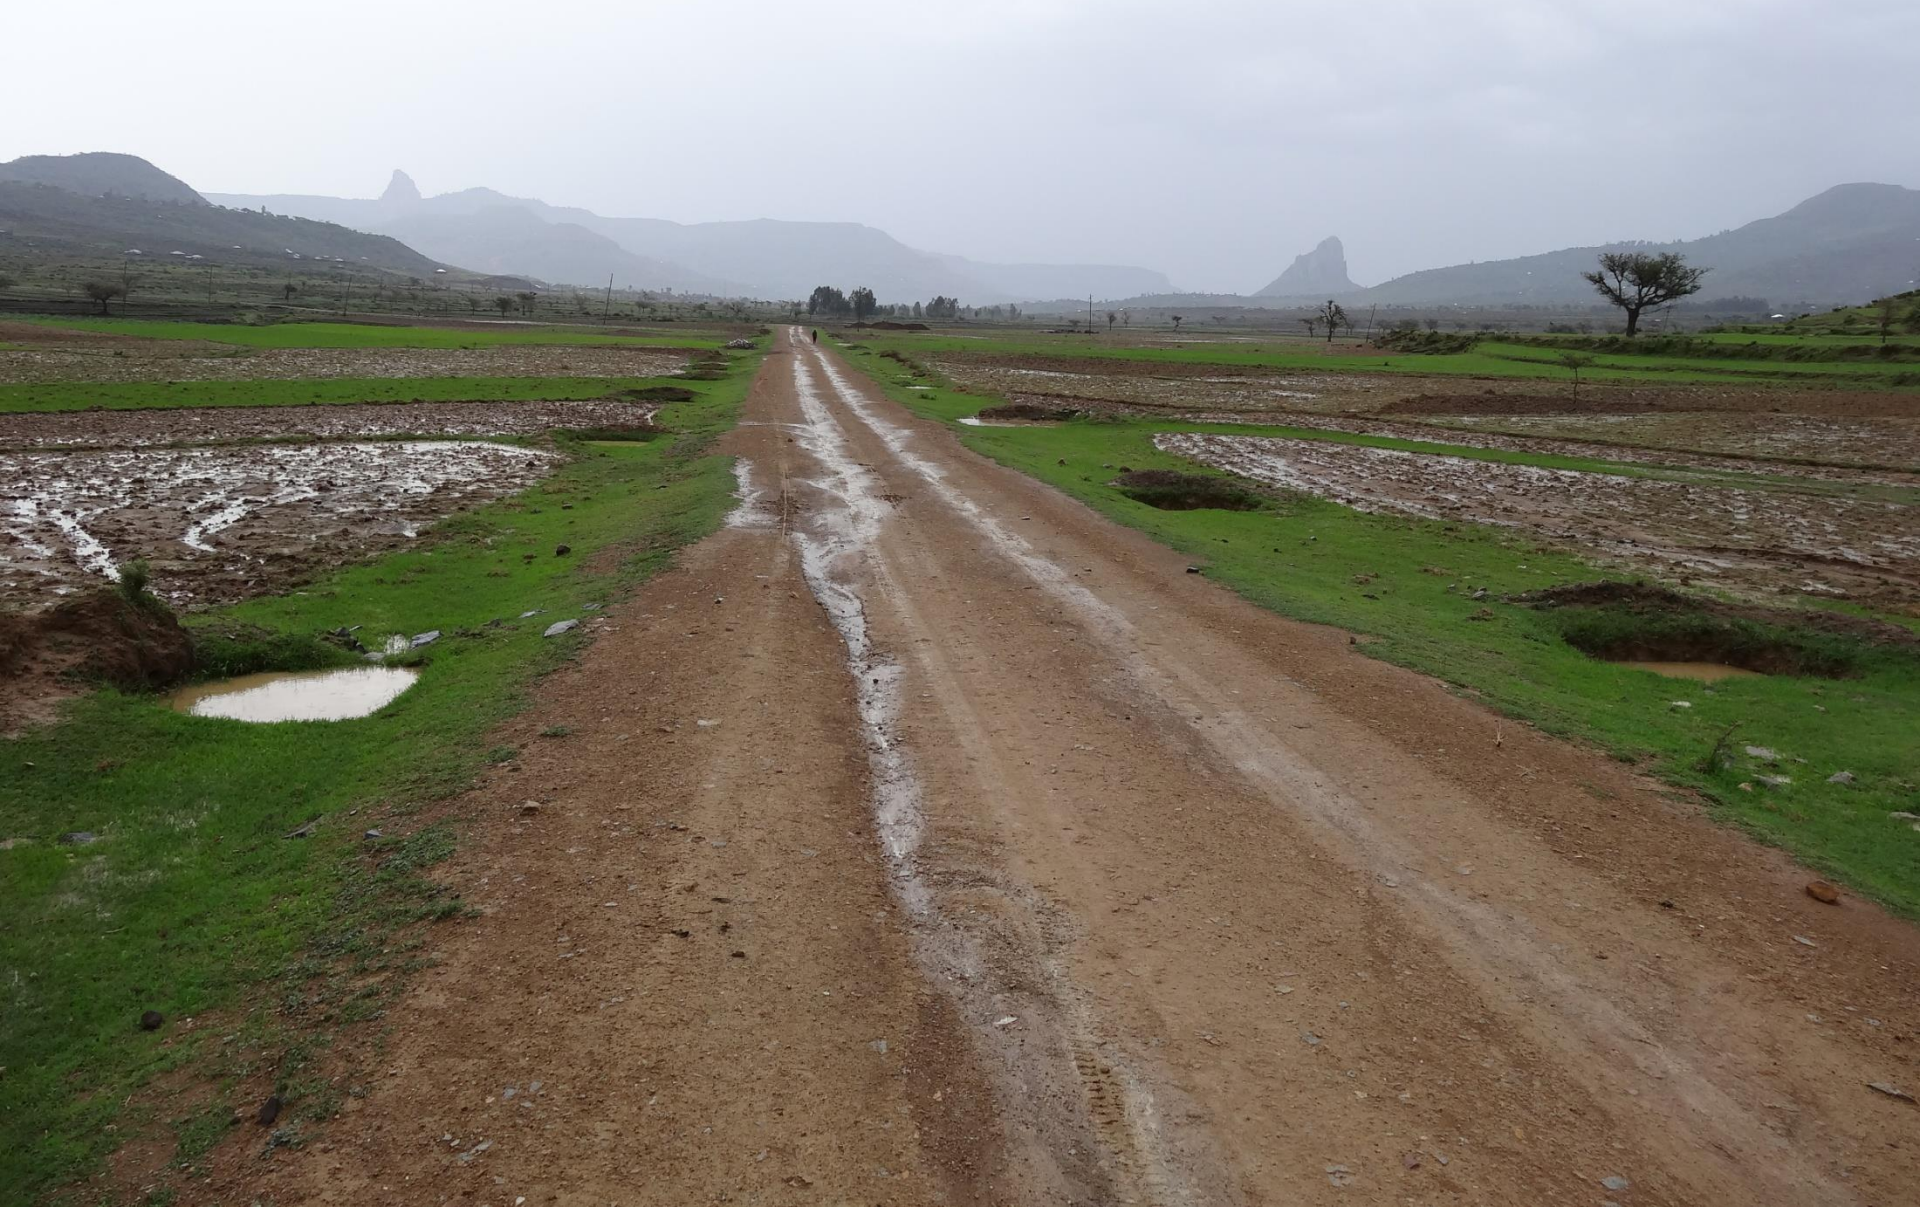
**Plate 16a. Road side ponds to recharge groundwater and enhance in-situ moisture in soils in Tigray, Northern Ethiopia**

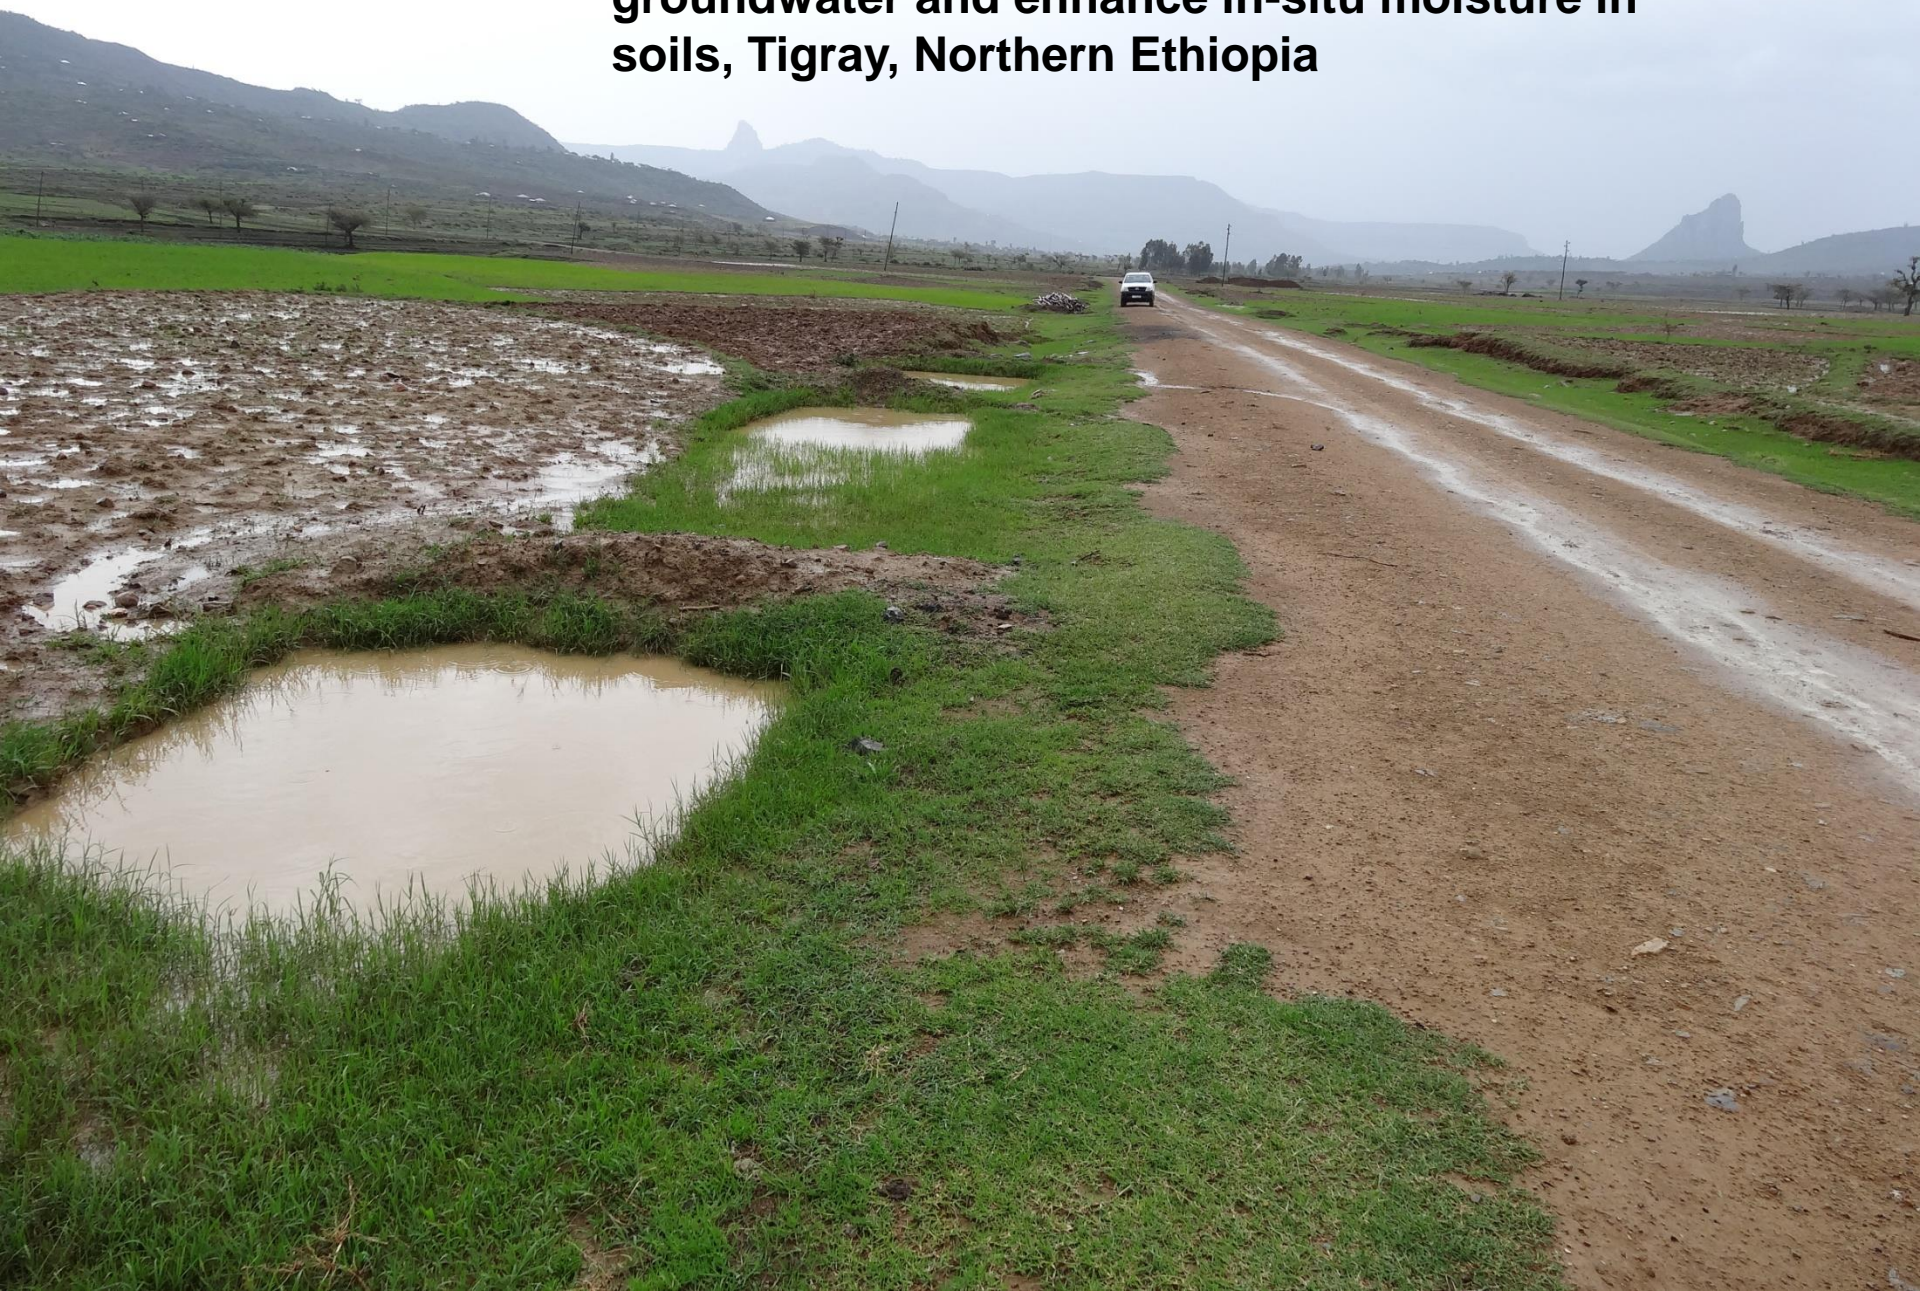
**Plate 16b. Road side ponds to recharge groundwater and enhance in-situ moisture in soils, Tigray, Northern Ethiopia**

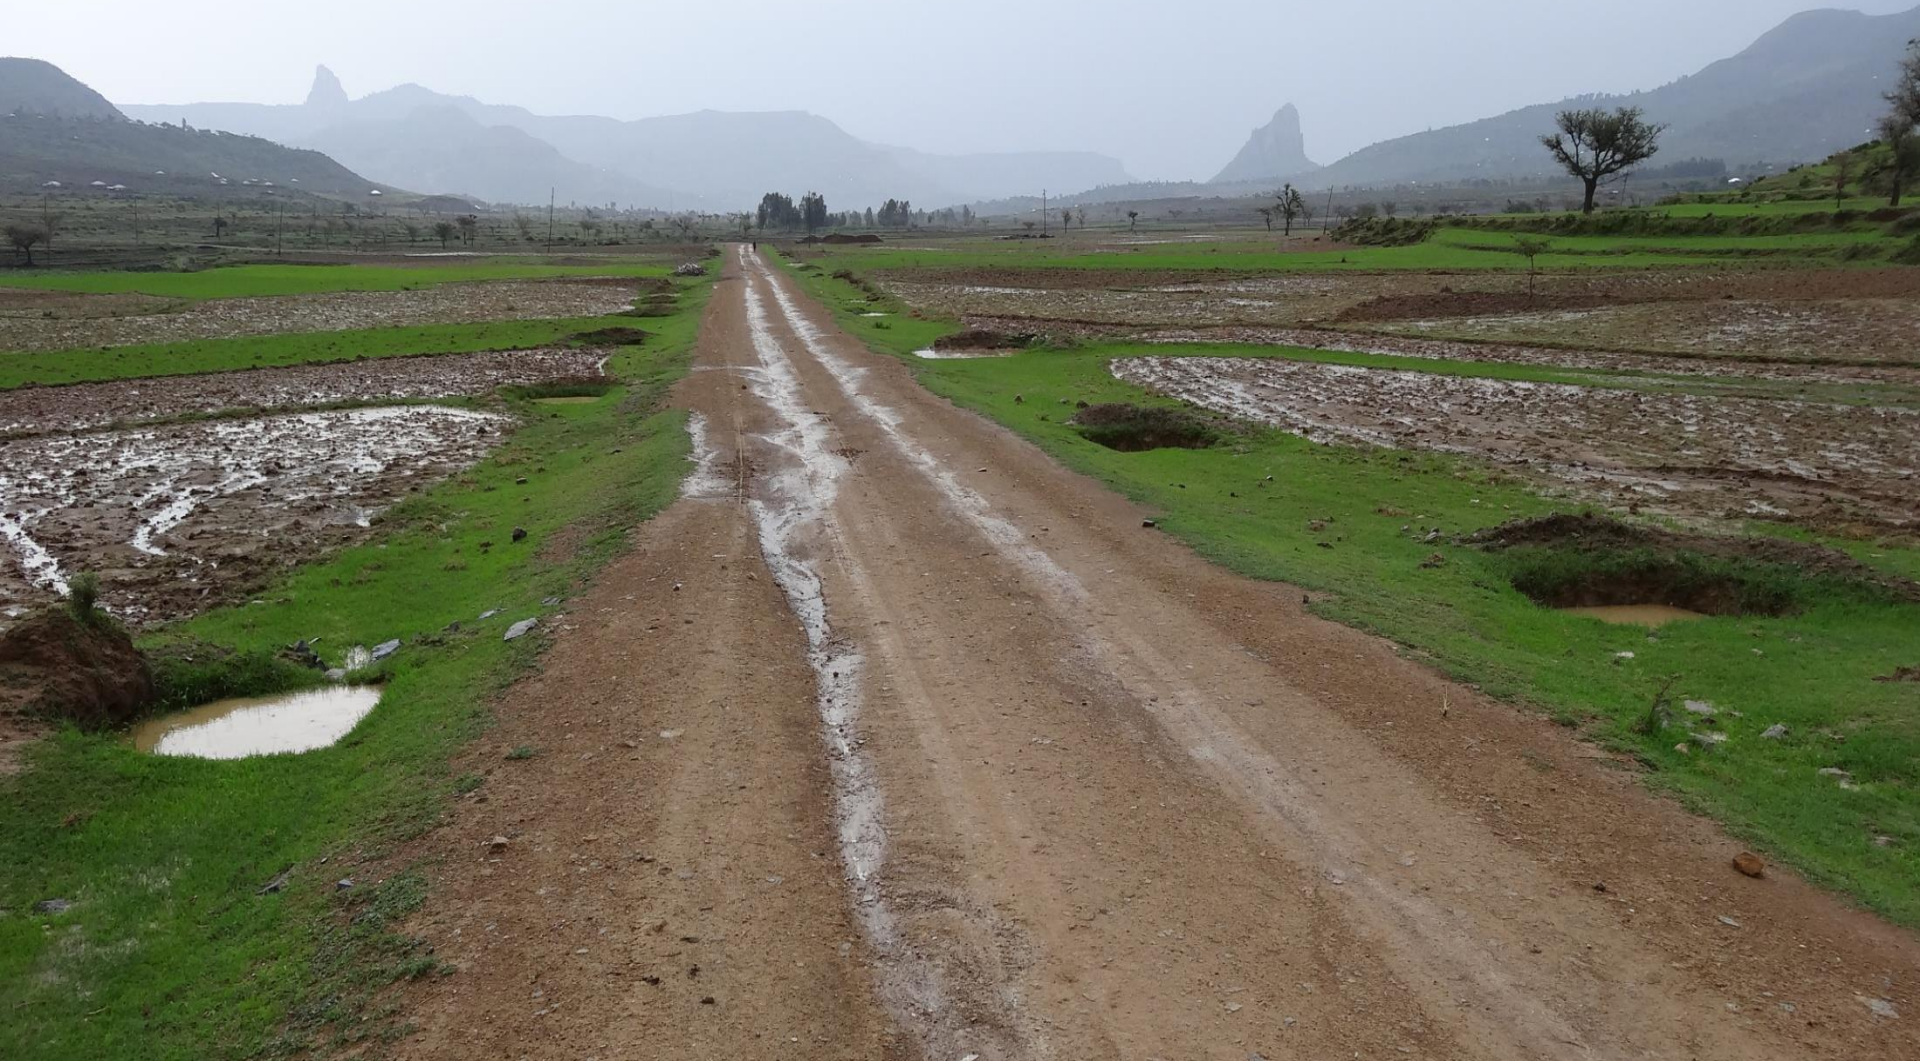
**Plate 16c. Road side ponds to recharge groundwater and enhance in-situ moisture in soils, Tigray, Northern Ethiopia**
