# Water Harvesting from Roads in Tigray, Northern Ethiopia: In Figures

***Kifle Woldearegay (Mekelle University, Ethiopia)***

***Frank Van Steengergen (MetaMeta, The Netherlands)***

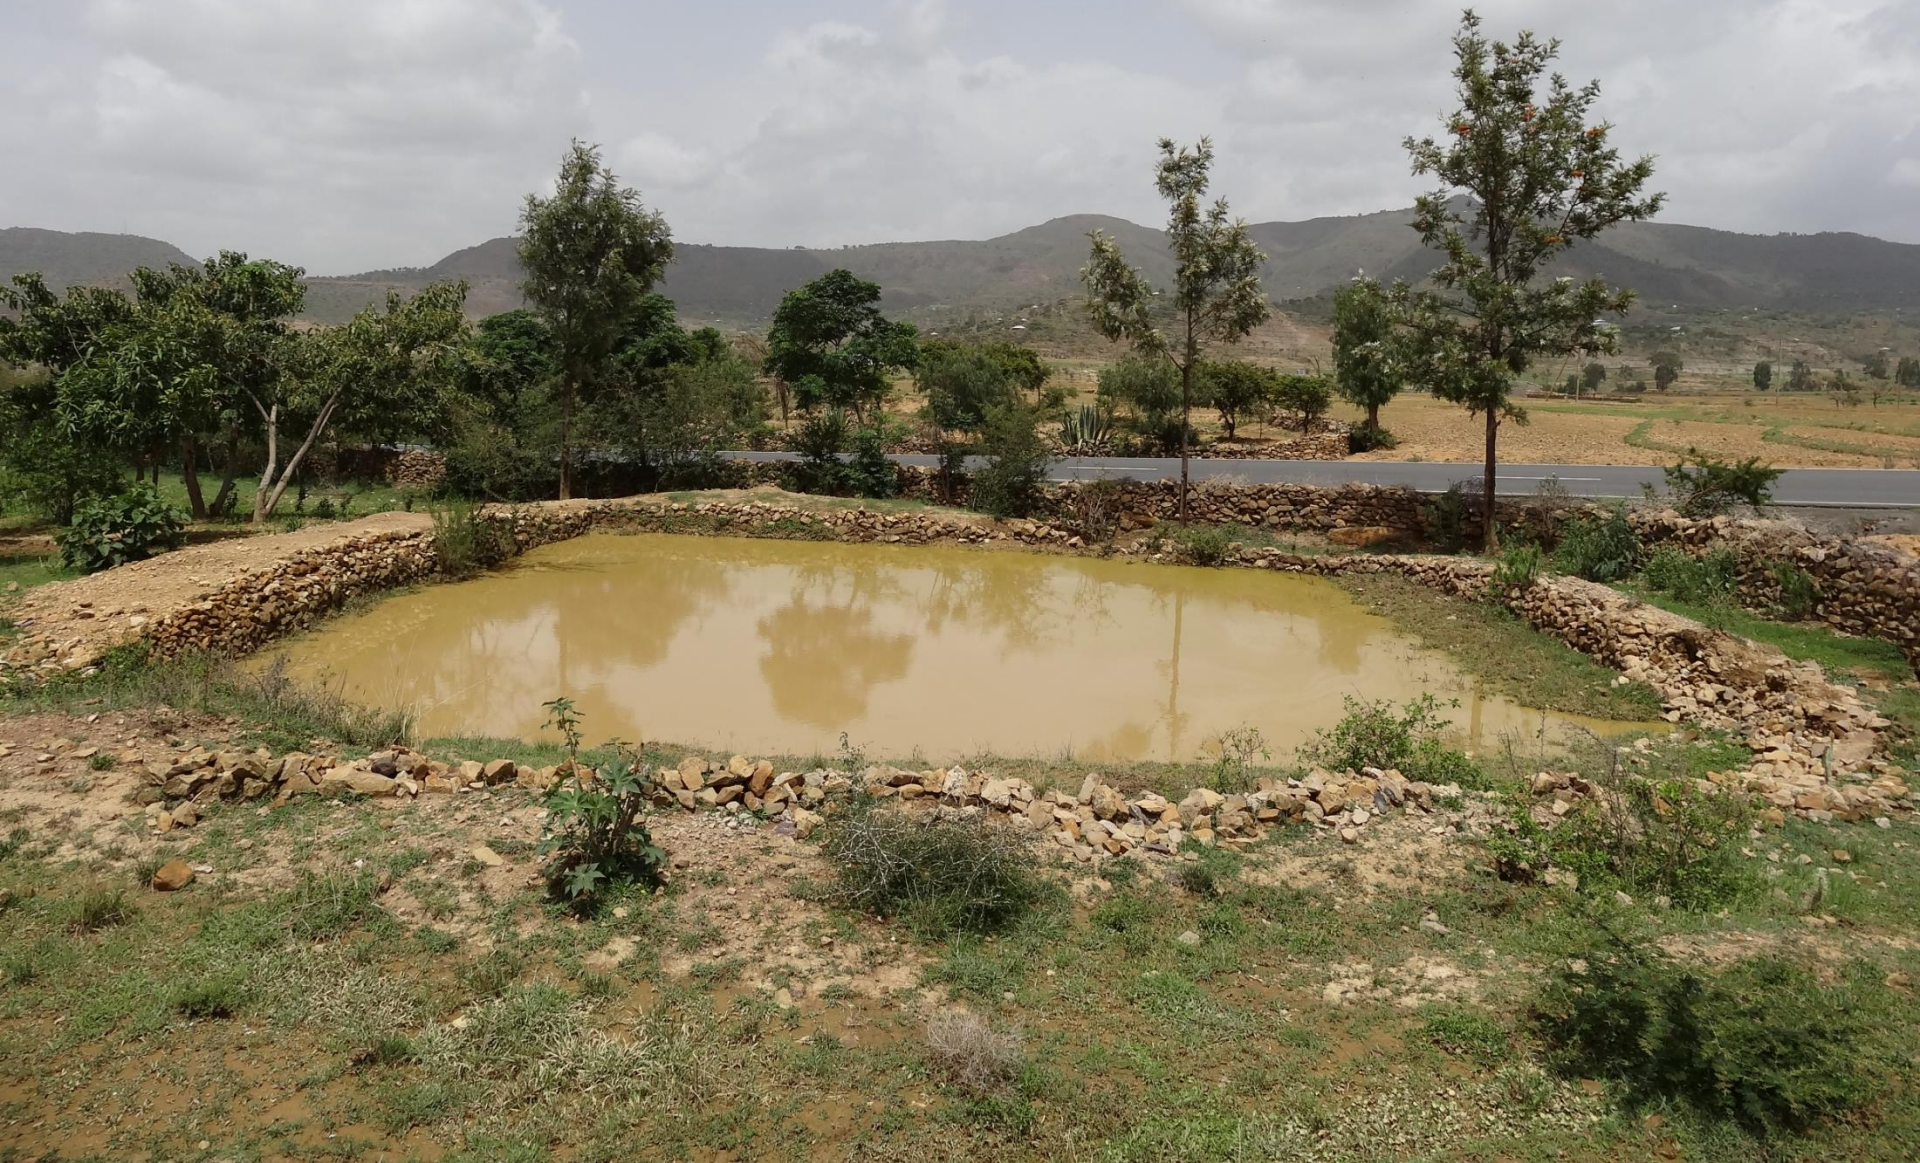
**Plate 17. Road side runoff diverted into ponds  
in Tigray, Northern Ethiopia**

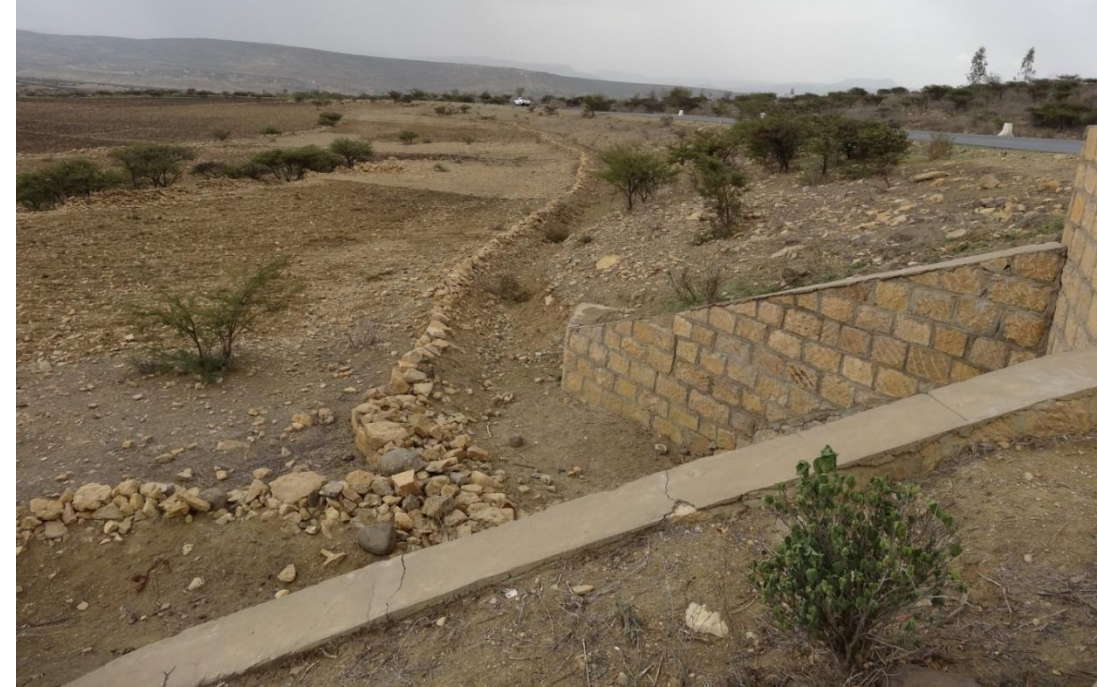
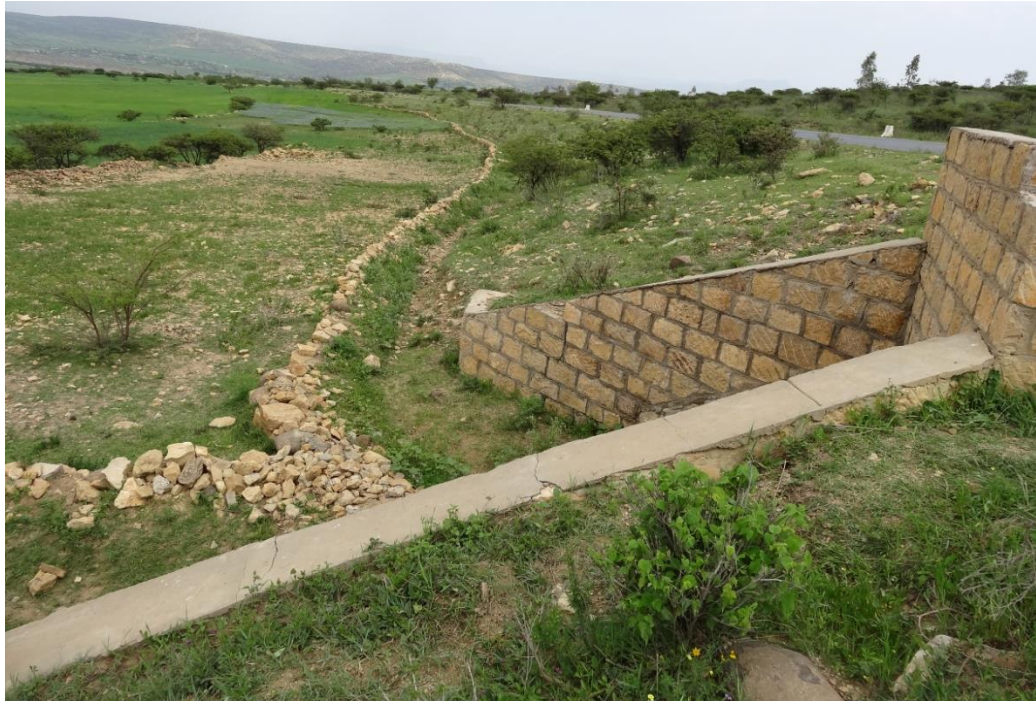
*June 2014*

**Plate 18a. Water from a culvert is channeled into farmlands with over 300m long trench, Tigray, Northern Ethiopia**

*Sept 2014*

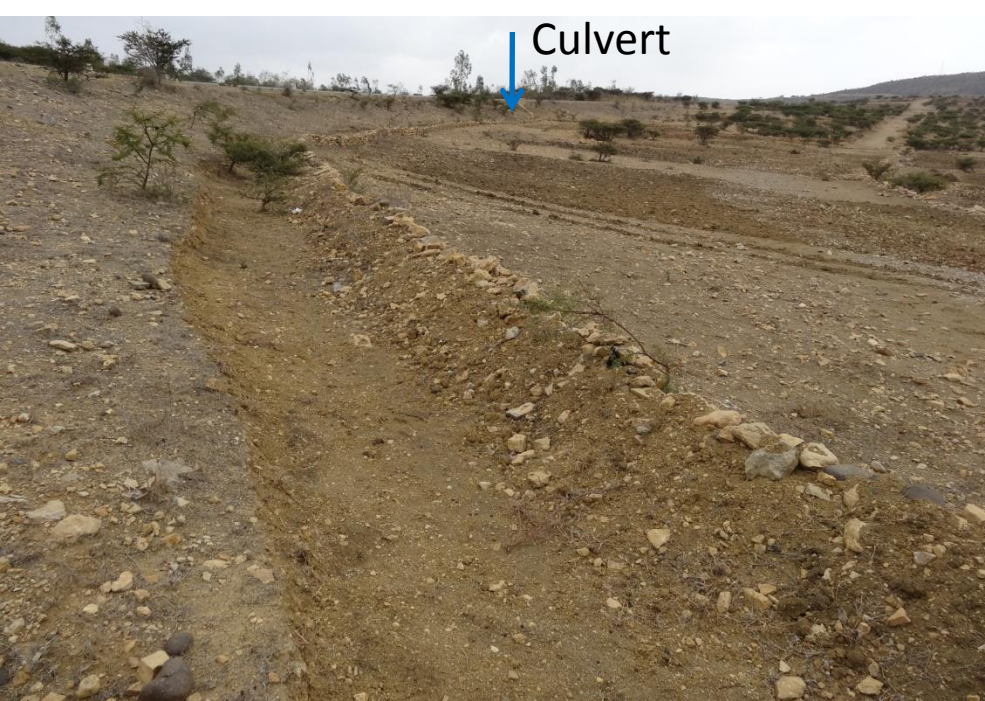
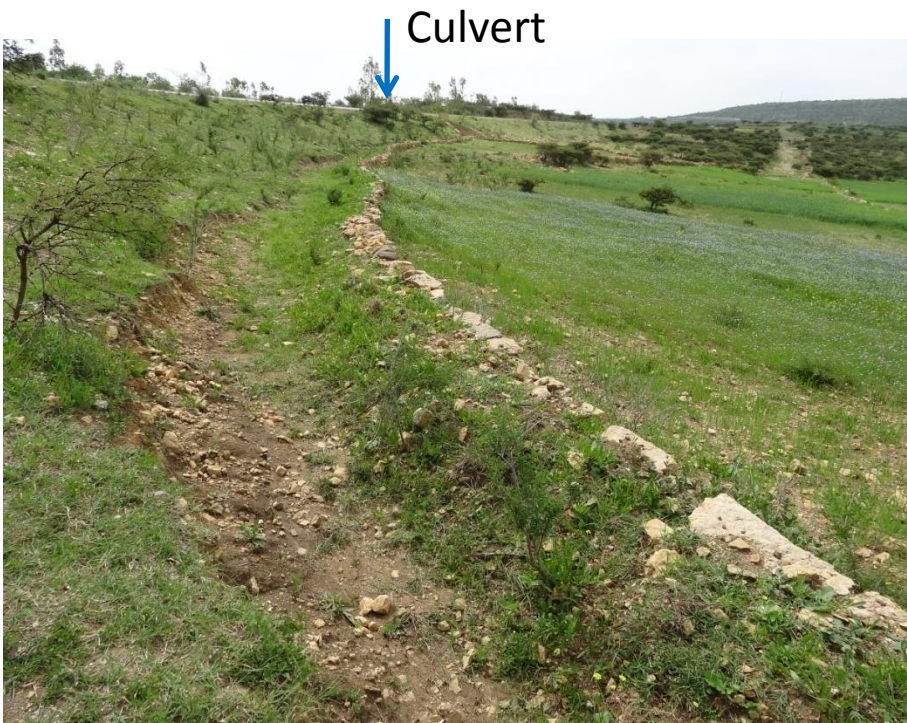
June 2014

**Plate 18b. Water from a culvert is channeled into farmlands with over 300m long trench, Tigray, Ethiopia**

Sept 2014

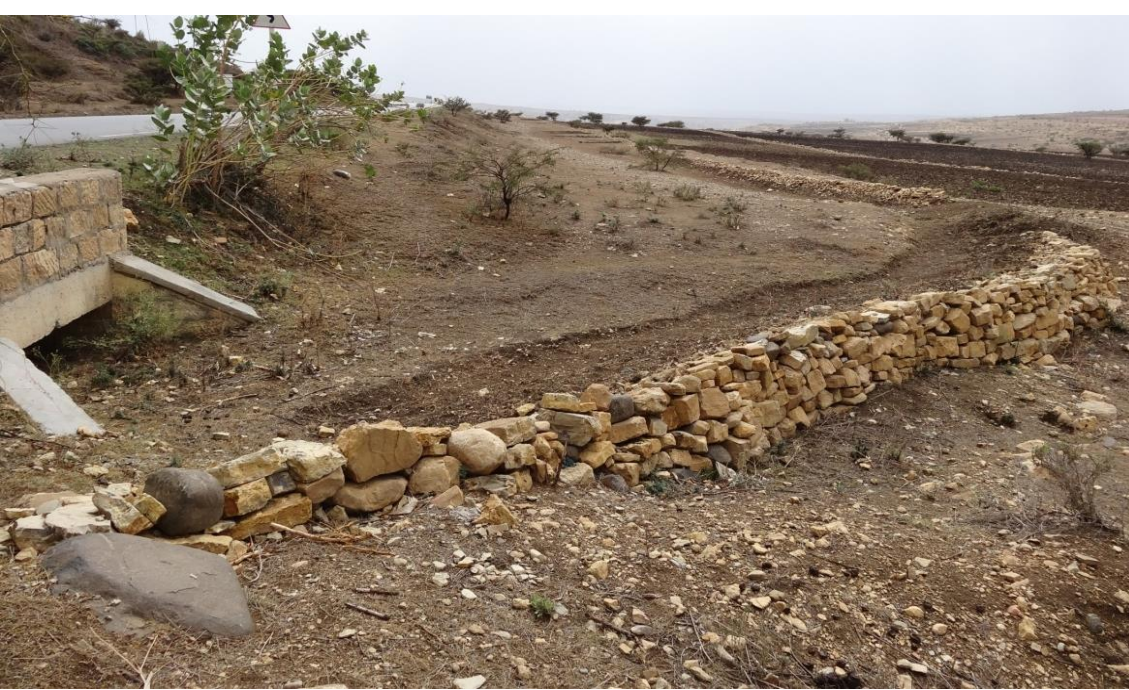
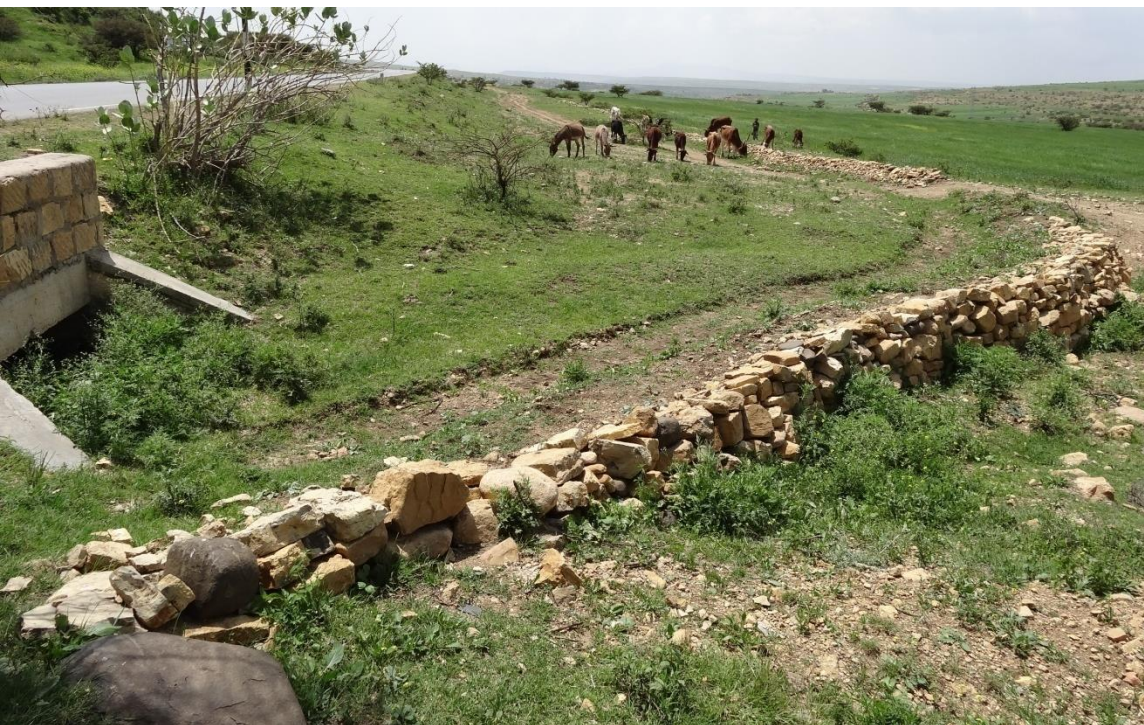
*June 2014*

**Plate 19. Water from a culvert is channeled into farmlands, Tigray, Northern Ethiopia**

*Sept 2014*

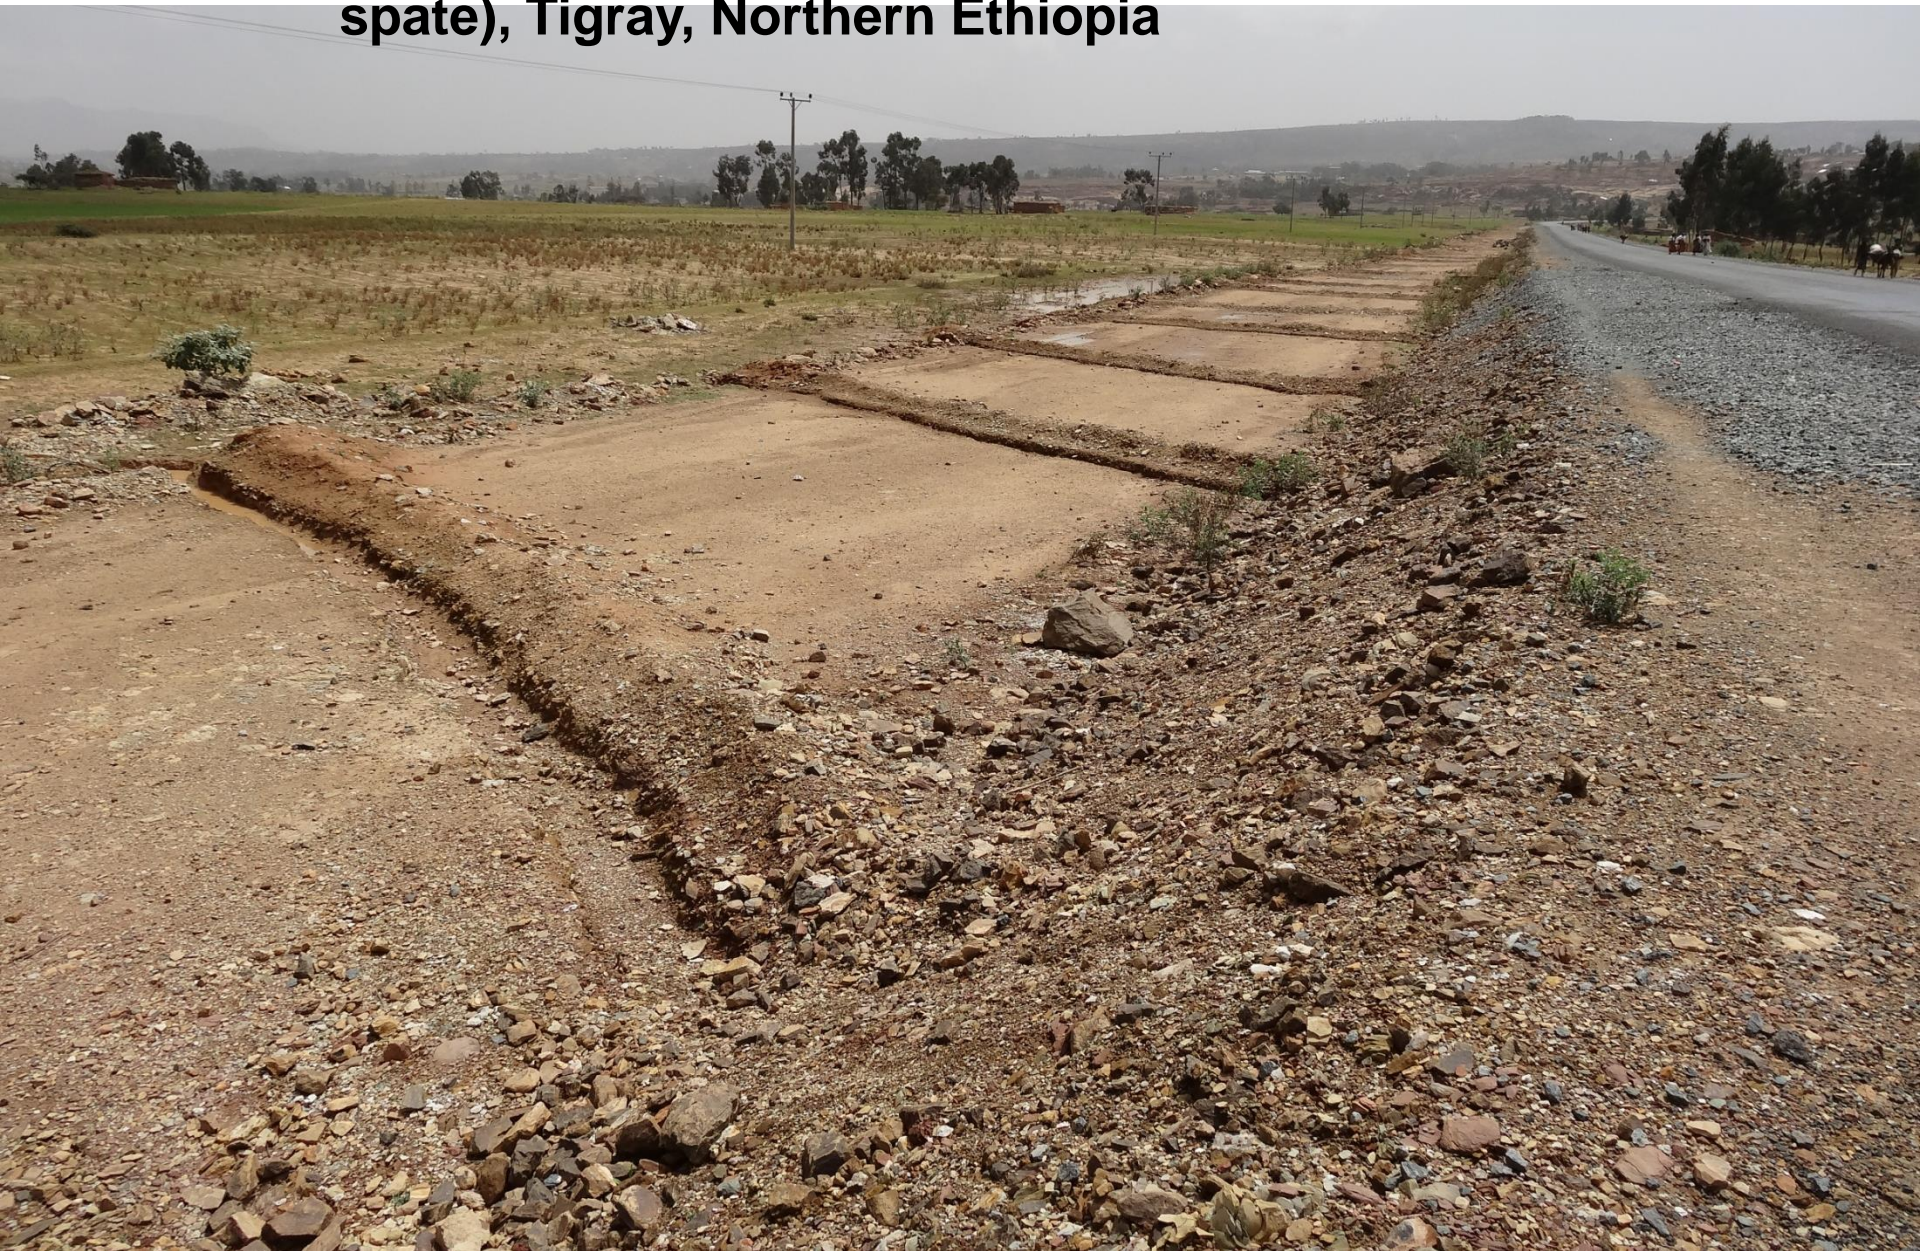
**Plate 20. Road side runoff is channeled into farmlands (as spate), Tigray, Northern Ethiopia**

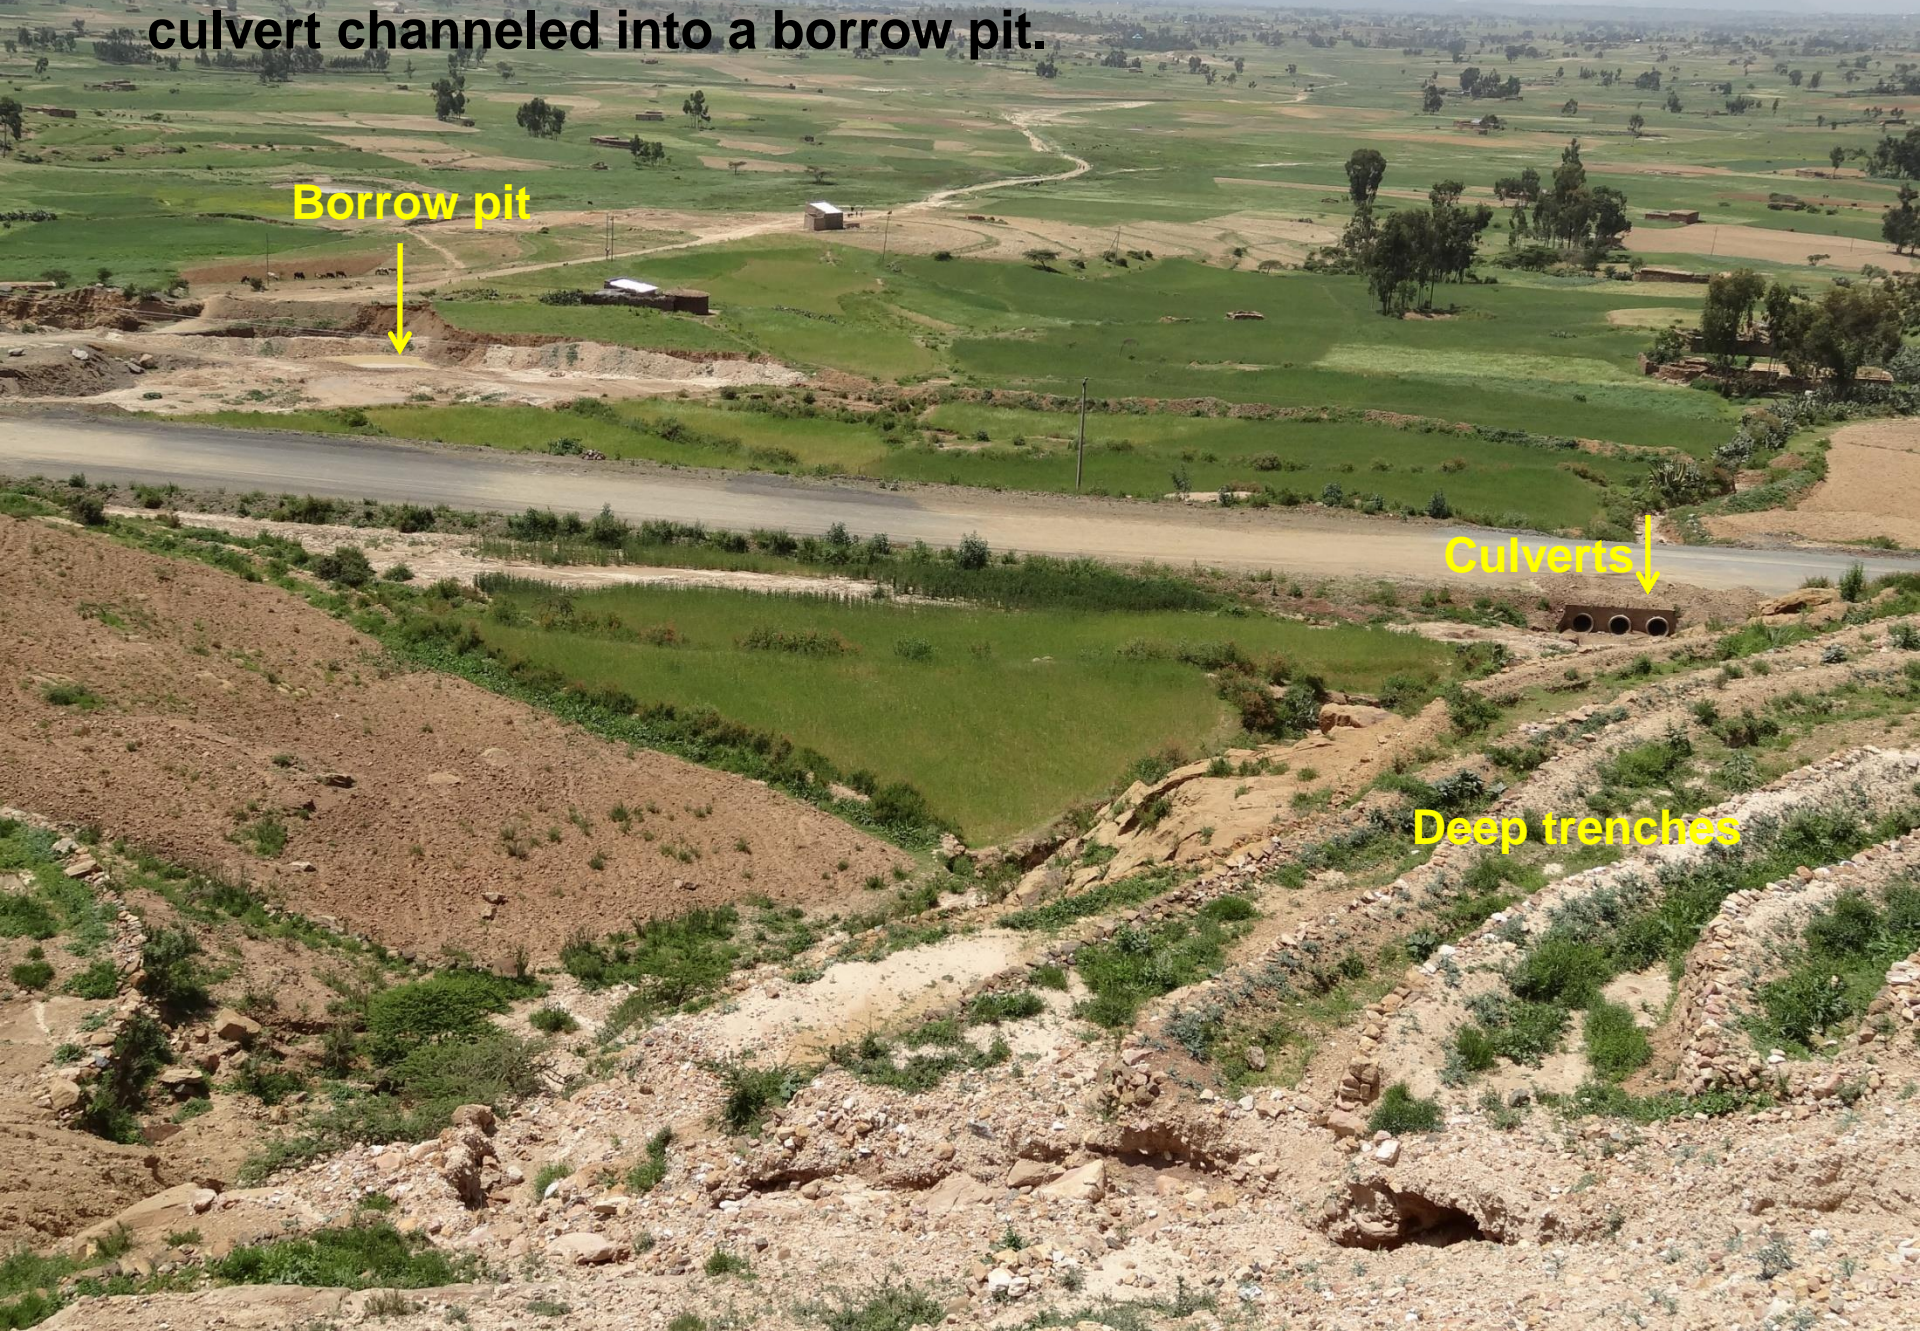
**Plate 21. Upstream deep trenches, and then water from culvert channeled into a borrow pit.**

**Borrow pit**

**Culverts**

**Deep trenches**

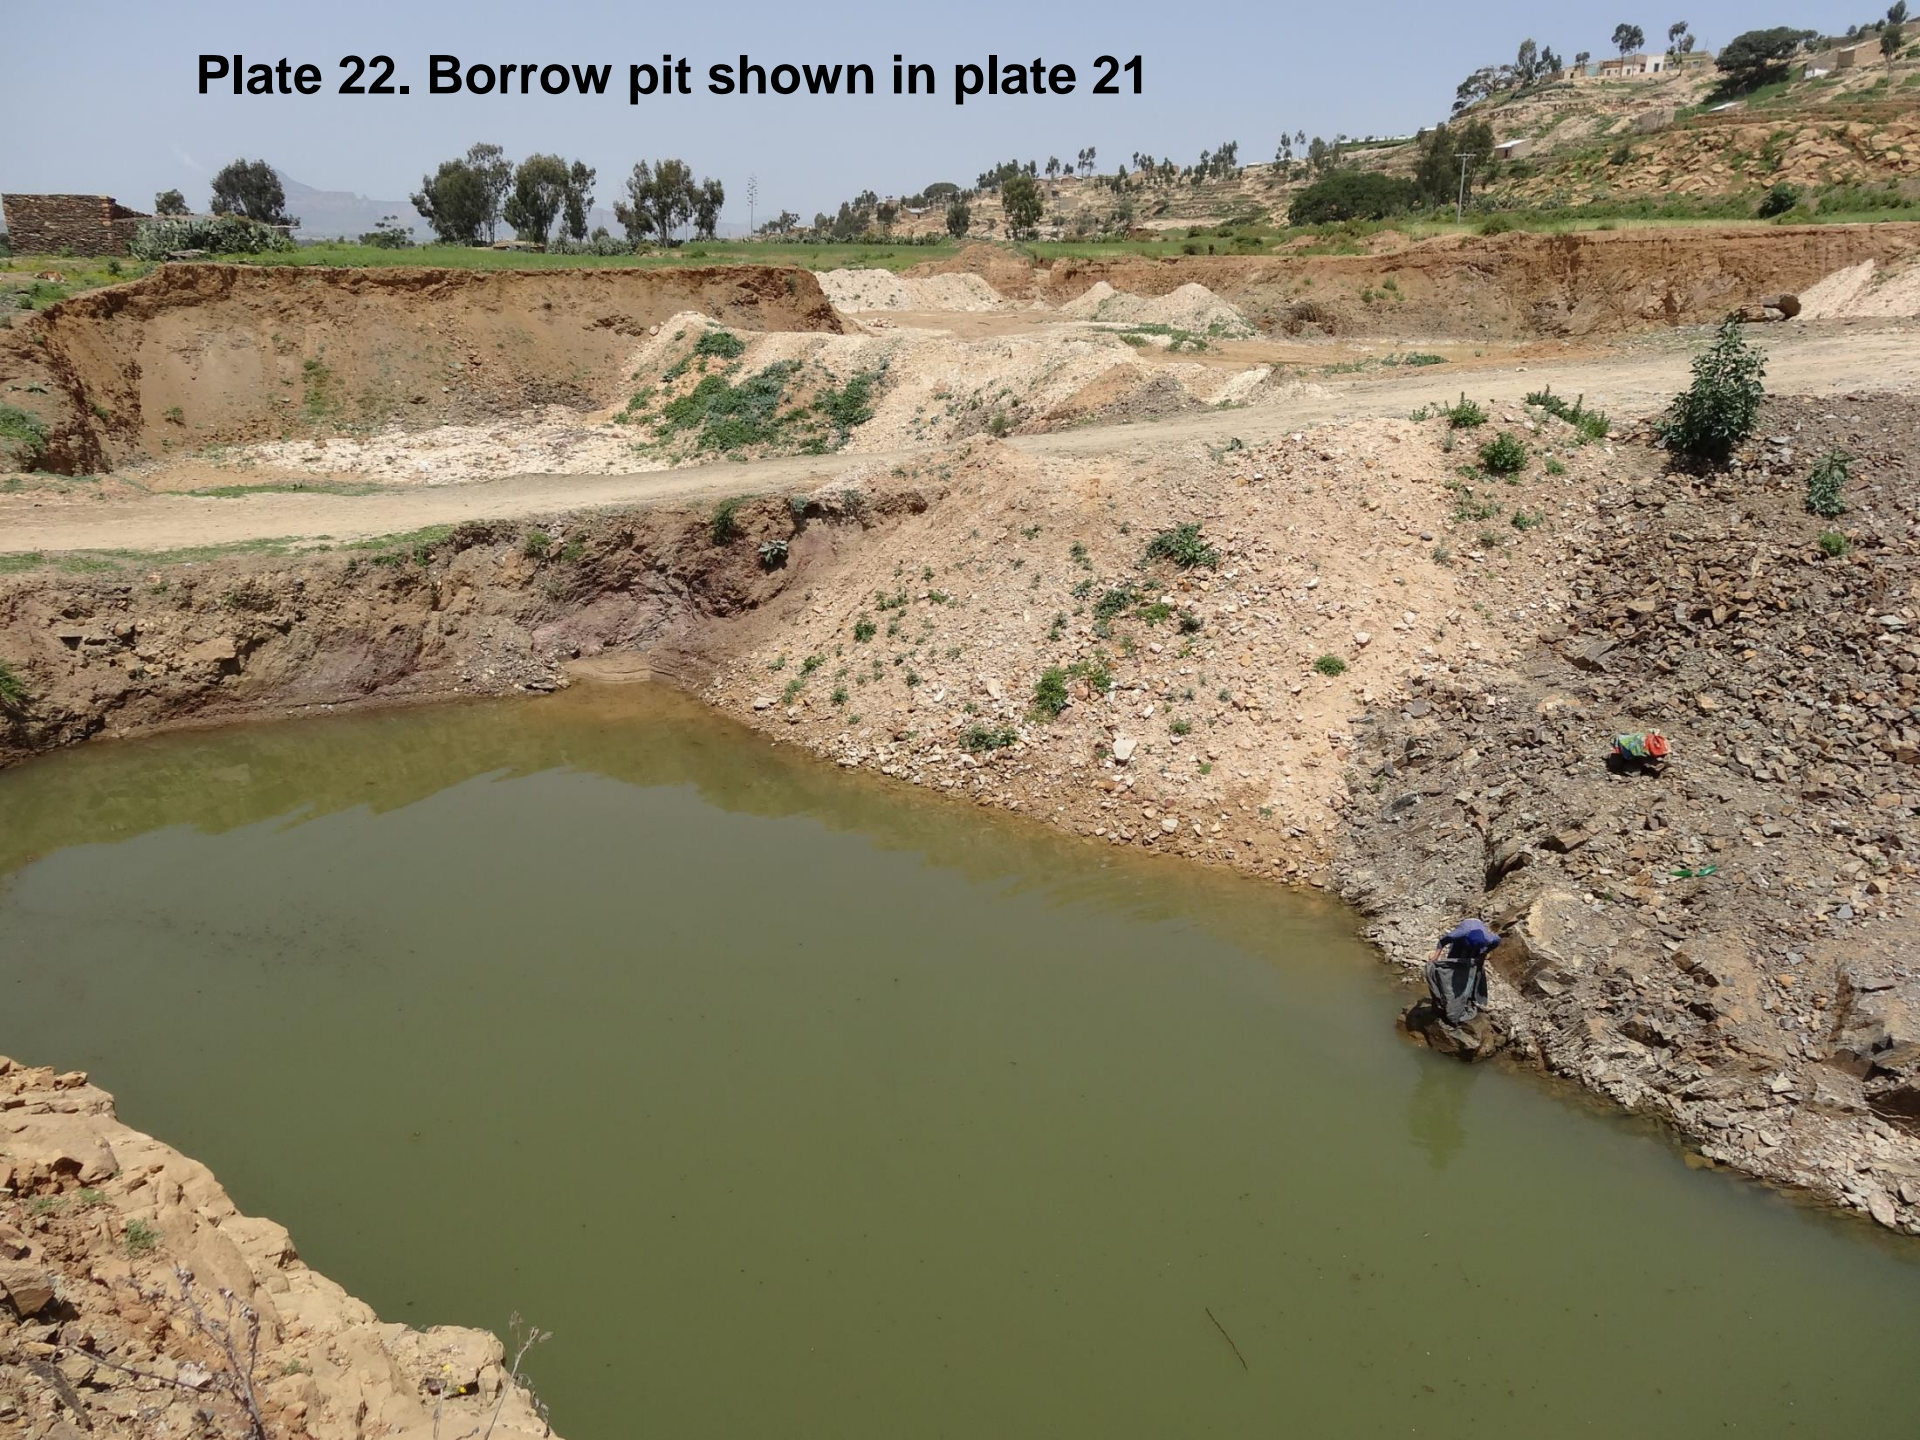
**Plate 22. Borrow pit shown in plate 21**

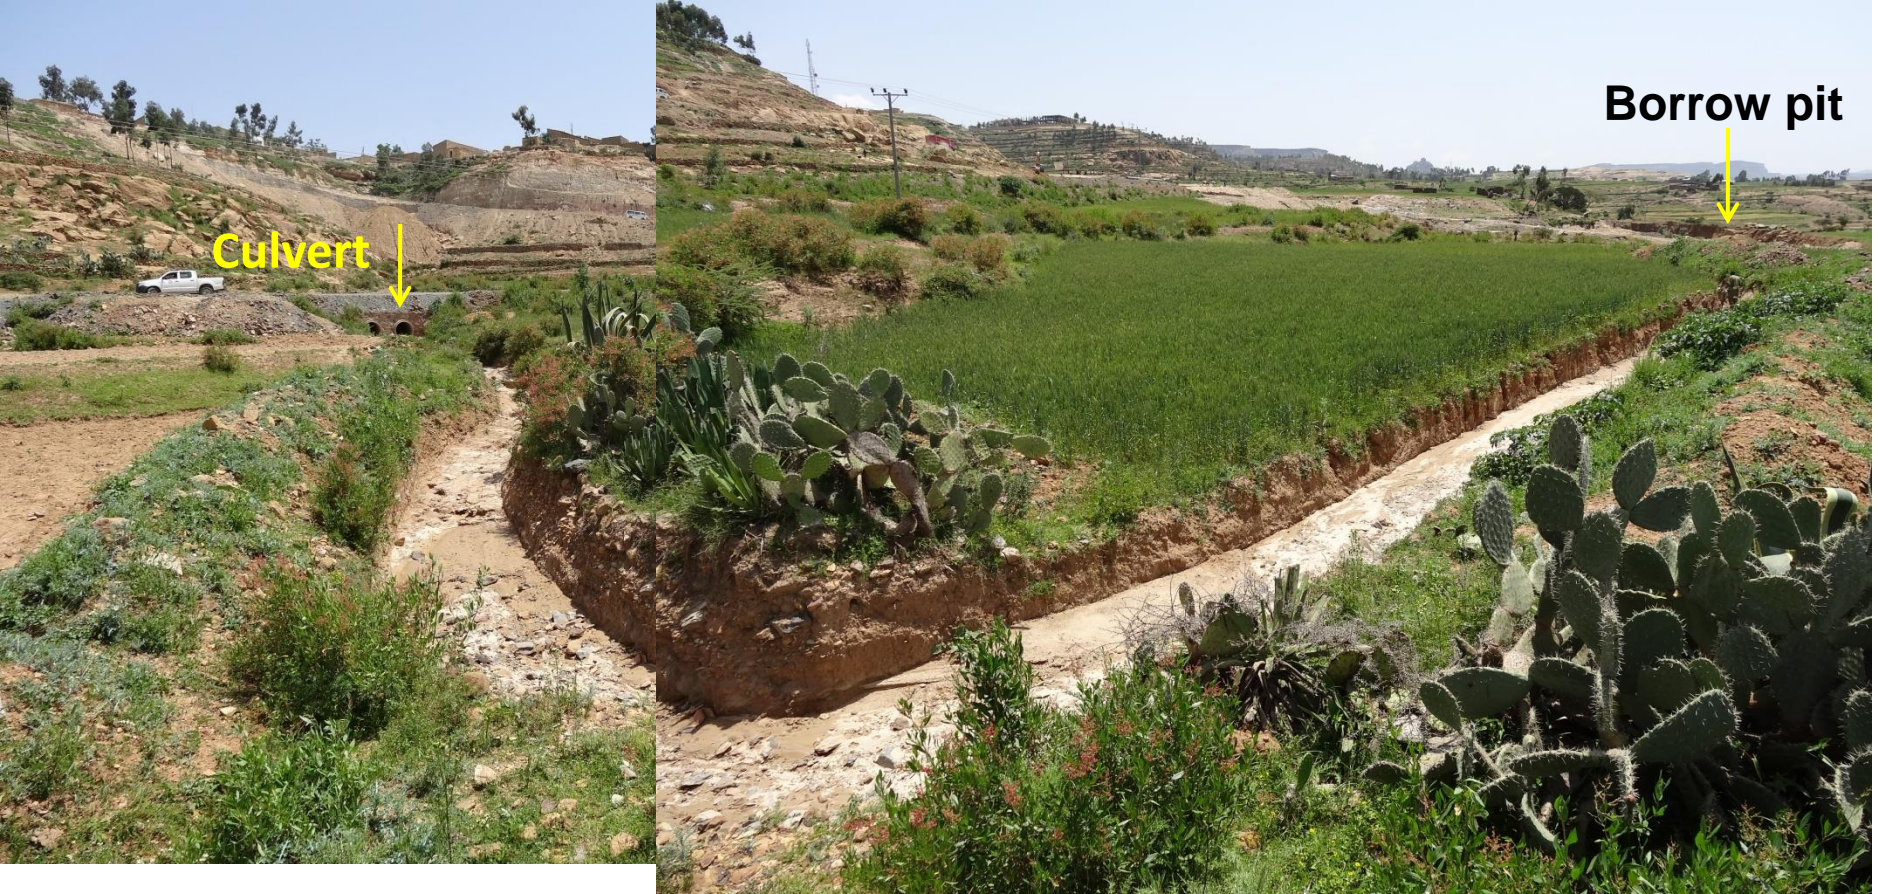
Culvert

Borrow pit

**Plate 23. Panoramic view of channels constructed to divert water from culverts into a borrow pit shown in Plates 21, 22.**

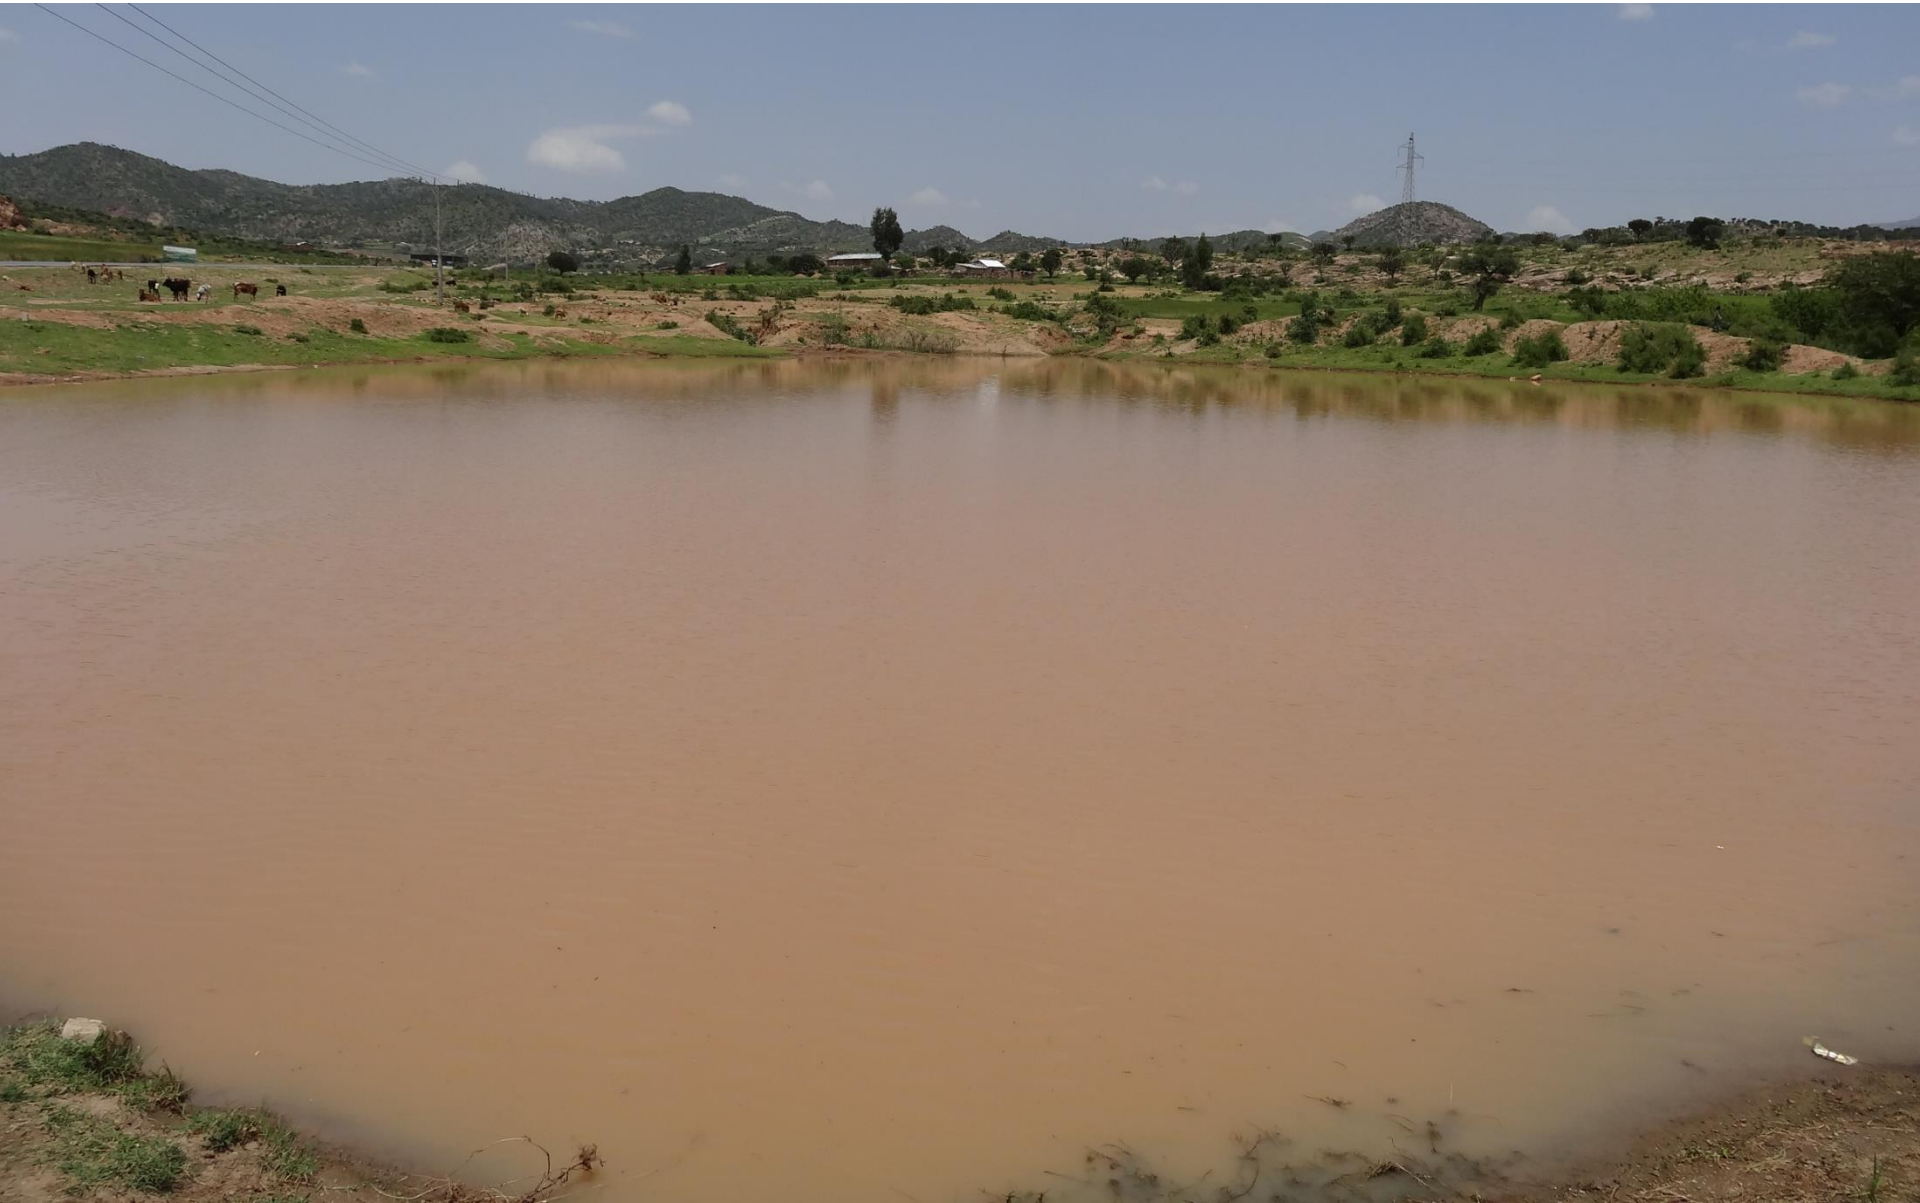
**Plate 23. A pond used to store water from road side and from a culvert in Wukro area, Tigray, Northern Ethiopia**

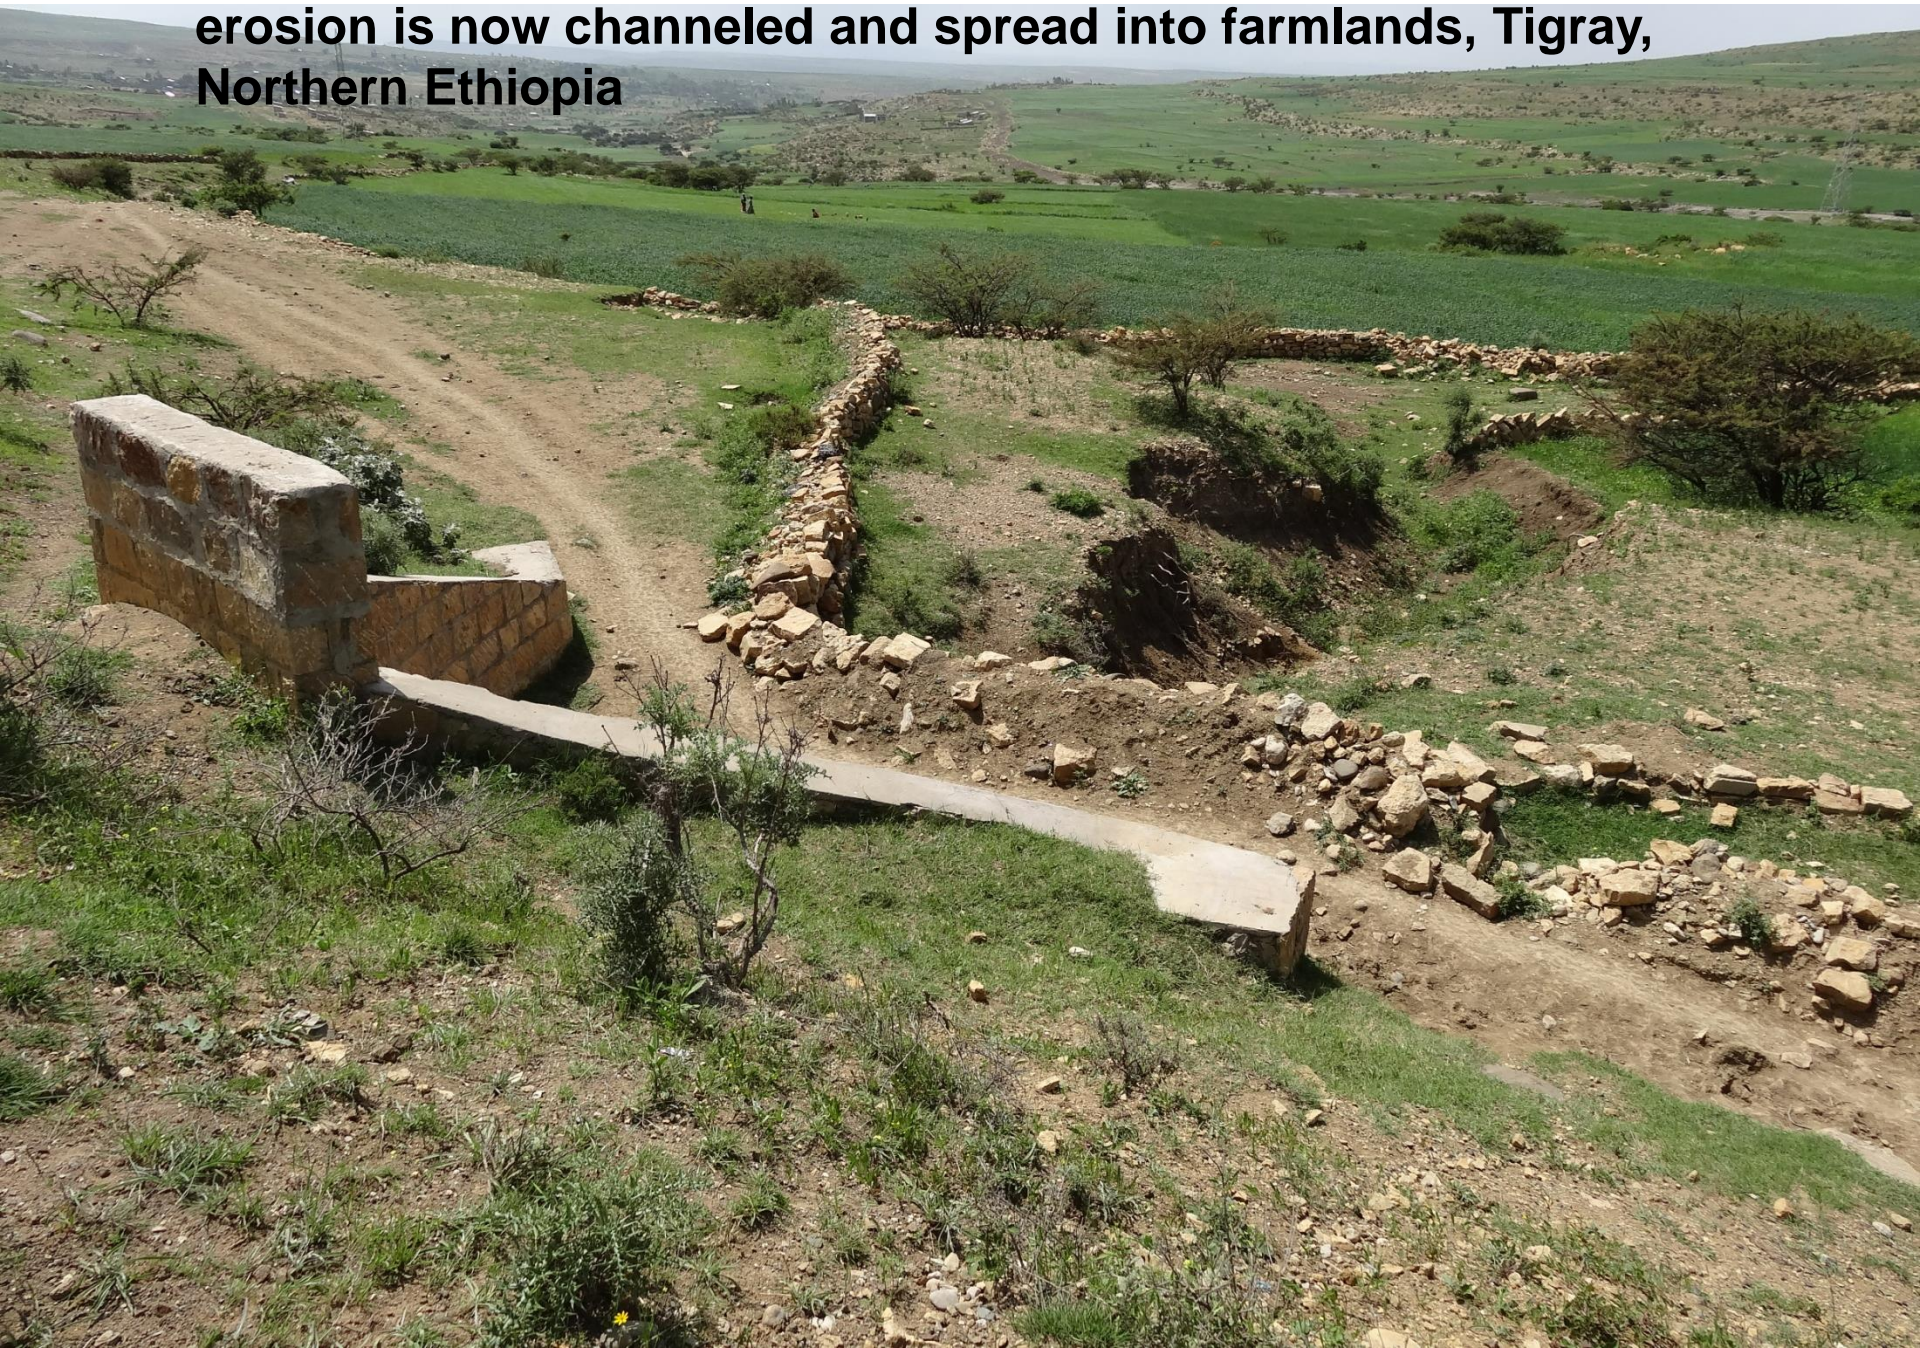
**Plate 25. Water from a culvert which used to cause gully erosion is now channeled and spread into farmlands, Tigray, Northern Ethiopia**
