# Water Harvesting from Roads in Tigray, Northern Ethiopia: In Figures

***Kifle Woldearegay (Mekelle University, Ethiopia)***

***Frank Van Steengergen (MetaMeta, The Netherlands)***

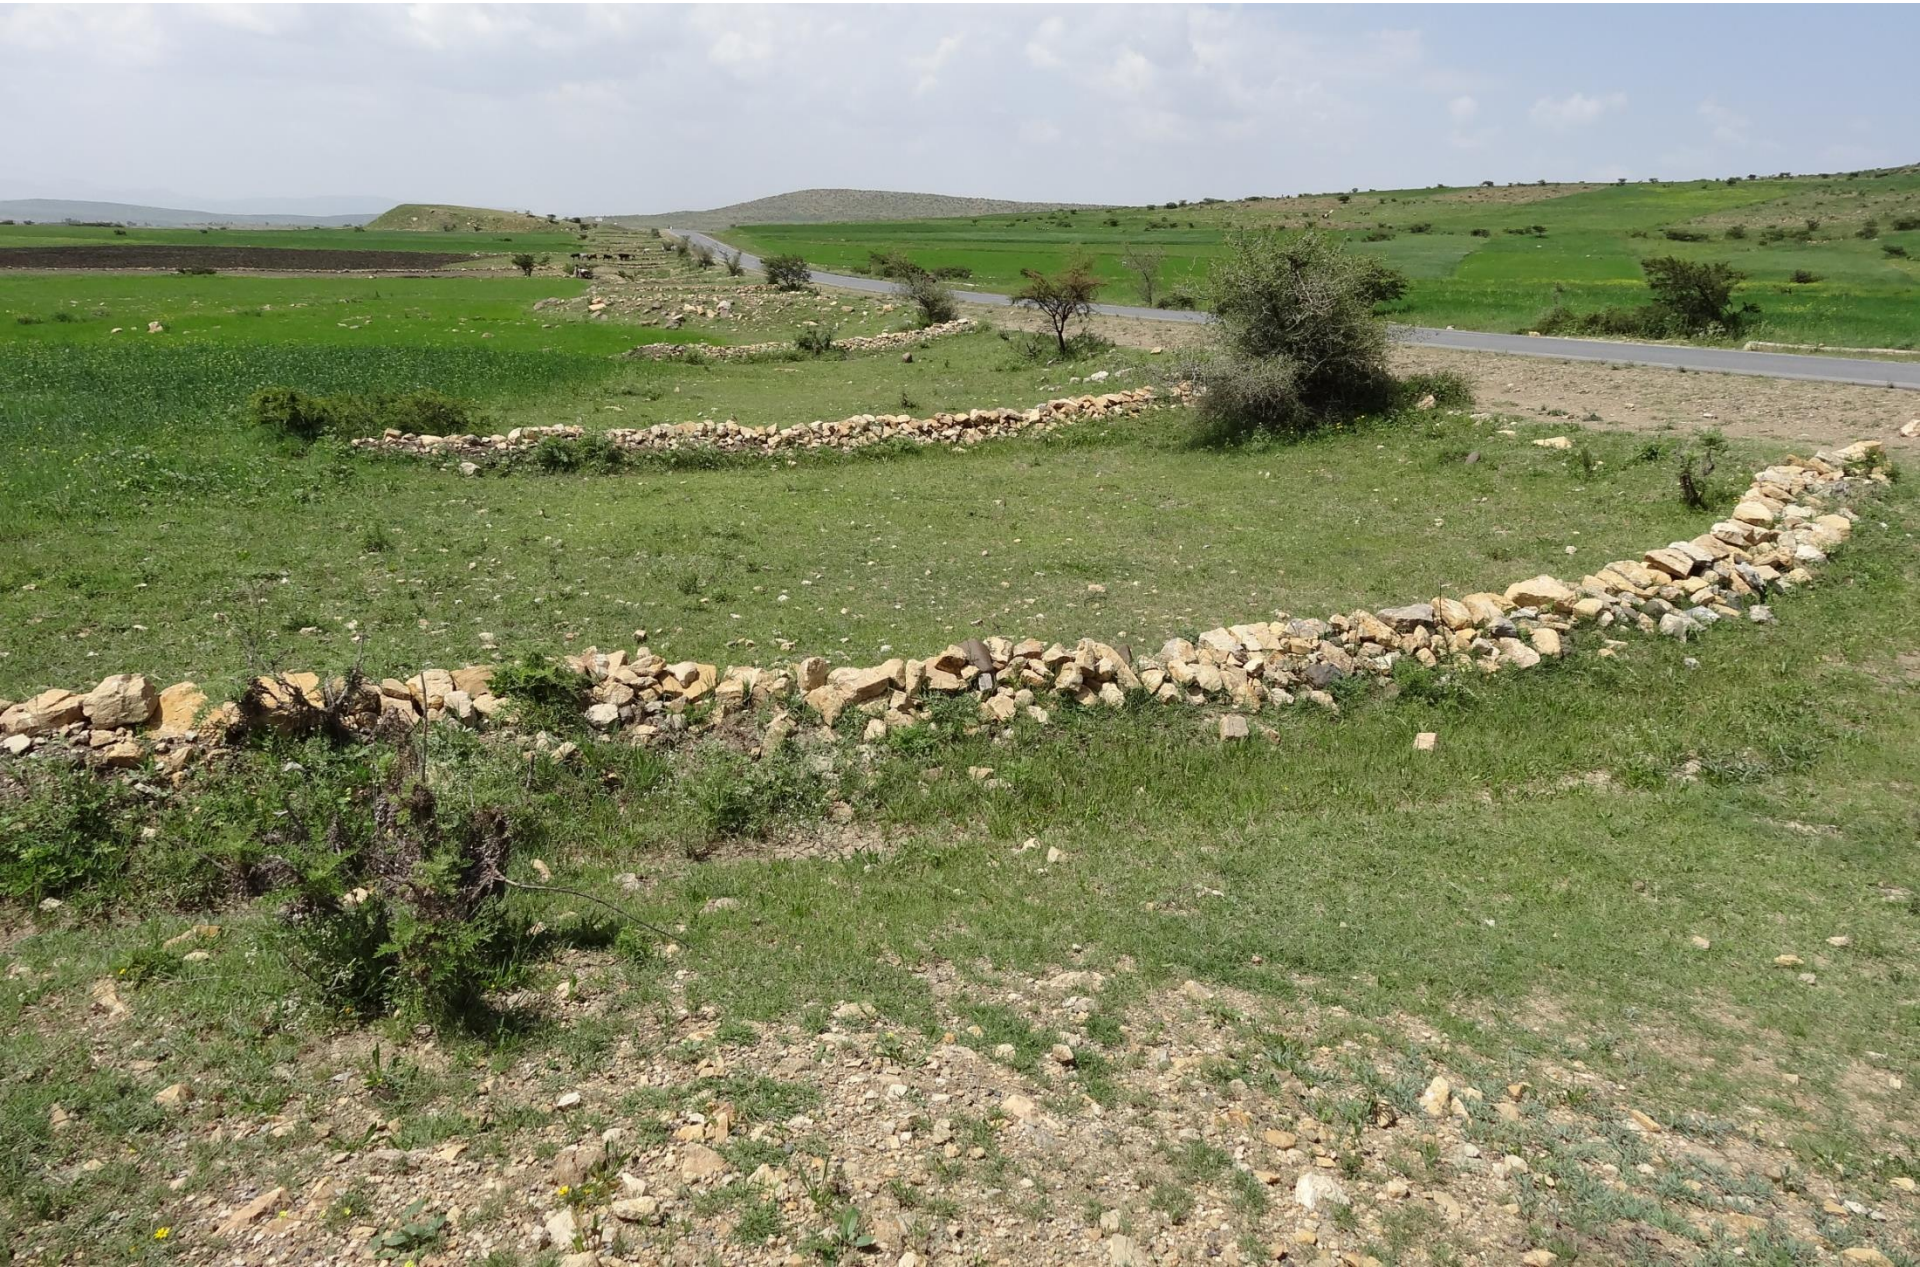
**Plate 26. Road side runoff is diverted and spread into farm lands through series of channels, Tigray, Northern Ethiopia**

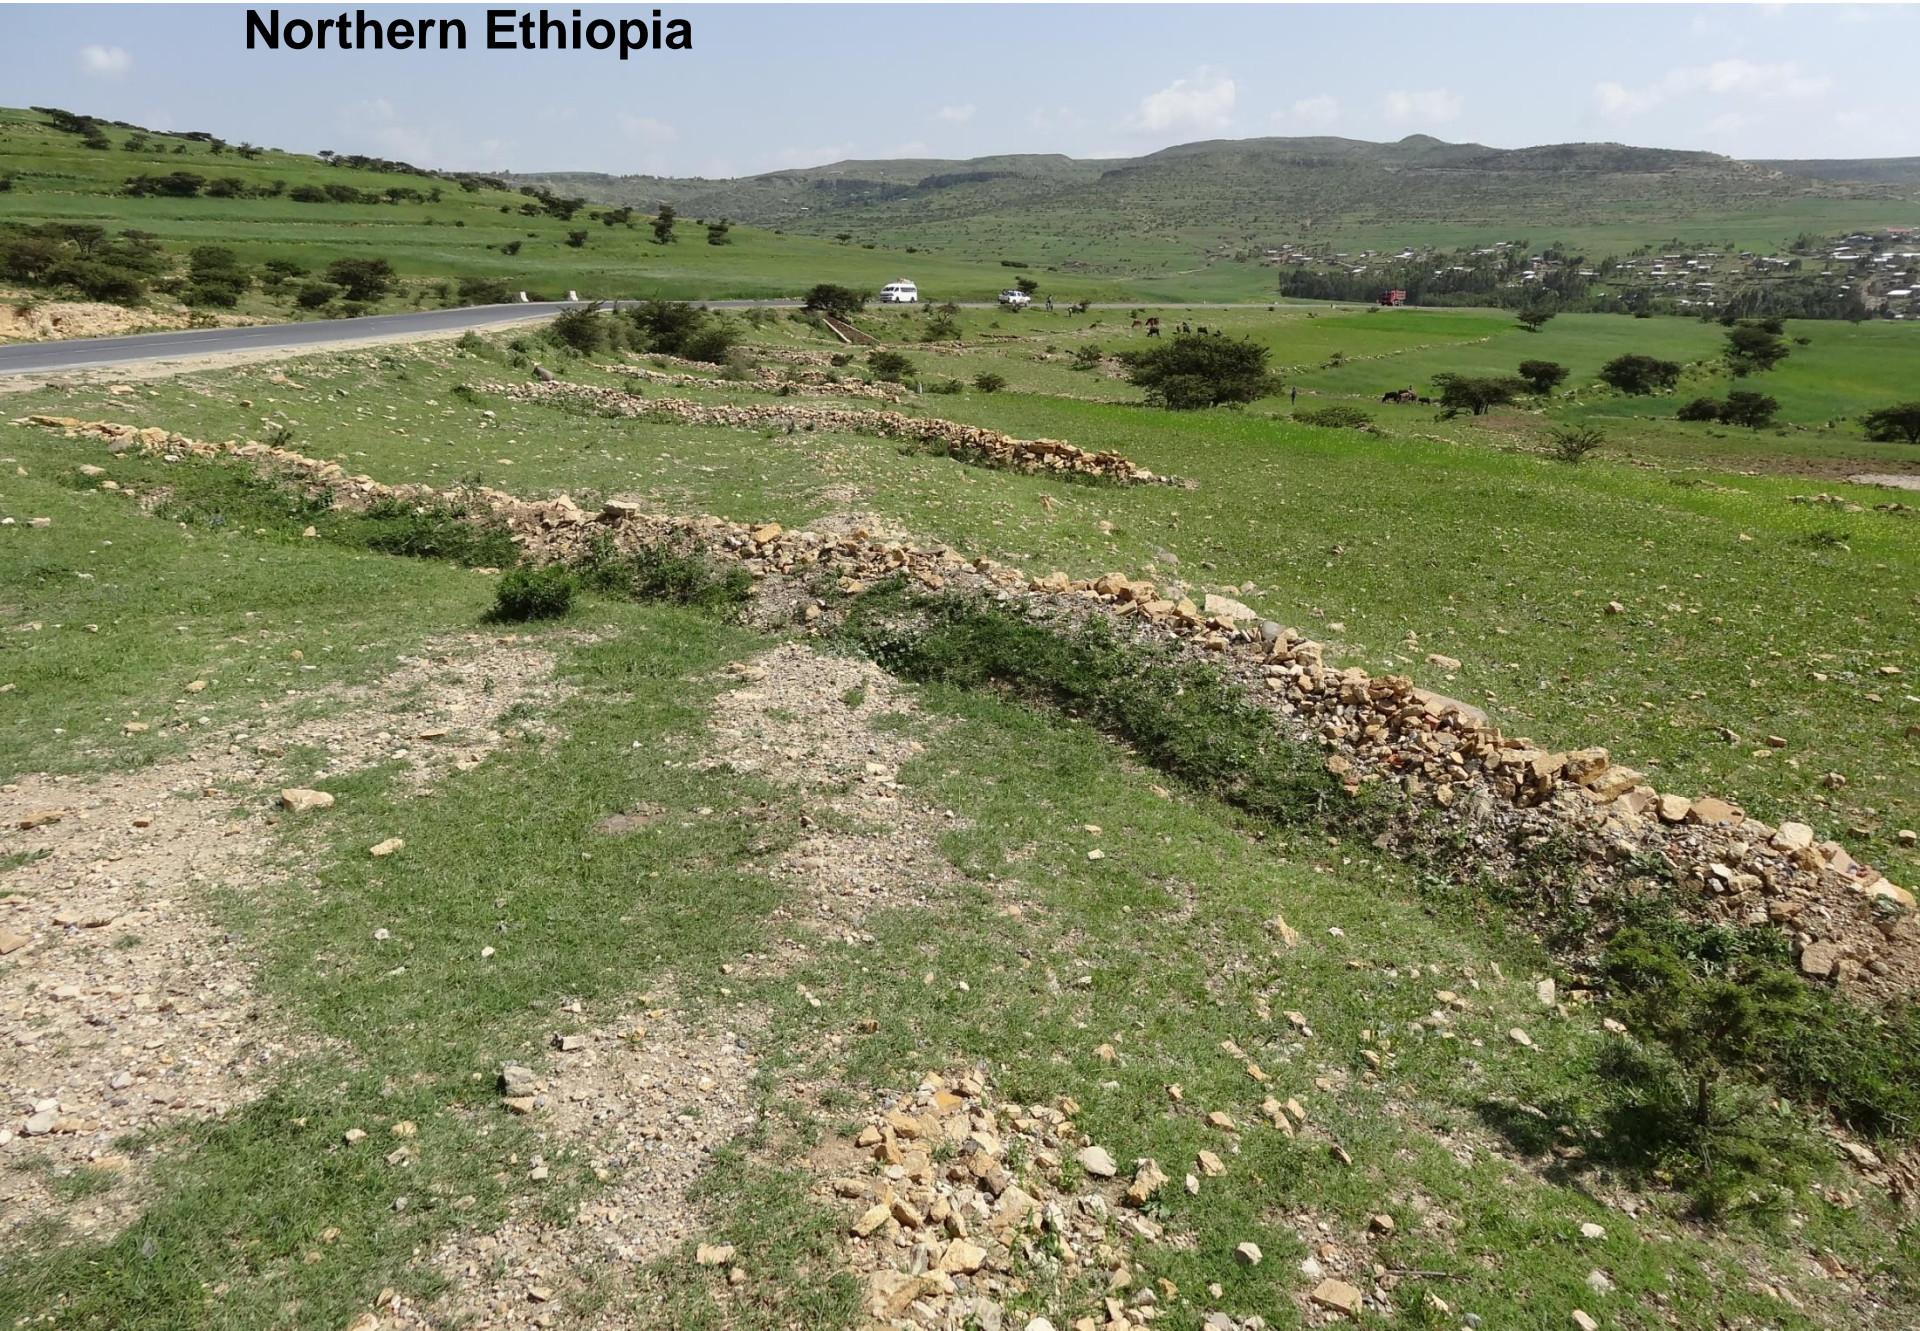
**Plate 27. Similar to Plate 26 but different site in Tigray, Northern Ethiopia**
