INTEGRATING CLIMATE CHANGE ADAPTATION AND WATER MANAGEMENT IN THE DESIGN AND CONSTRUCTION OF ROADS

Assessment of Opportunities in
Mozambique

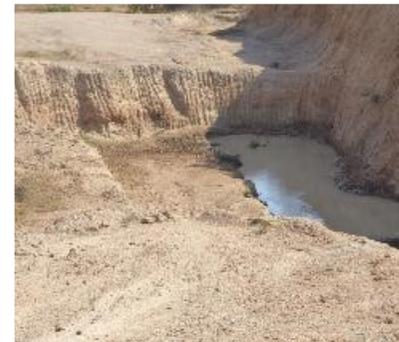
(1) Example of abandoned borrow in Gaza

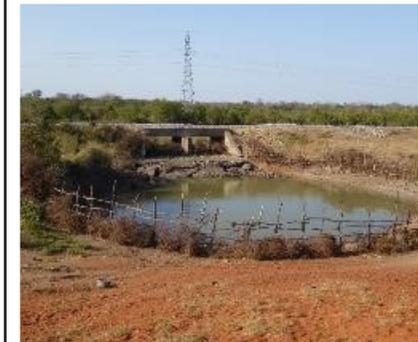
(2) Collecting water from pond at railroad crossing along N212

channels should be protected to prevent wash-out. Next, the borrow pits have to be supplied by the cross drainage from the N212 and the railway track running parallel to it. The location of the culverts on the railway and the road is not synchronized, yet this would be simple to do and place culvert on both the road and railway in the same position. As there are a large number of borrow pits (one every 5 kilometer) with different shapes and depth it would make sense to select the borrow pits that are most promising to rehabilitate and provide with proper management, protection and measures to ensure water of acceptable quality. Borrow pits (for development or conversion) should be close to areas where people reside or where there is interest in irrigation or possibility to recharge wells. In pastoralist areas in general it is useful to plan the location of water resources taking into account the grazing resources. Ensuring water quality can be done by providing sand filters in the converted borrow pit. Such sand filters can be equipped with hand pumps: if immersed the sand filter will remove large part of the harmful bacteriological contamination. An alternative option for ensuring good water quality from the converted borrow pits is to make wells that collect the groundwater recharged from the borrow pits or to place the so-called 'village pump' that combines pumping with filtering and automated cleaning of the filters.

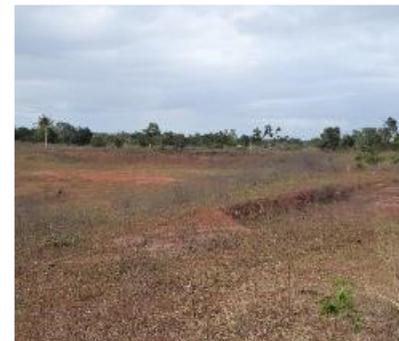
(3) Landscaped borrow pit along N1 – unused as there are other sources of water

Usually these borrow pits are not landscaped. Moreover, not all borrow pits are suitable for conversion. In some cases (for instance along the R902 and R481 in Inhambane) the borrow pits are located too high to collect substantial amounts of water. In other cases the borrow pits are far from habitation. It may also be that the areas surrounding the borrow pits have sufficient other sources of water and there is no need for additional storage

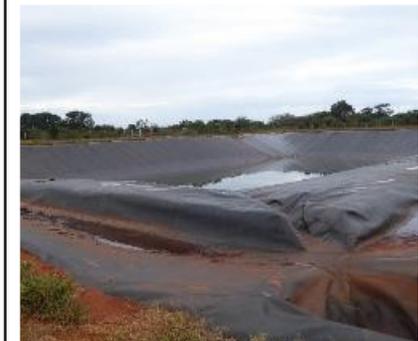
(4) Mavanza upgraded borrow pit – with geomembrane lining and fencing – intensely used

Nevertheless, there are many areas where it would be interesting to rehabilitate the borrow pits. For instance, one borrow pit visited (Mavanza in Inhambane) was lined with geomembrane by ARA-SUL and surrounded by a fence. The borrow pit was also equipped with an Afridev pump, leading among others to some distant animal drinking troughs to avoid livestock

coming near to the open water source. In Mavanza the management of the reservoirs and the pump was no longer in place. Even so, the use of the borrow pits was very intensive. Water was collected by a population in a radius of 4 kilometer from the pond. The storage pond, with an estimated storage capacity of 20,000 m³, was storing water throughout the year. Though the cost of upgrading the borrow pit to a full-fledged reservoirs was high, in the Mavanza area it served an important purpose as there was no other source of water.

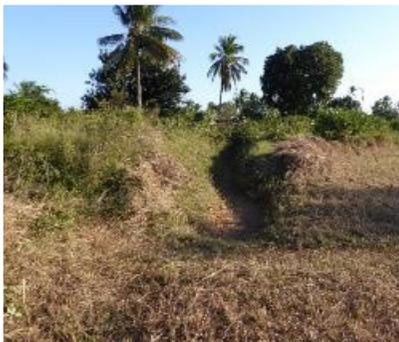
(1) Short road trench – standard practice now

A common practice observed in Mozambique on both class 1 roads (such as the N1) and class 2 and 3 roads is to provide short road side trenches, called sanjas. During rain, these trenches take road run-off of the road surface in order to preserve the road body. The road side trenches are usually placed at very short distance from one another. During the transect visits to Inhambane Province, it was found for instance that there were 10-16 such road side trenches per kilometer. Ideally the trenches align with the road slope, though this is not always the case. They are in most cases made by the grader working on the road surface. The length of the trenches is very short: typically 3-5 meter.

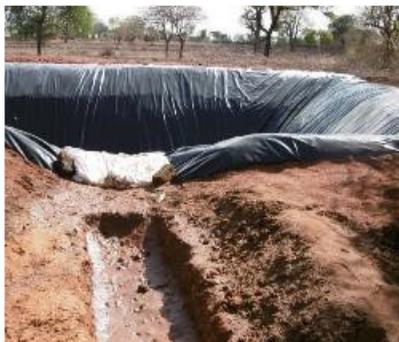
(3) Improved practice in Kenya – trench and pond

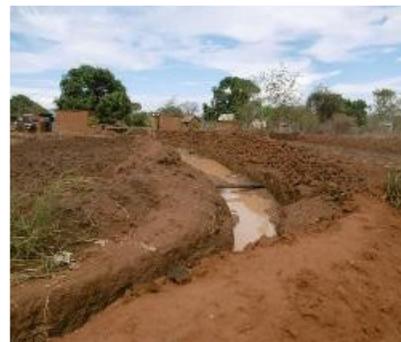
(4) Improved practice in Kenya – farm road trench filled with water

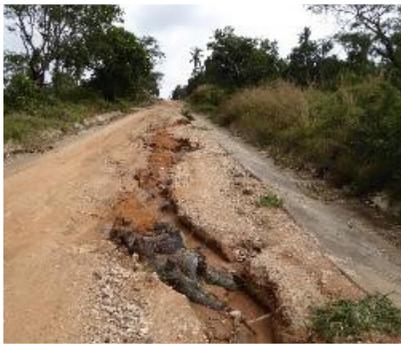
(1) Massive gullying on red sand road slope

The maintenance of un-sealed roads, especially Class 3 roads, is a major challenge – financially and technically. Section 2 gave an overview: The challenge is compounded by the fact that in several areas there is no suitable sub-base and base material available. This was observed in Inhambane in road R905 for instance where the main material is highly erodible red sand. Under the impact of traffic movement and water run-off the material disintegrates and is washed away in large quantities, requiring substantial maintenance efforts.

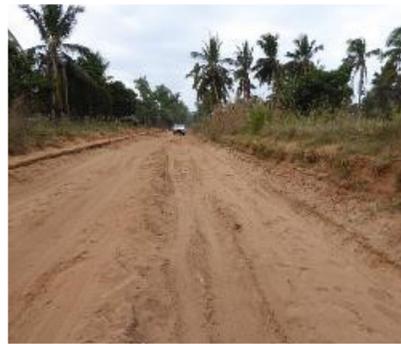
(2) Road lowered 90 centimeter due to wash out

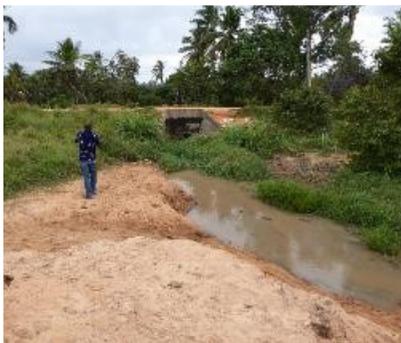
(3) Large deposits of washed away road material

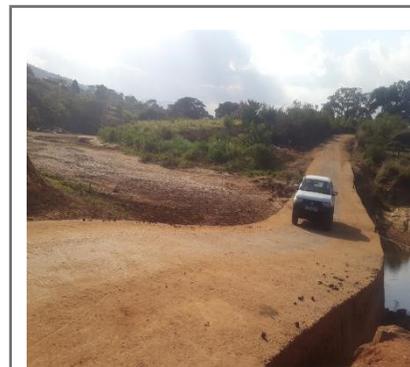
(1) Non-vented drift doubling up as sand dam in Kenya

The second major advantage of the use of non-vented drifts – provided the river is sandy – is that a package of sand and gravel will be deposited immediately upstream of the non-vented drift. This sand and gravel deposit forms a local new mini-aquifer, storing water in the river bed that will feed the nearby wells. The river bed can also be drained with a slotted pipe to provide relatively safe water.

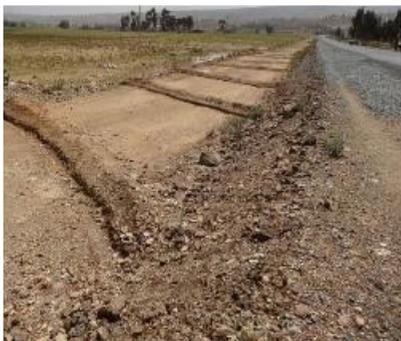
(1) Flood water spreader from paved road surface

- Floodwater spreaders from paved road surface – these spread road surface run off to adjacent land
- Floodwater spreaders from culverts – these take water from road culverts and spread it widely over the land, avoiding the development of gullies in the process. Important – as in all these measures – is that the drainage water is removed to a safe distance from the road subgrade
- Road side infiltration trenches – these collect run-off obstructed by roads into recharge structures
- Road side infiltration or storage ponds – this sees road drainage filling ponds used either for surface storage or infiltration and recharge of groundwater

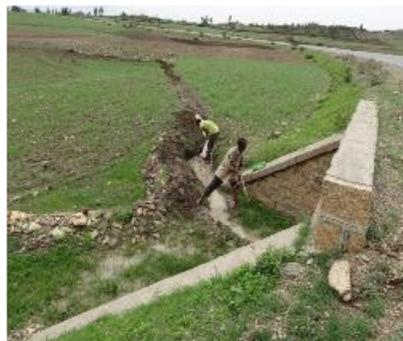
(2) Flood water spreader from culverts

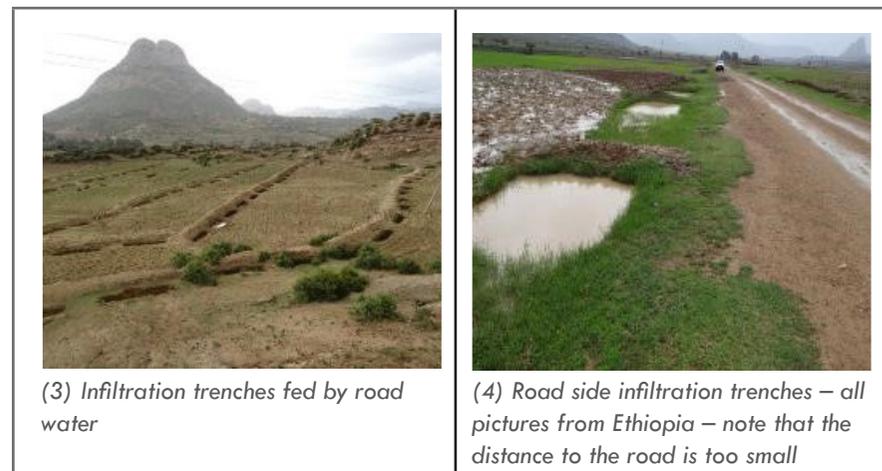
(3) Infiltration trenches fed by road water

(4) Road side infiltration trenches – all pictures from Ethiopia – note that the distance to the road is too small

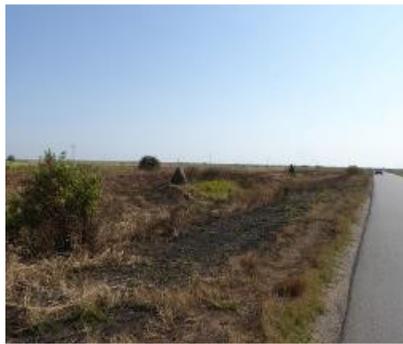
(1) Example of Limpopo flood plain dissected by road – dry downstream side with termite hills

In many cases roads have been built on relatively high embankments in flood plains. This is to avoid them being overtopped during floods. Yet even with such high embankments, flood water however still had to get its way, which leads to uncontrolled flooding – putting life, infrastructure and connectivity at risk. The damage experienced in 2015 floods owes itself to high embankments to a large extent. The damage happened once when the floods water crossed towards the higher area and then once it receded. Quite often the receding flood was more damaging. Also the high embankment roads have often dissected the flood plains – causing waterlogging on one side and dry areas on the other side.

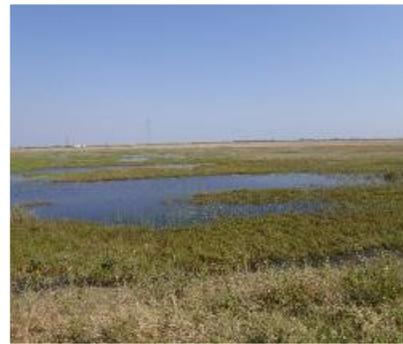
(2) Same flood plain on river side – with extensive water logging

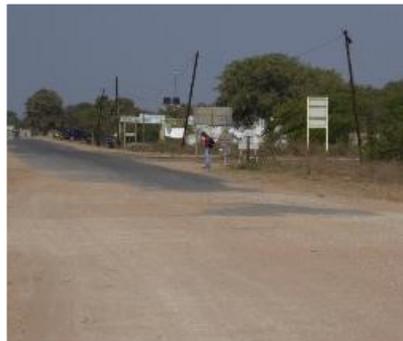
(3) During floods the same road was overtopped and wash away – with extensive damage

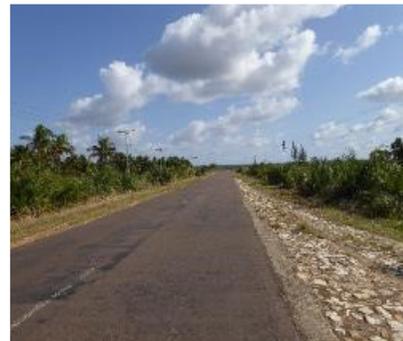
(4) Good practice of low embankment road in Lindella – with armoured overflow area complete with flood velocity reducing trees along the overflow area

The practice is not common in Mozambique but merits wider application. It has been applied successfully in Lindella in Inhambane – where the wetland is preserved including its functions for grazing and reed collection – by including a 100 meter overflow section in the road traversing the flood plain.

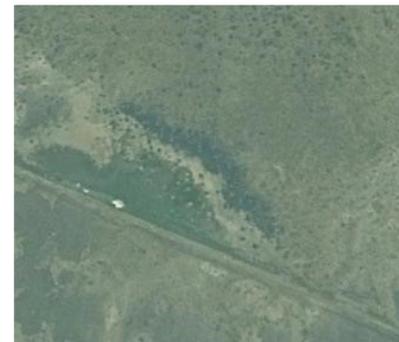
(1) Dissected flood plain – with different moisture levels and land use on either side of the road

roads divide the flood plain in an active/ wetter and a protected/ drier part, the exact level of water retention and ‘wetness’ in either side of the dissected flood plain can be regulated by the cross drainage provided in the flood plain road, i.e. the number of culverts and bridges and importantly also the bed level of the culverts or of the bridge sills. Lowering or raising these bed levels has a tremendous impact on the water levels in the flood plain.

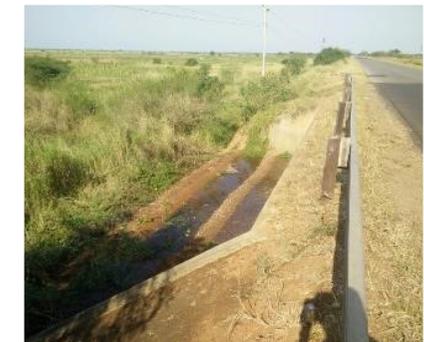
(2) Bridge on N1 – bridge sill level determining moisture levels in sugarcane growing area

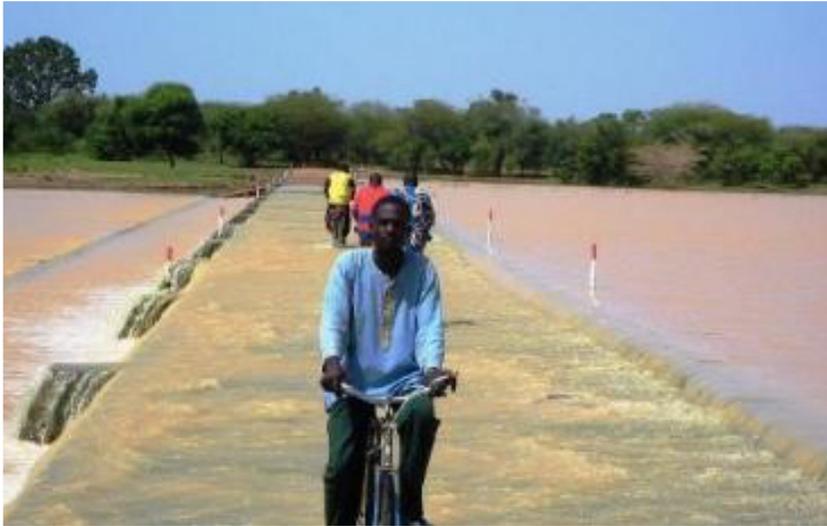
(1) Road cum flood water spreading weir in Niger

Thirdly, especially in flood plains fed by ephemeral streams, roads can be used to spread short term flood water flows over a large areas – this improving its beneficial use. Spreading such short term floods can improve recharge, soil moisture for farming and the opportunities for grazing. The technique of flood water spreading weir is common in Niger and Ethiopia. Two possible locations were noticed in Inhambane too – that would need further study, Pembara along the N1 and the floodplain area along the R481.

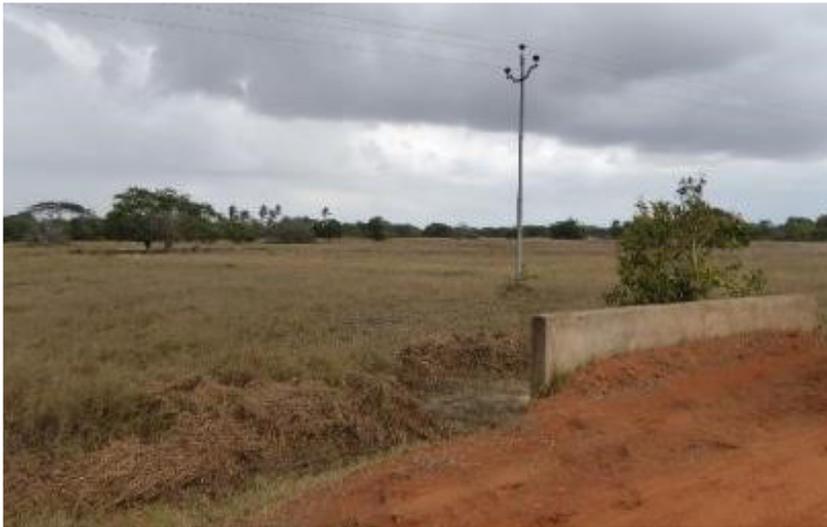
(2) Potential area along R481
