**Comparative analysis of
lining materials for reduction
of seepage in water harvesting
structures**

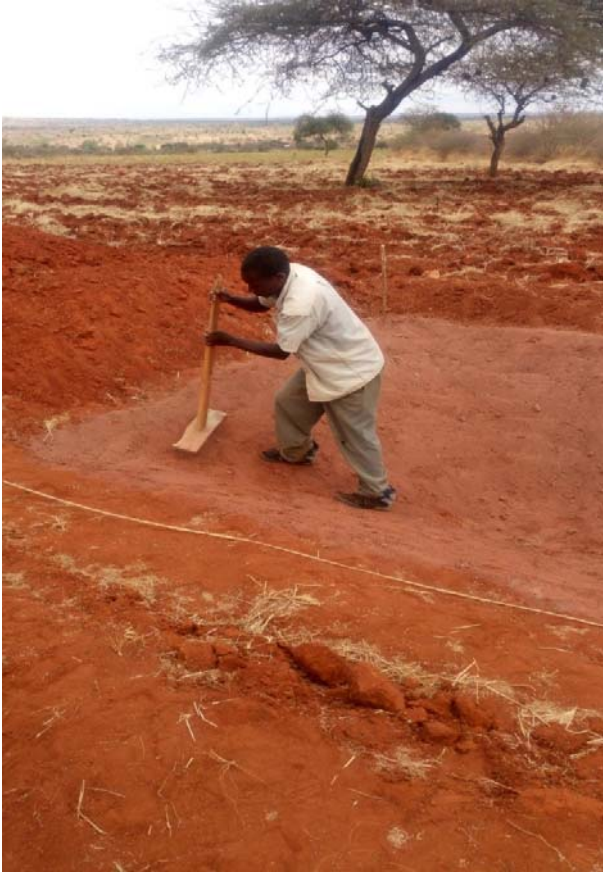
Figure 3: Compacting a mixture of soil and cement mixture layers applied on the pond size.

A heap of the dry soil to be treated was placed besides the pond approximately 1.5 -2.2 m³ for 1 pond. The soil was crushed by breaking the lumps such as to make it in fine form. The 10 buckets of the fine soil were mixed with cement to make a homogenous layer. The mixture was then spread on the pond sides and evenly compacted. A mixture of Terrasil & Zycobond and water solution at a ratio of 1:400 was sprayed on the compacted layer as a top coat. A similar procedure was replicated for the other layers until a thickness of 150mm was attained. A drying interval of 2 – 3hours was allowed before placing the other layers. On completion, the pond lining was allowed to dry for 2-3 days before pond testing in water

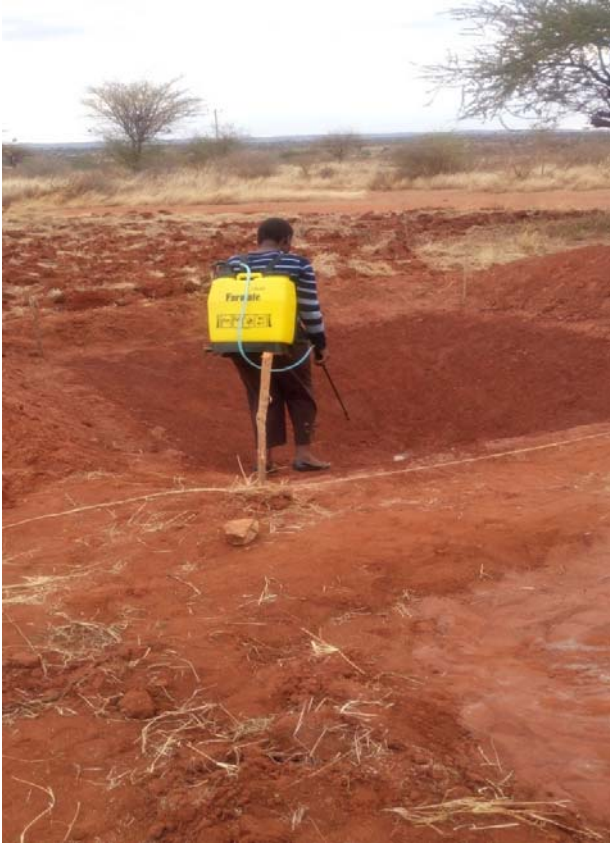
Figure 4: Spraying Terrasil on the compacted layers.

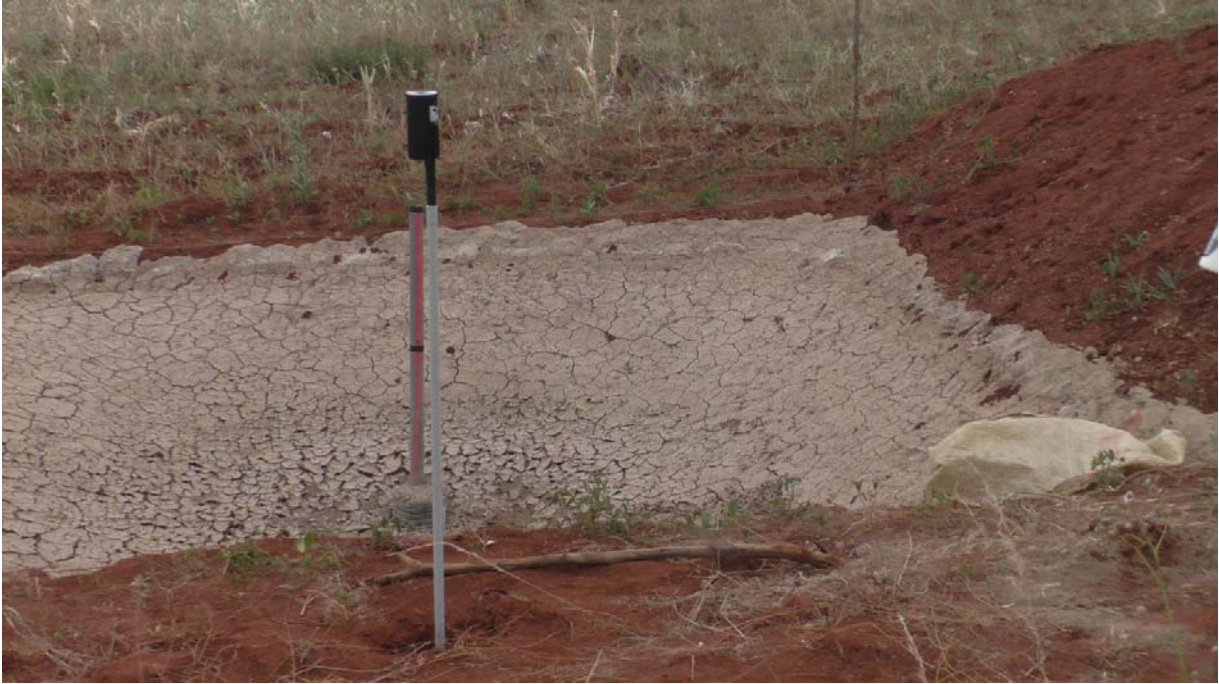
Figure 5: Clay lined pond.

For the clay fill pond, clay material was transported to the area and lining was done starting from the base by compaction. Lining of the pond sides was done in layer to allow better compaction. Small amount of water was applied during compaction to moisten and facilitate binding of the soil material at OMC (Optimum Moisture Level). Then the gentle sloping sides were lined carefully up until the desired slope thickness (150mm) and smooth surface was finally maintained

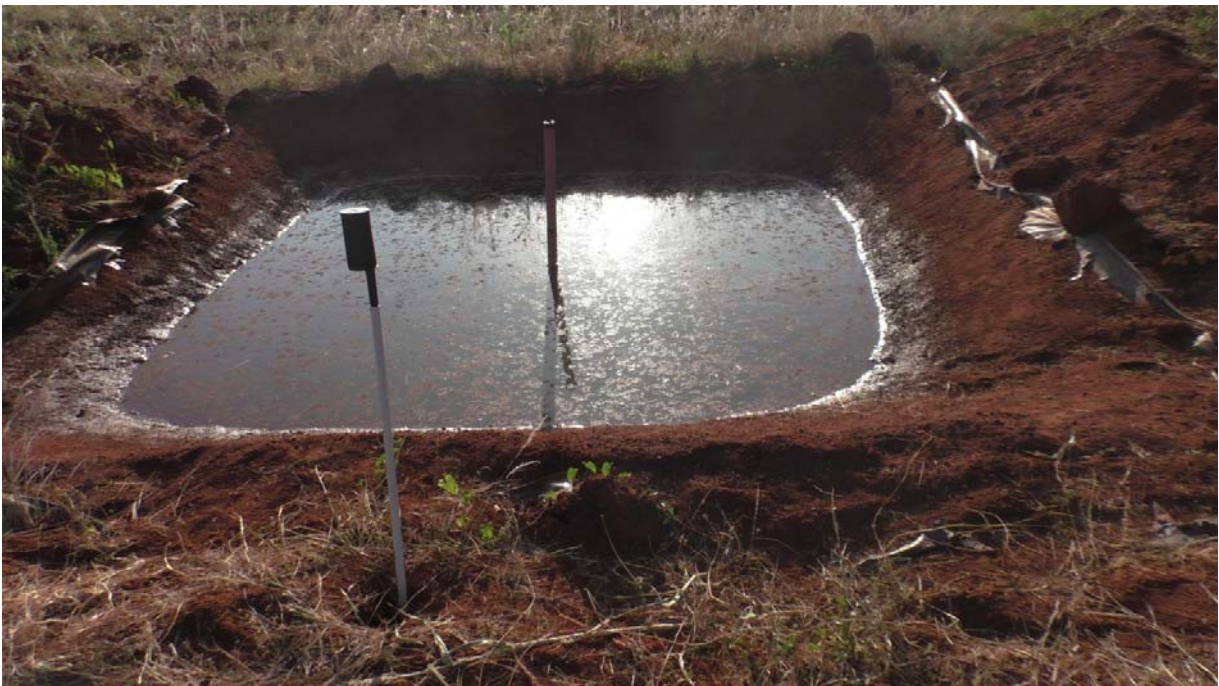
Figure 6: A pond lined with geomembrane and covered with field soil on top.

A thin geomembrane was placed skillfully on the pond surface and was then overlaid by layers of soil treated with Terrasil and Zycobond

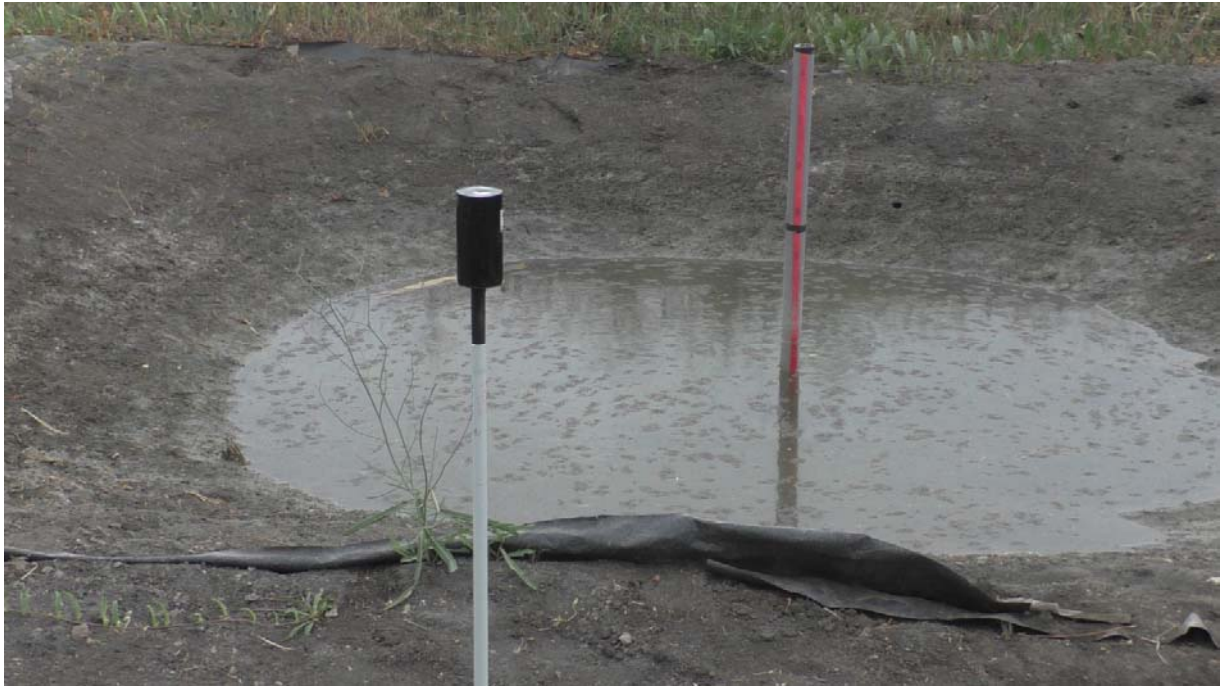
Figure 7: A pipe with a tape attached on the outside to help monitor water level.

The changes in water depth was observed by placing a concrete footed pipe with a tape on the outside at the center of each pond, which enabled monitor decline in the water level of the pond.

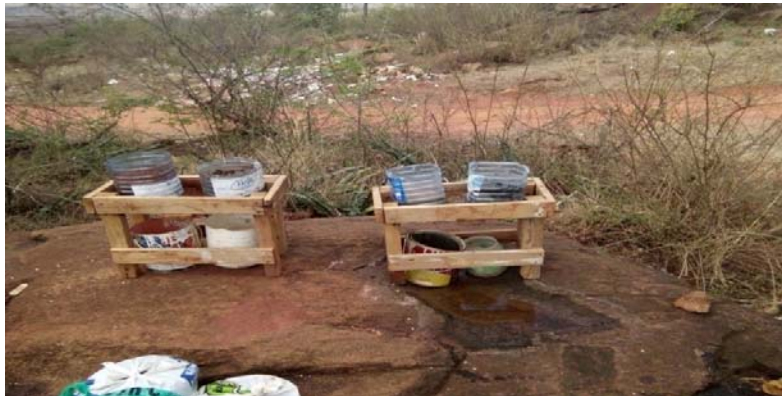
Figure 8: laboratory model setup

A laboratory test was constructed to investigate the infiltration rate of the lining material used to reduce seepage in ponds. The material used in making the model included; Hollow cylindrical containers (5litres), stands, sieves and collecting containers and measuring cylinder. The hollow cylinders were vertically placed on the stand and the lower circular ring was covered with a 2mm sieve was attached Below the stand empty containers were kept to collect the outflow water from the hollow cylindrical container. Individual lining materials 5cm thick were then added to each hollow cylinder but clay lining compaction was not done due to size of the container. A measured quantity of water was poured on the upper part of the model and allowed to pass through the lining for 24hrs and was then collected on the empty containers. A measuring cylinder was used to quantify the outflow from the cylinder.

This model was used investigate the effects of lining materials on the infiltration rate in a controlled environment.

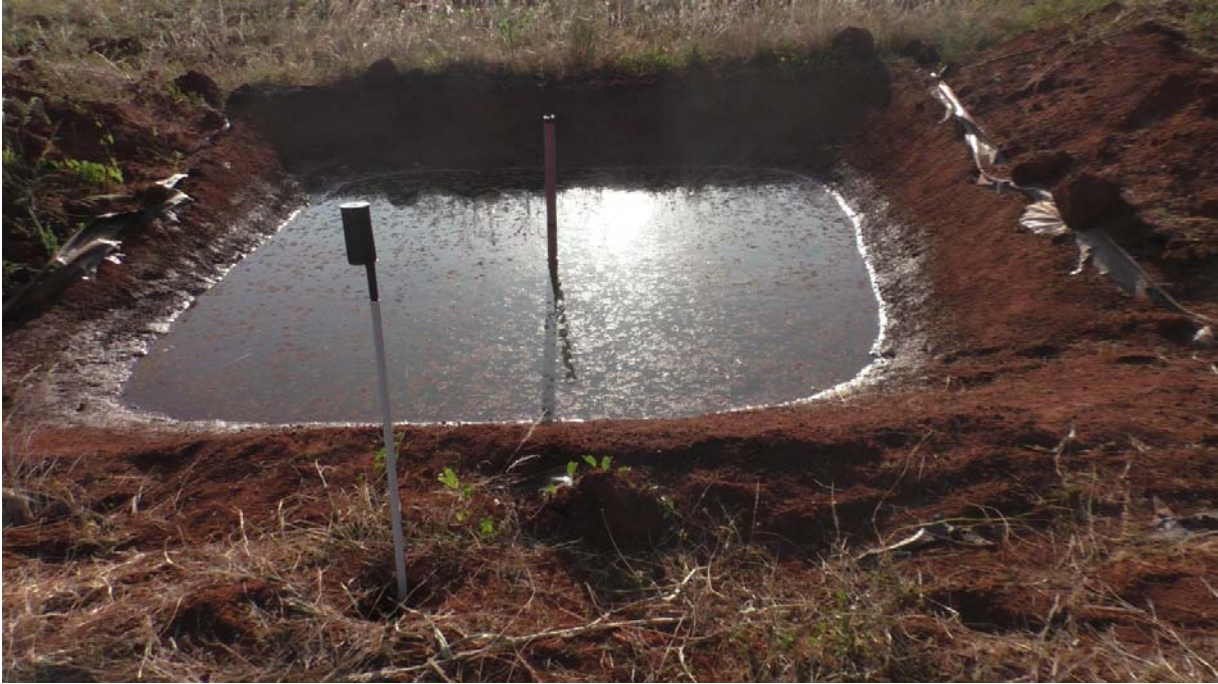
Figure 12: A sensor used to monitor soil moisture.

This was achieved by use of a PlantCare Mini-Logger, which is a maintenance-free sensor which records soil moisture and soil temperature. The sensor is based on micro thermic measurement of soil moisture. It has a specially developed felt material in moisture balance with the soil acts as the interface between the surrounding soil and the sensor. To measure the moisture level, the sensor is briefly heated and the cooling-down time, which varies depending on soil moisture, is determined. The sensor's cooling-down time thus provides a reliable statement of the soil's moisture content.

According to the Plant Care mini logger operating instructions on how the sensor measures soil moisture, the sensor is briefly heated and the cooling-down time which varies depending on soil moisture is determined. The sensor cooling- down time thus provides a reliable statement of the soil moisture content.
