# Landslide Related Road Failures in Ethiopia

**By: Kifle Woldearegay (PhD) (Mekelle University, Ethiopia)**

*(Modified after the presentation made at National Workshop on Natural Hazards Monitoring and Risk Management in Ethiopia; Nov. 06-07, 2014; IGSSA; AAU, Ethiopia)*

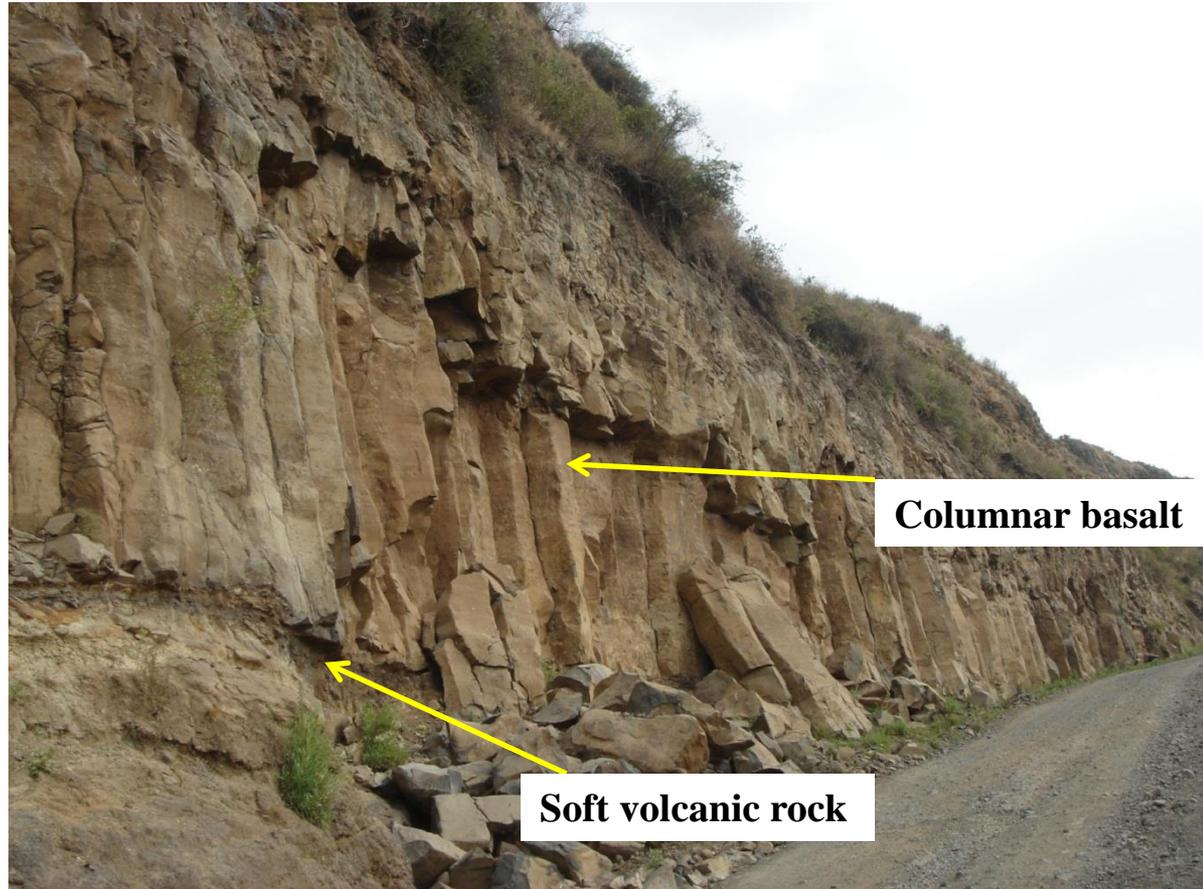
- On steep slopes: volcanic as well as sedimentary terrains.
- Presence of soft, erodible materials contributes to instability.

*Along Lemi-Alem Ketema route*

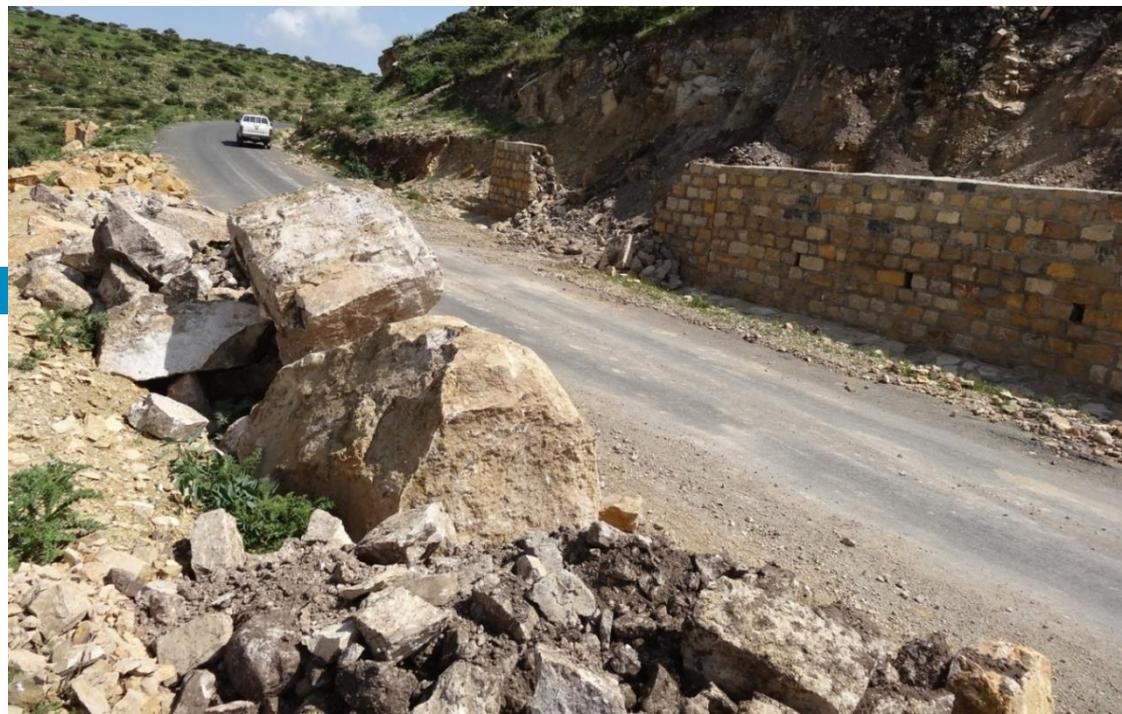
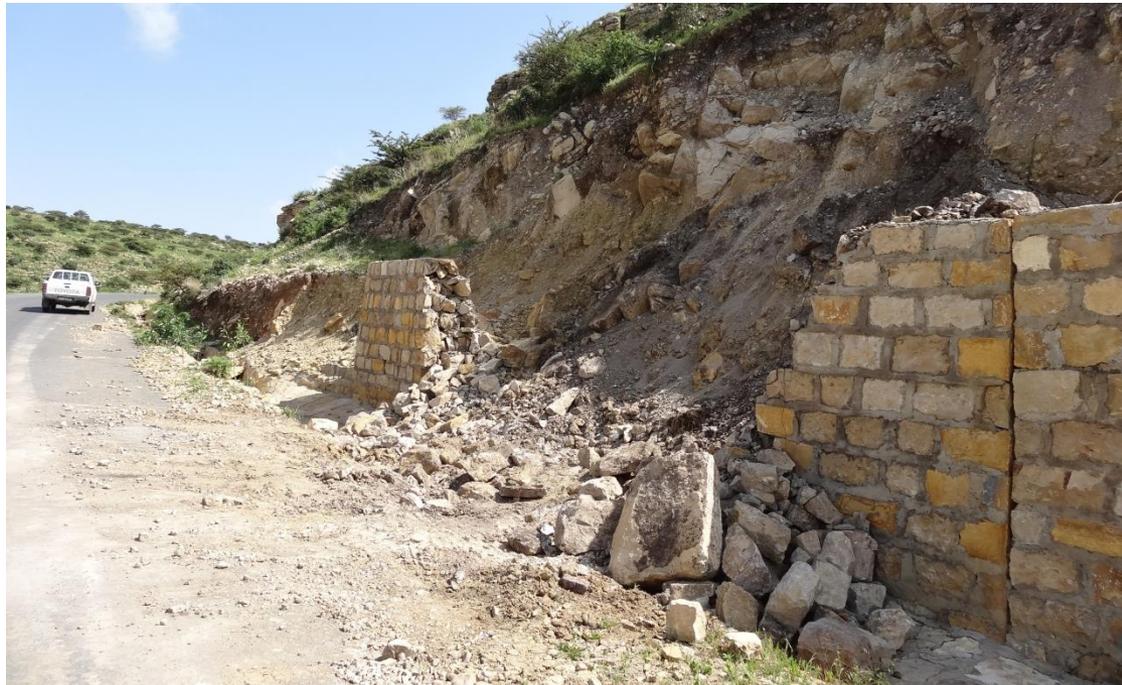
- Sliding of limestone and shale intercalating slope mass, leading to failure of retaining structure.
- Presence of shale material contributes to instability.

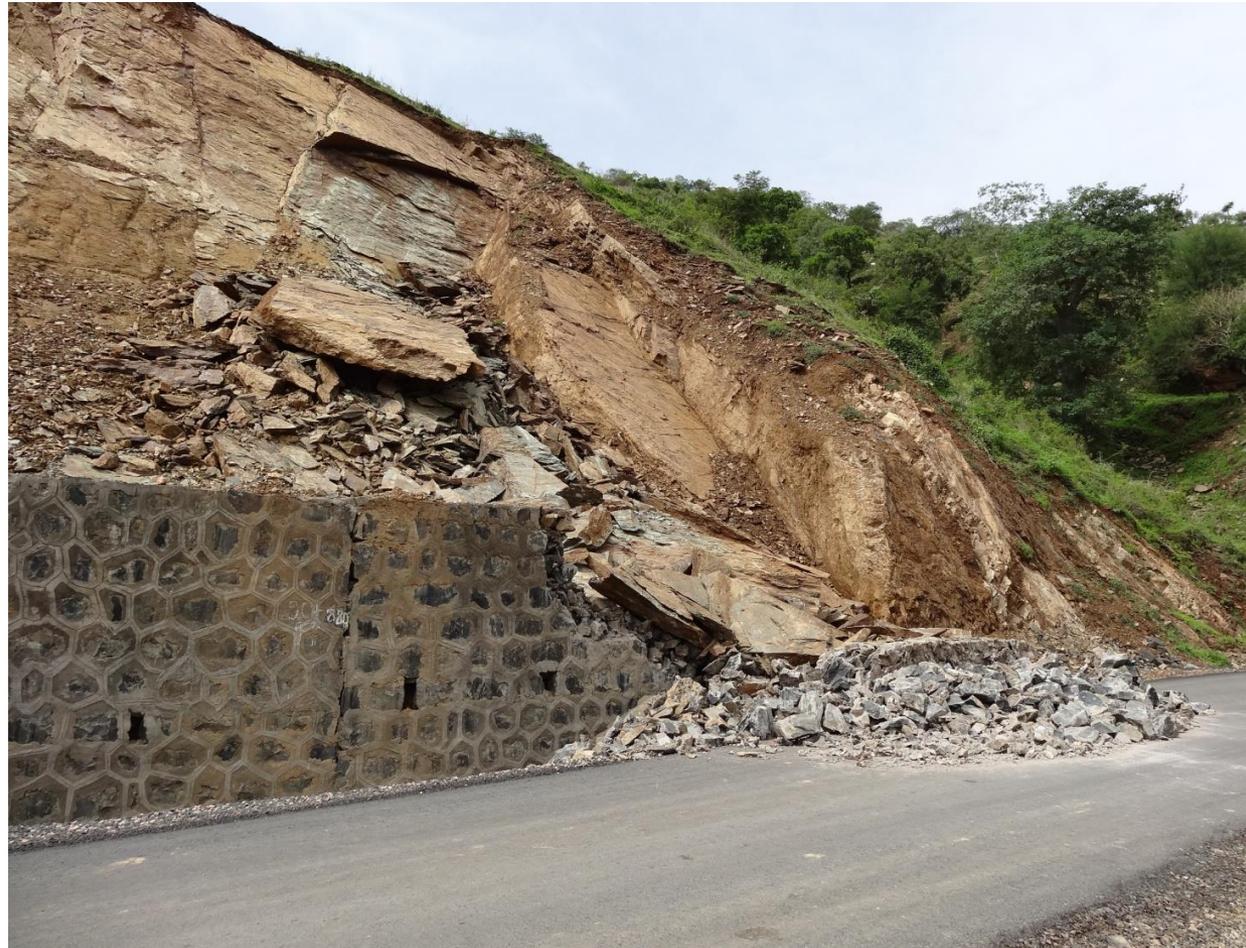
- Rockslide controlled by discontinuities (that daylight on the slope), leading to failure of masonry retaining structure.

*Along Shire-May Tsebri road*

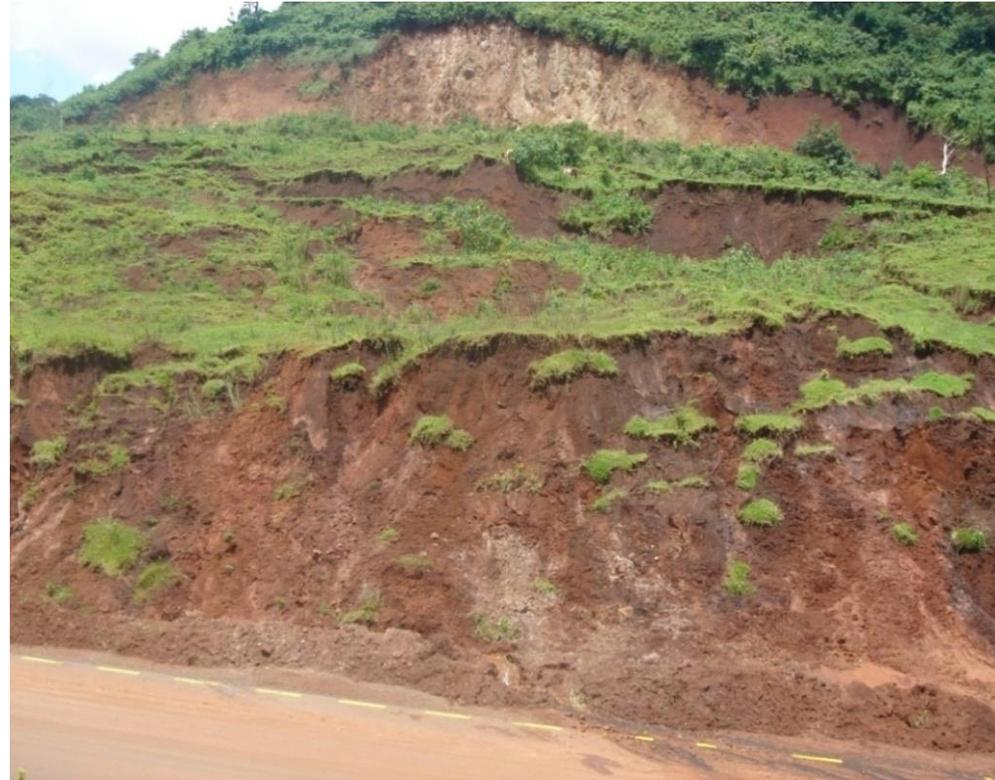
Failure took place at the interface between soil (colluvial/earth material) and the underlying bedrock.

- ***Water pressure developed*** at the interface between soil and bedrock.
- Over 60% of the failures are associated with stream/river incisions or with gully development from water from culverts.
- Failure characteristics can be categorized into ***four Models***.

*Earth slide along Jimma-Agaro road*

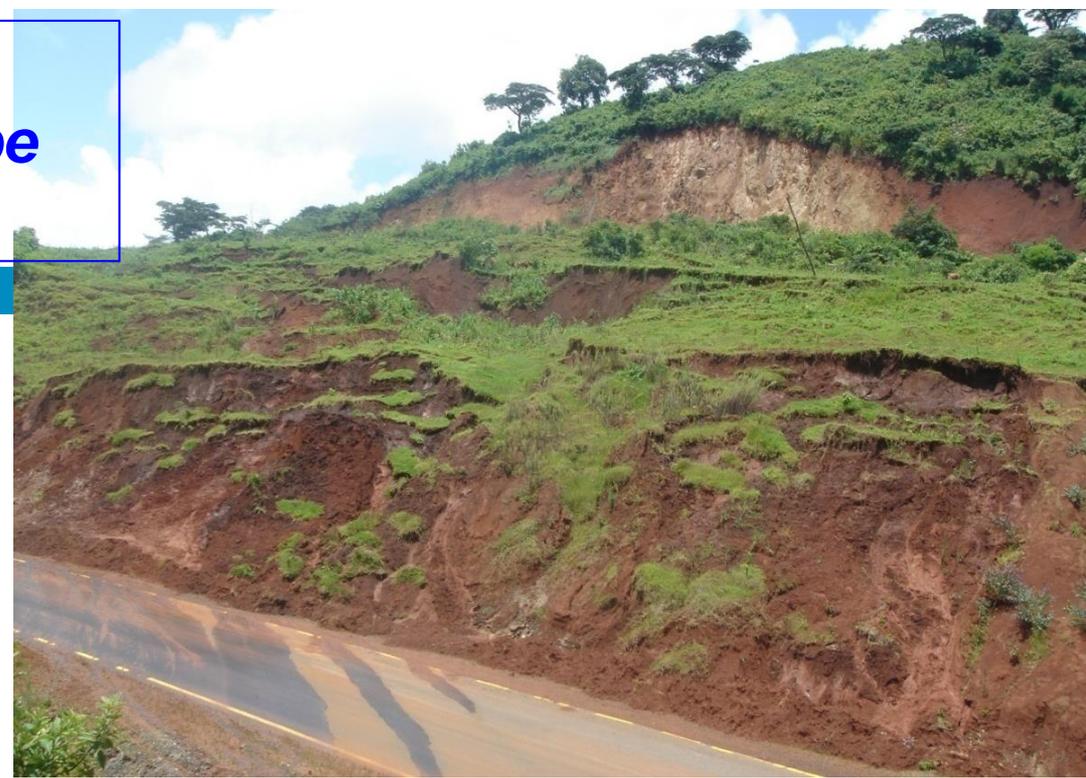
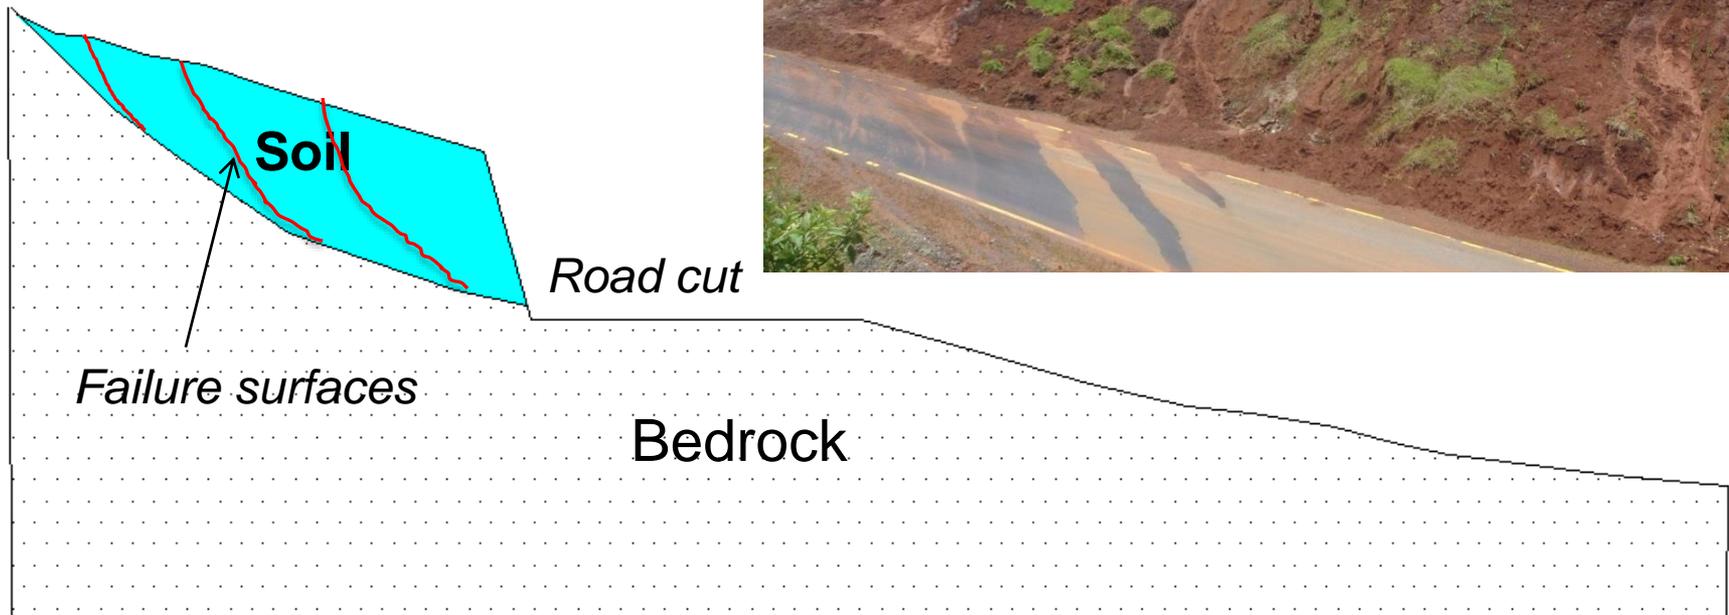
***Model 1: Road (including subgrade) is stable; upslope side is sliding***

- *Removal of support due to road excavation has initiated instability of the upslope.*
- *Provision of proper retaining structure coupled with drainage systems (surface and sub-surface) is the solution.*

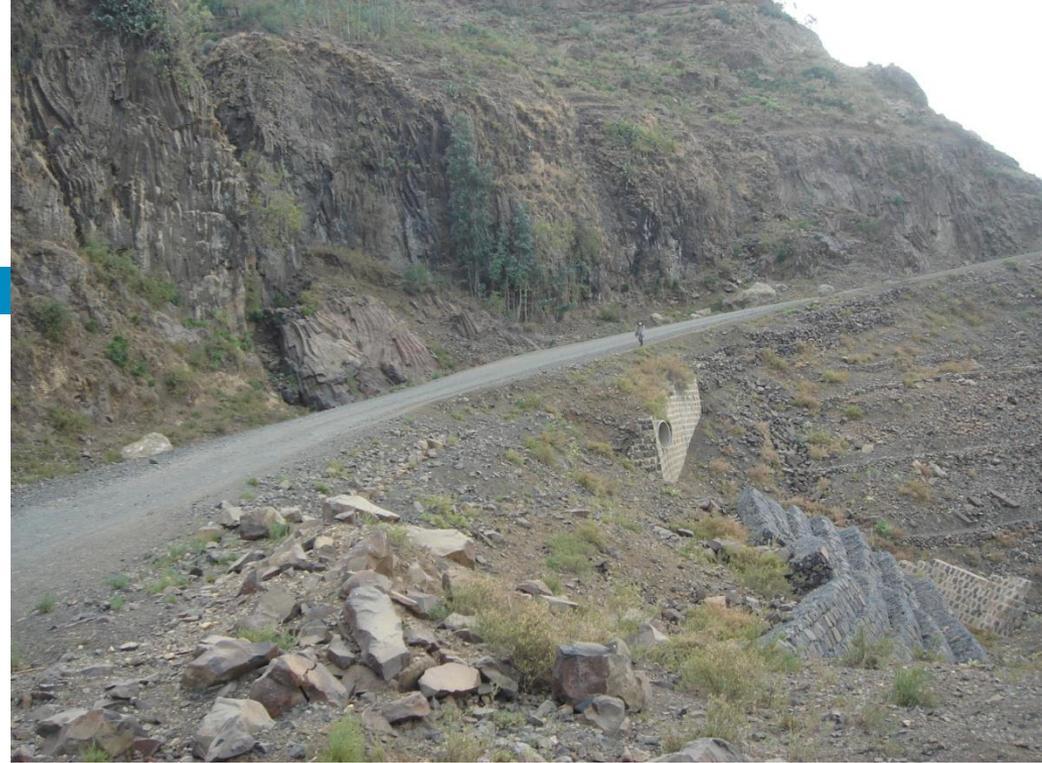
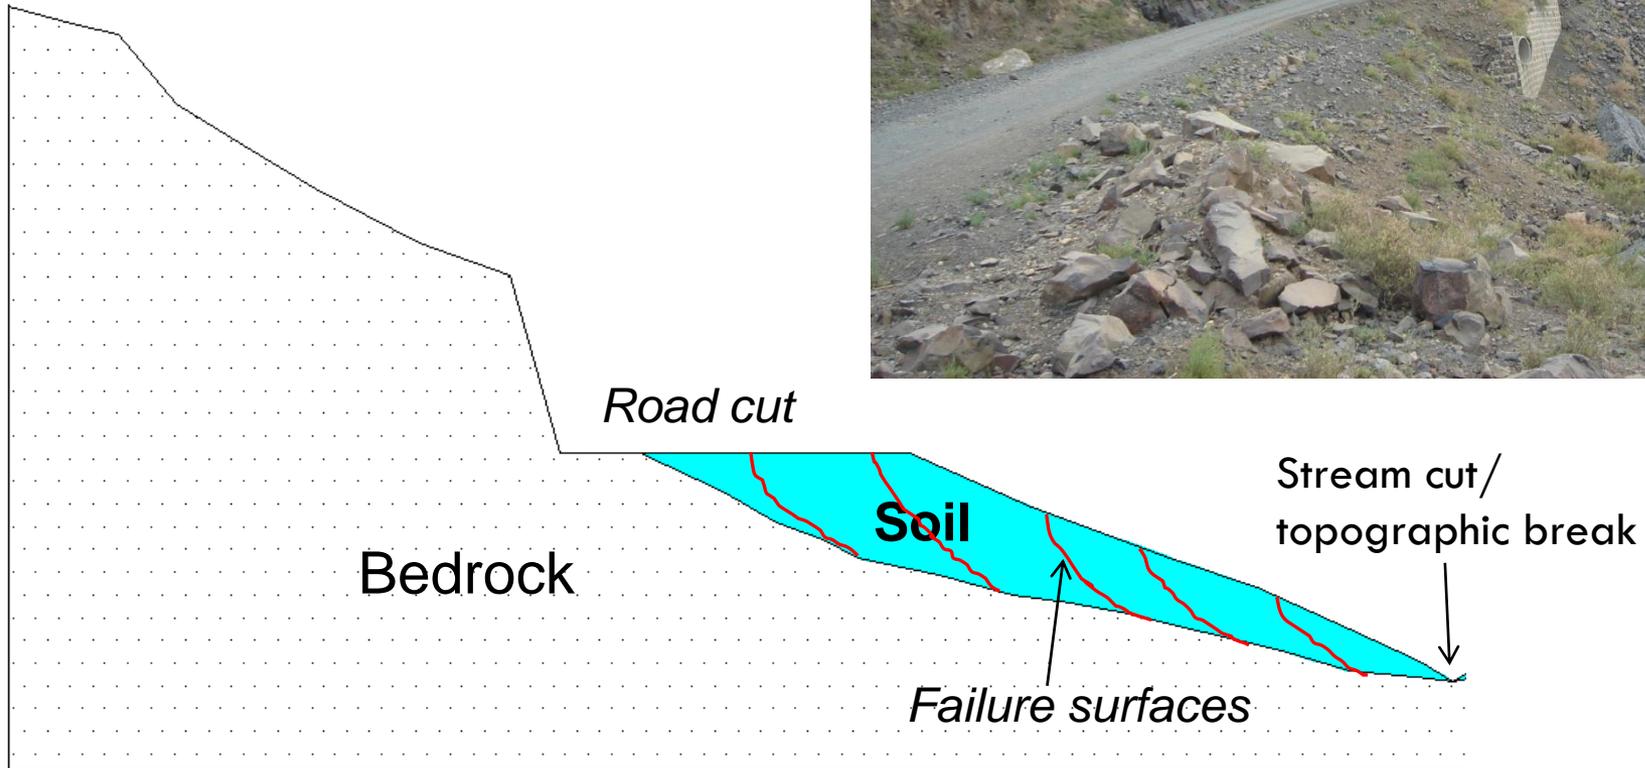
**Model 2: Upslope side is stable; downslope side is sliding**

- *Additional load (due to road construction) on a slope which was already unstable or on marginally stable state is initiating instability of slopes.*

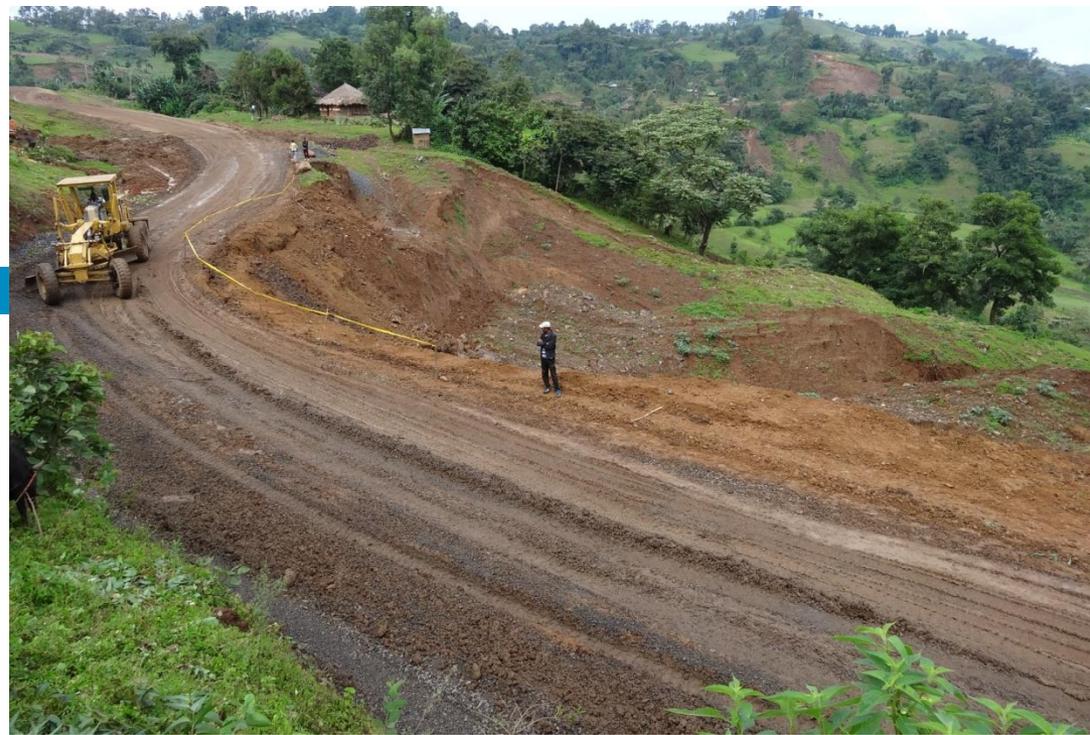
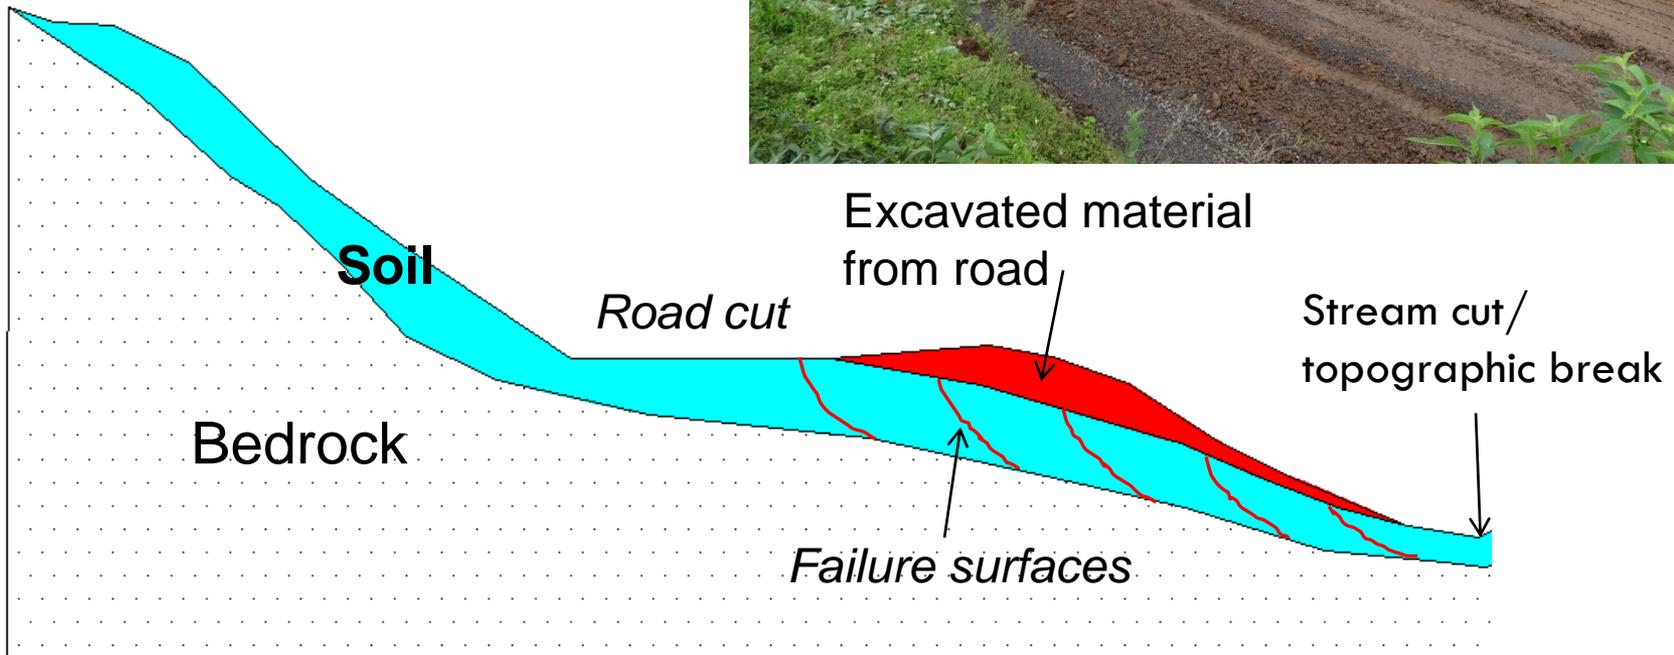
## ***Model 3: Placement of excavated material on marginally stable slope***

- *Placing excavated material from roads on marginally stable slopes or on unstable slopes is initiating instability of slopes.*

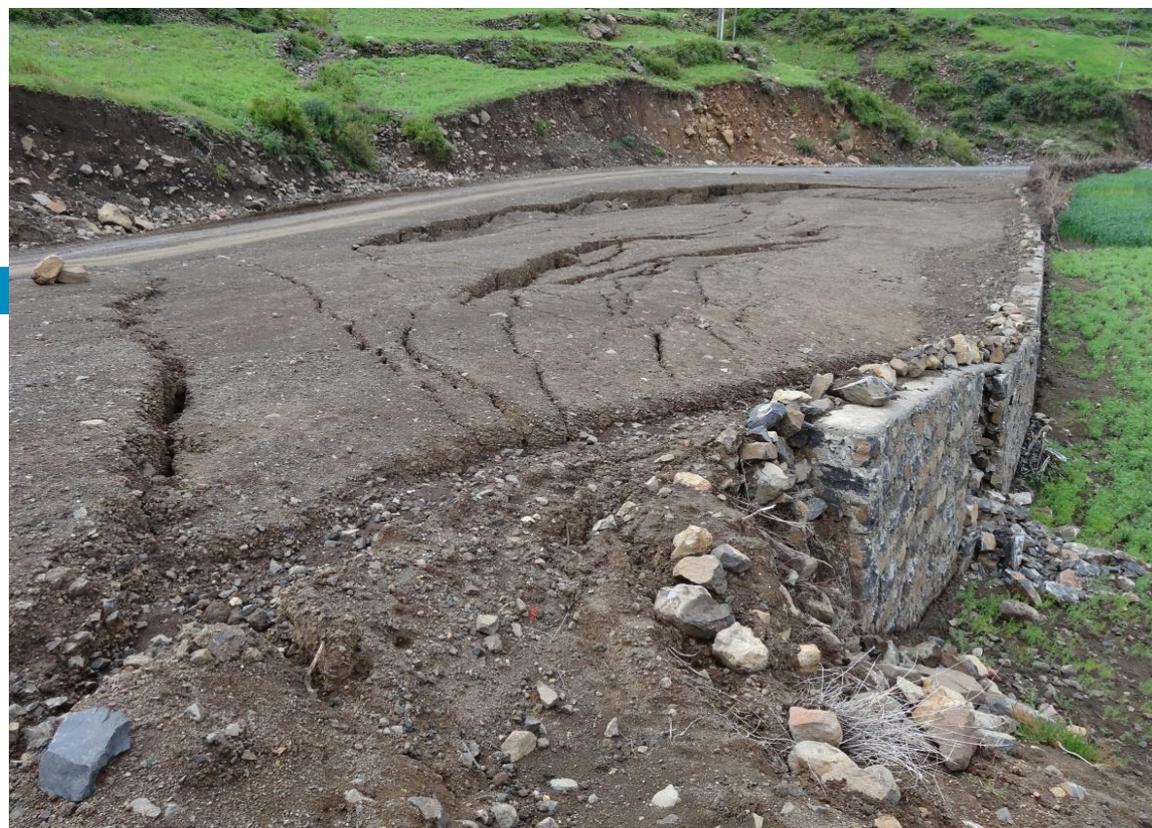
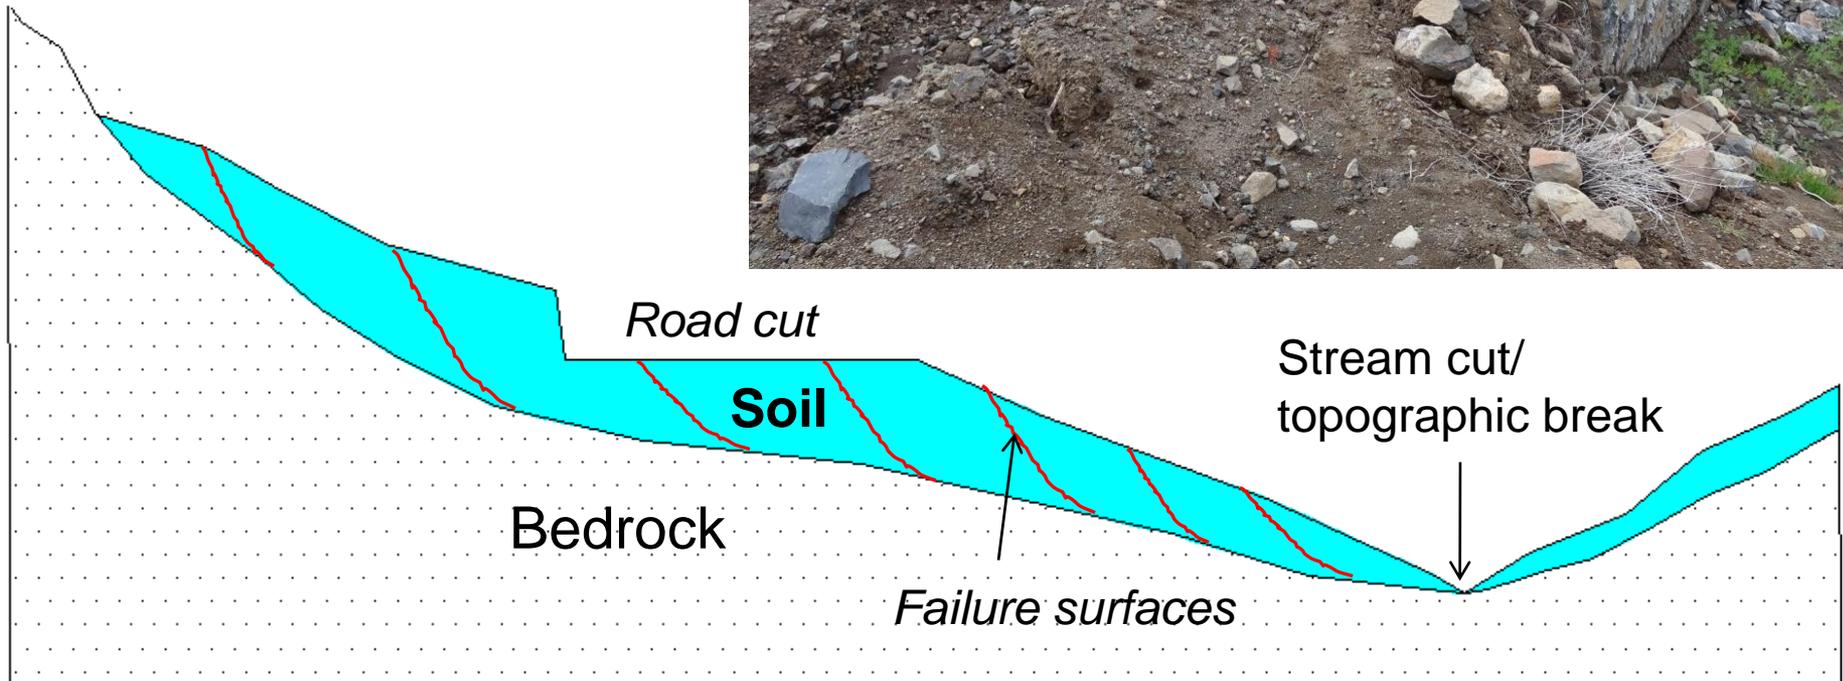
## Model 4: Whole road section is on a sliding mass

- Excavation and placement of additional load (road) on already unstable slope or on marginally stable slope is initiating instability of slopes.

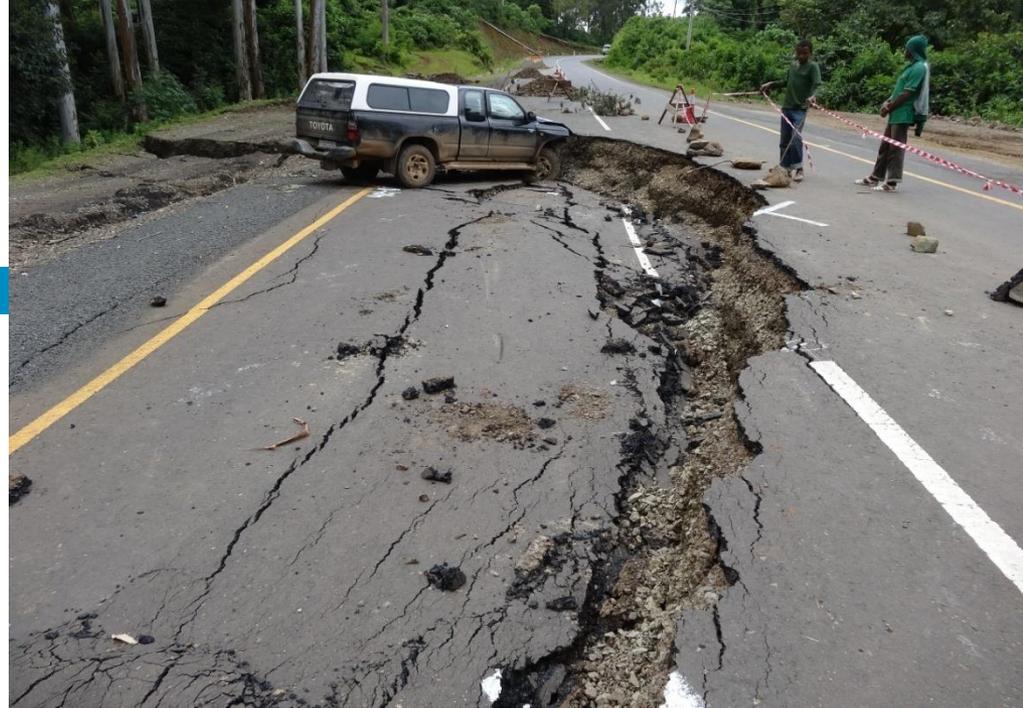
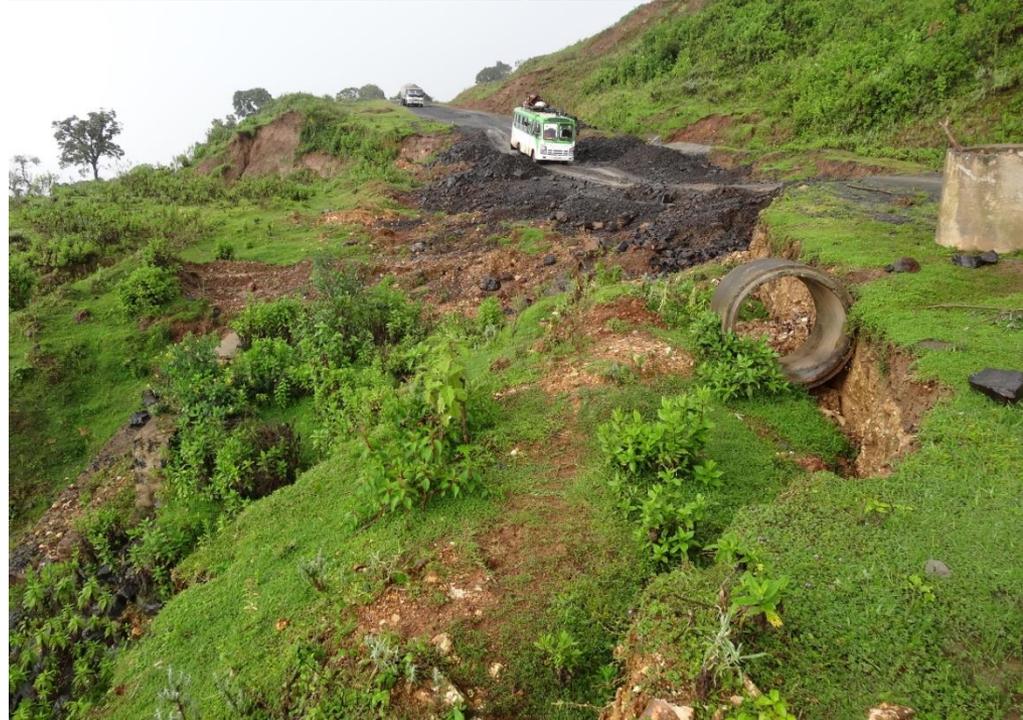
*Damaged asphalt road  
in Tarmaber area*

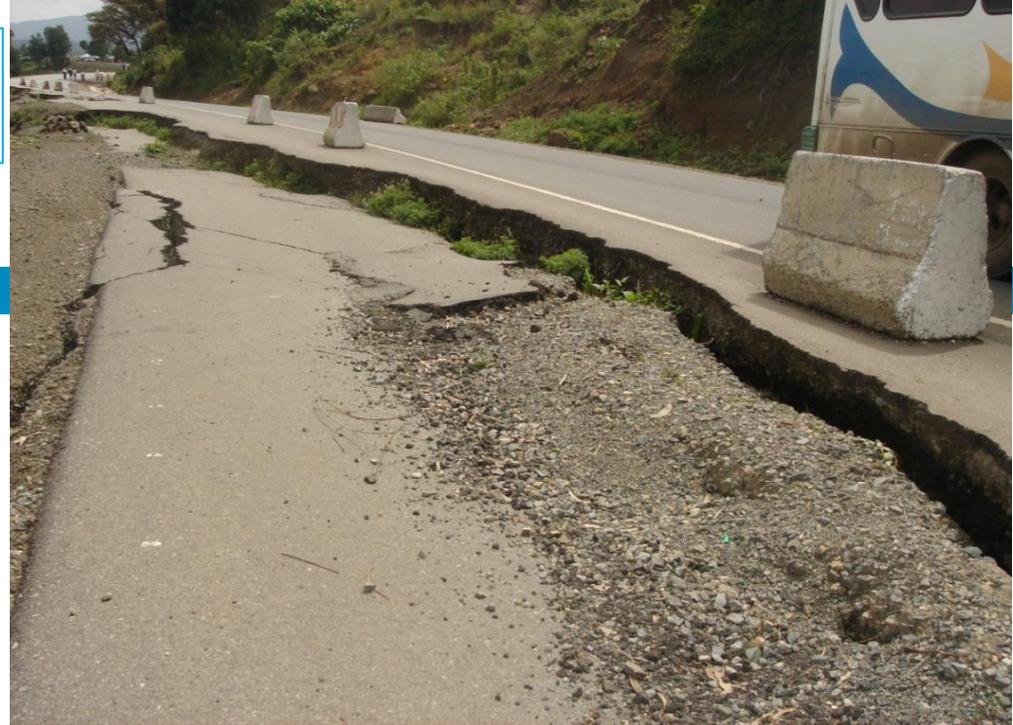
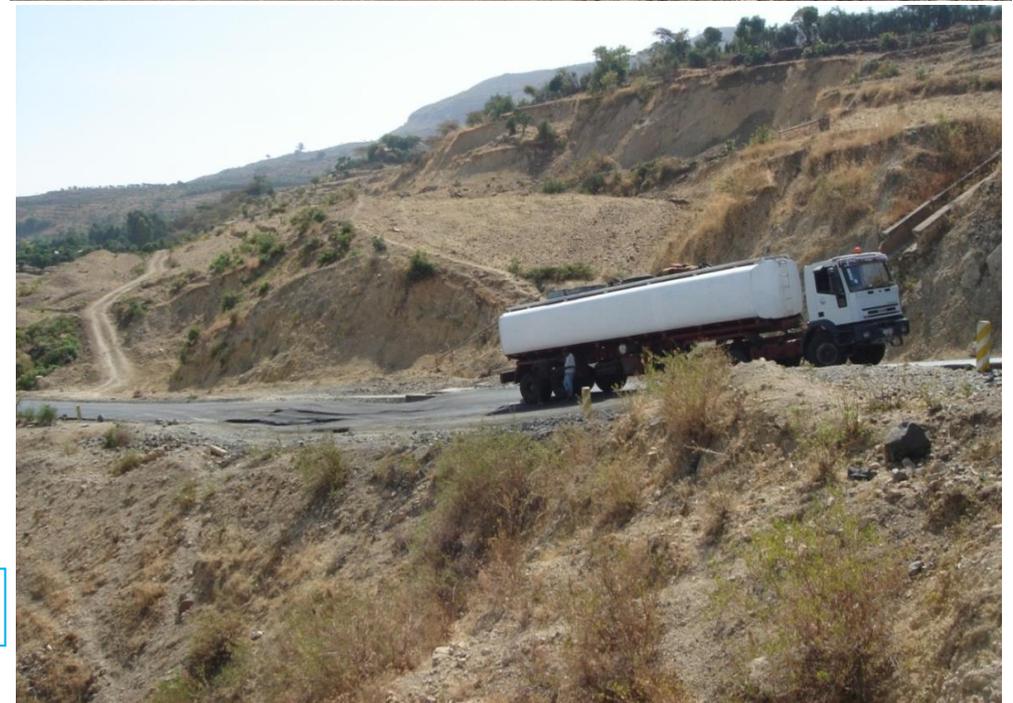
*Landslide in Abay Gorge*

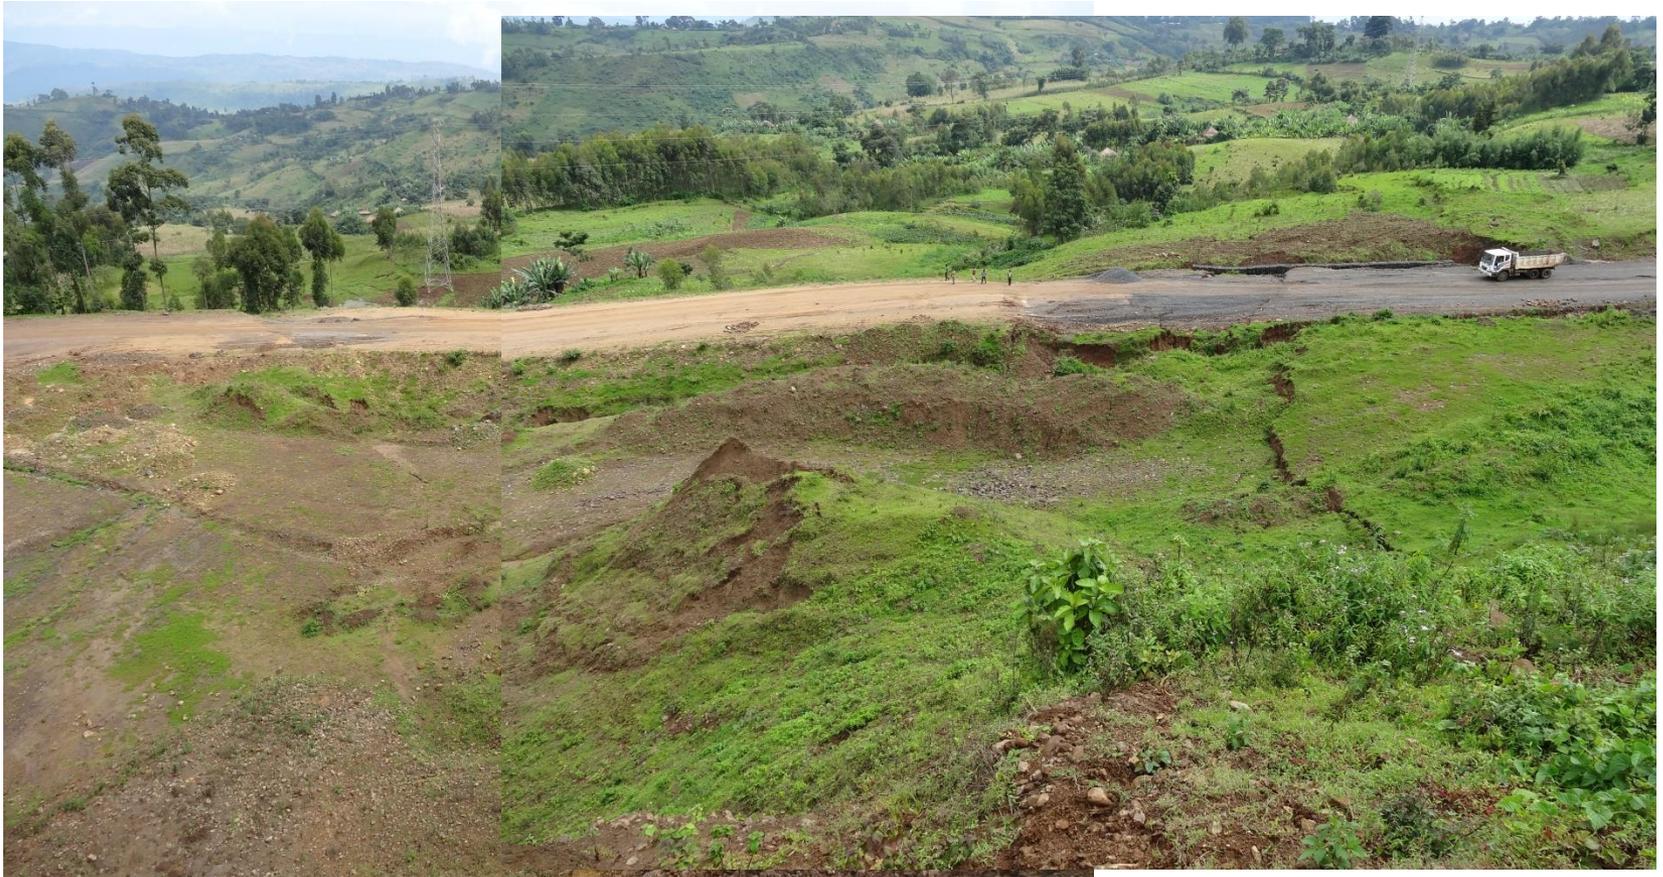
*View of a large-scale landslide: affecting roads, power lines and farm lands along Bonga-Mizan road.*

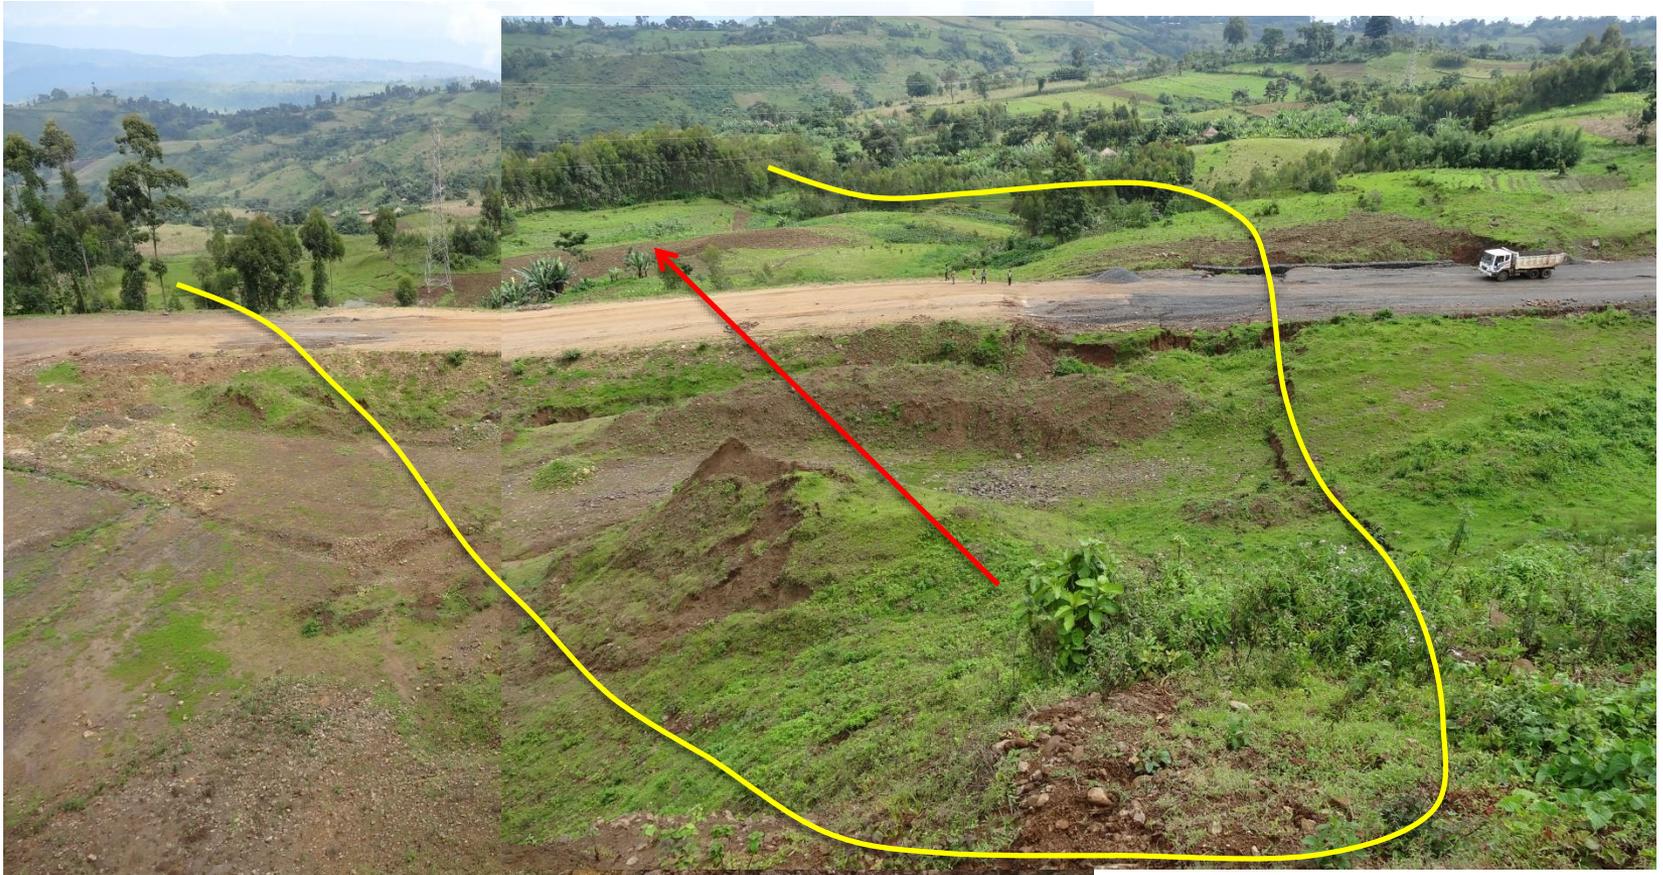
*View of a large-scale landslide: affecting roads, power lines and farm lands along Bonga-Mizan road (arrow indicates direction of movement).*

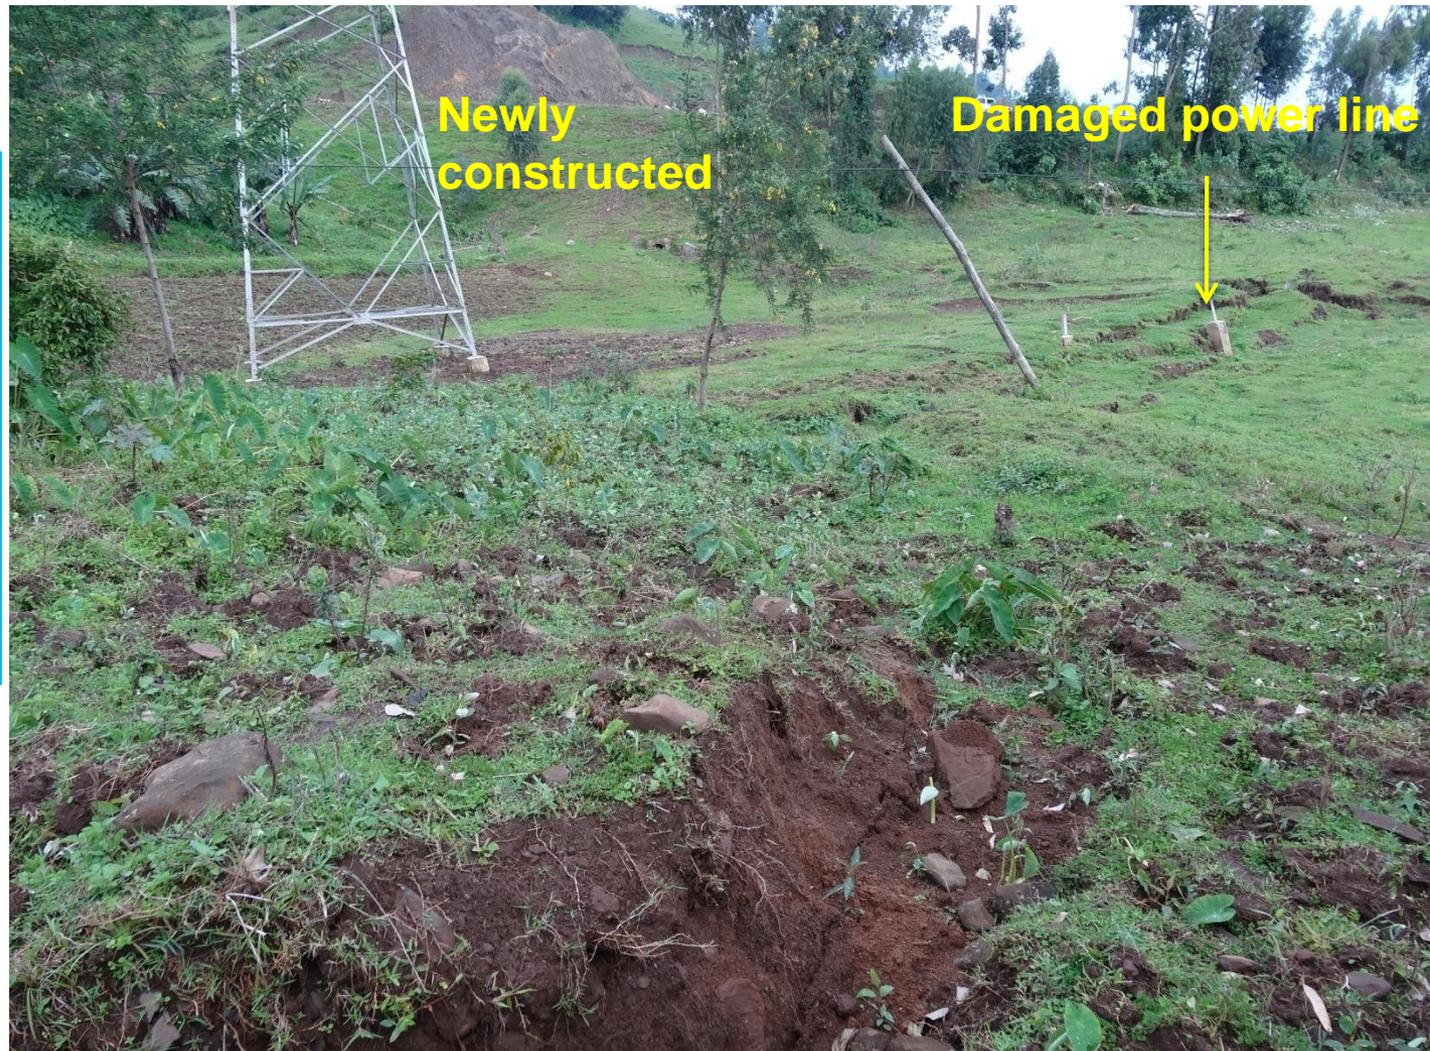
Main Power line damaged by a landslide is shifted but still endangered by the same landslide along Bonga-Mizan road
