# Landslide Related Road Failures in Ethiopia

**By: Kifle Woldearegay (PhD) (Mekelle University, Ethiopia)**

*(Modified after the presentation made at National Workshop on Natural Hazards Monitoring and Risk Management in Ethiopia; Nov. 06-07, 2014; IGSSA; AAU, Ethiopia)*

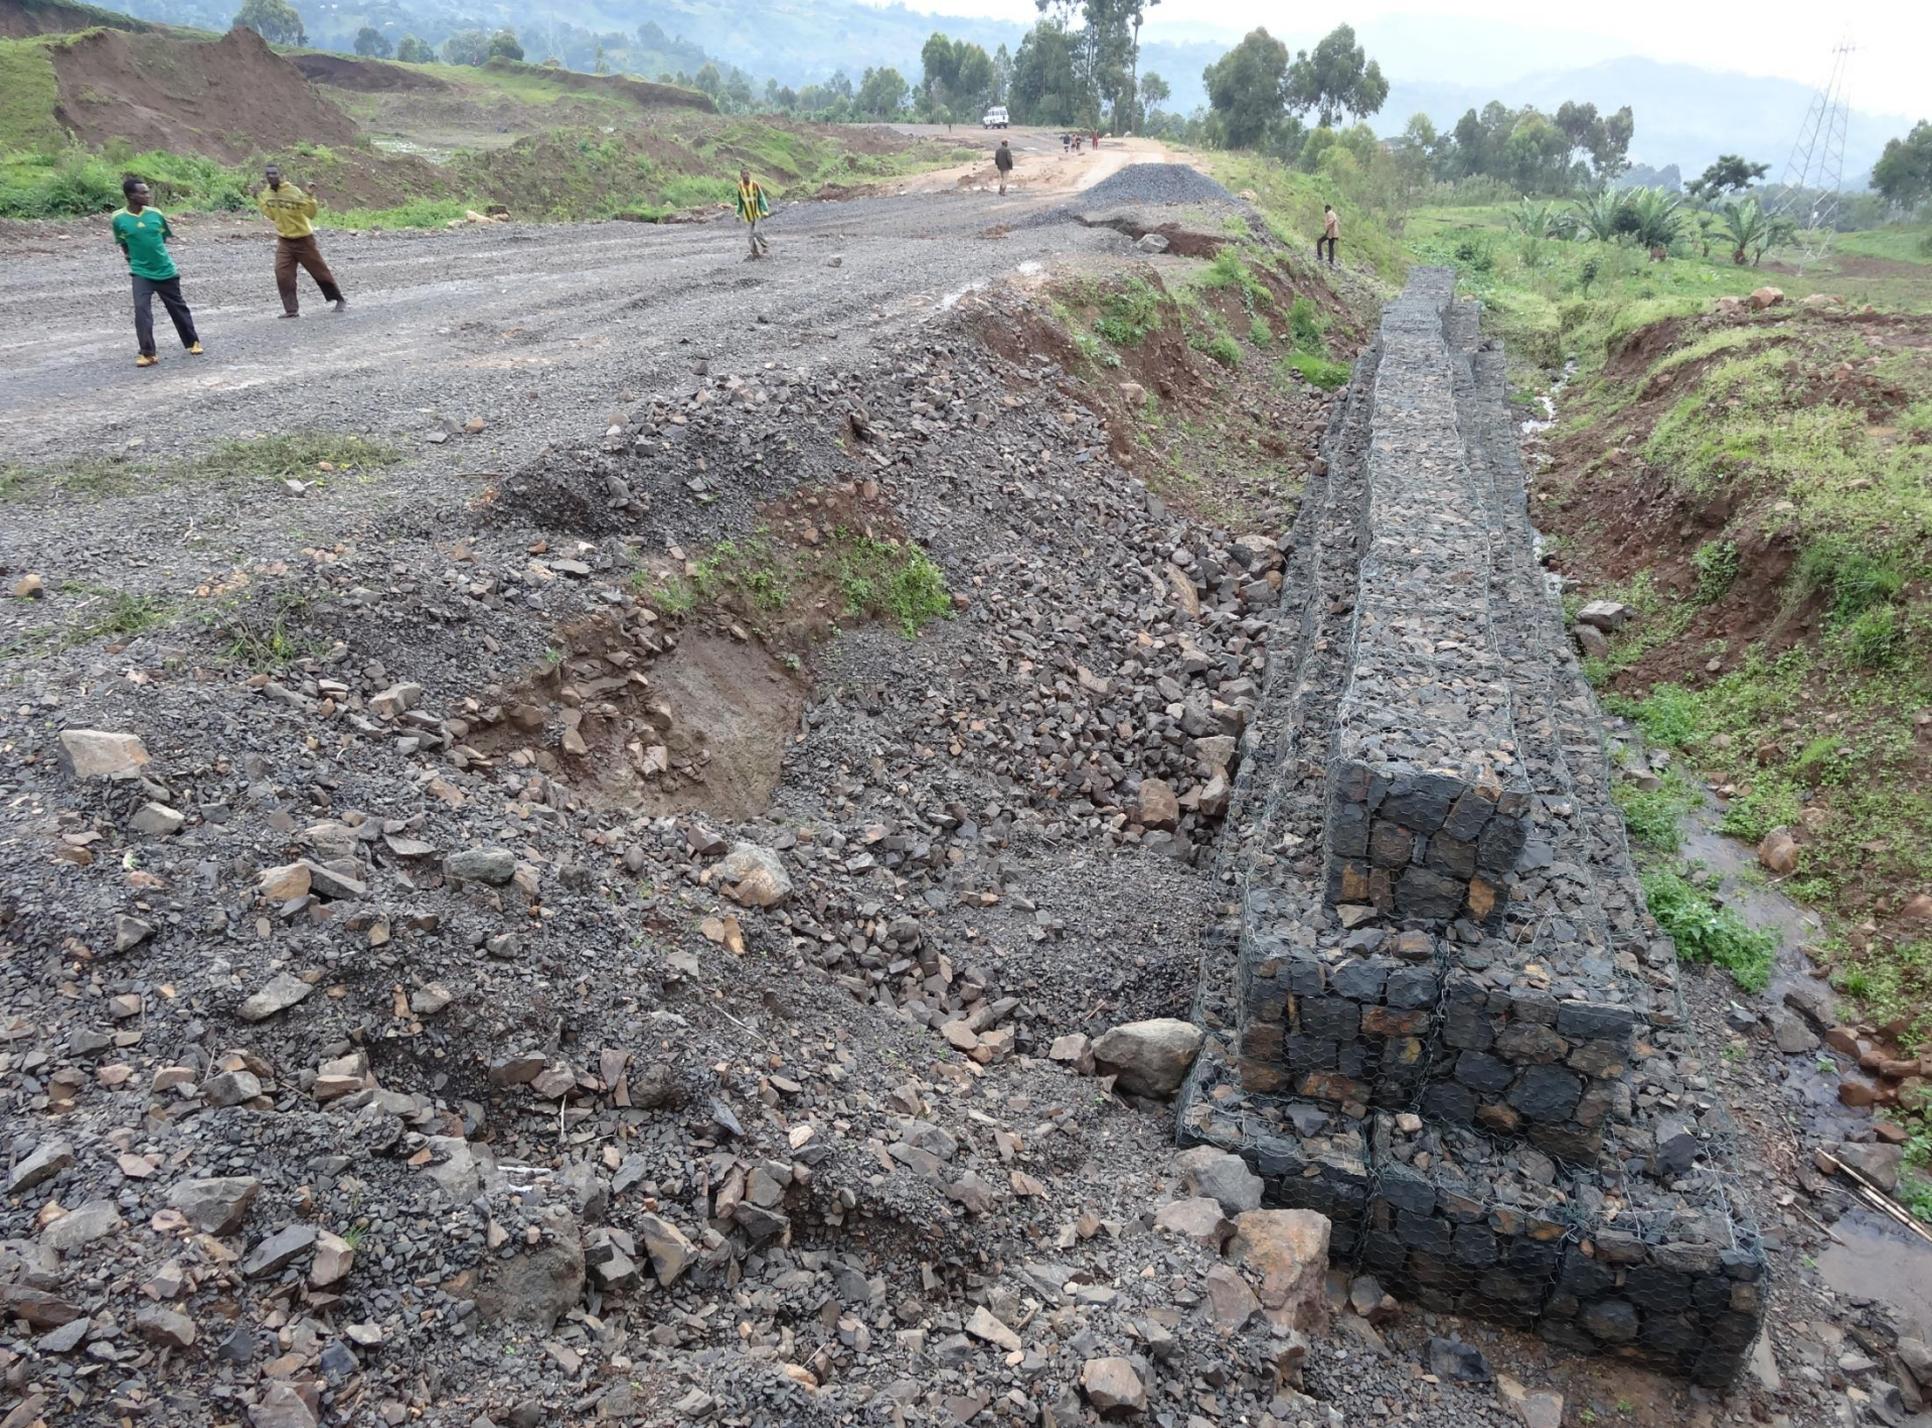
*Landslide related road failure along Kombolcha area (head of the slide).*

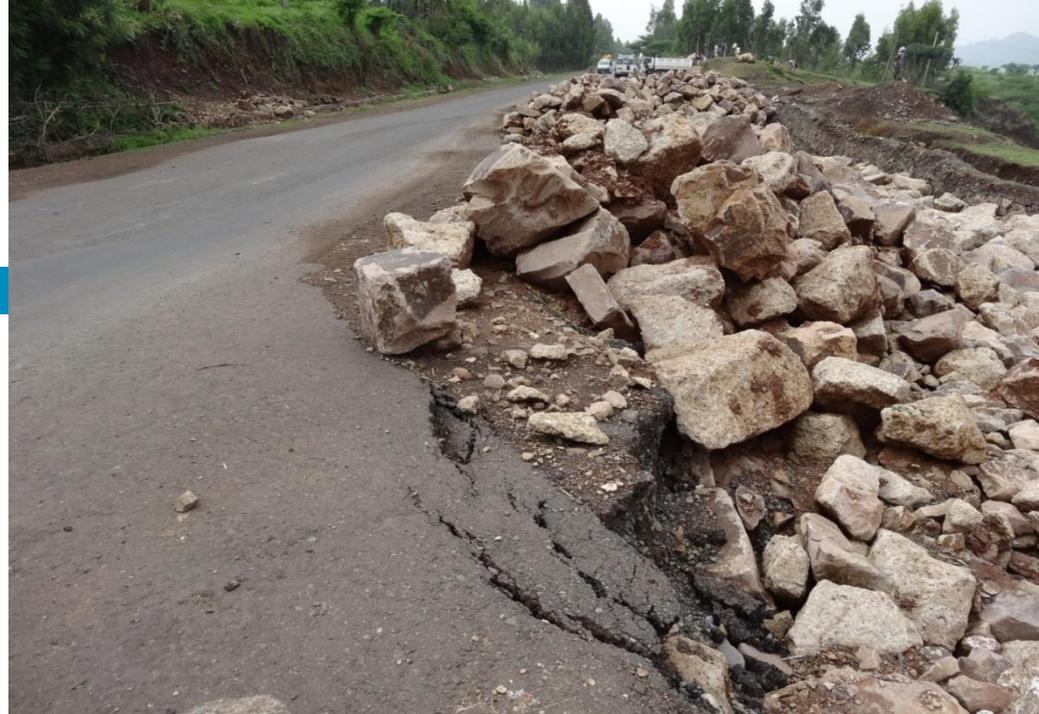
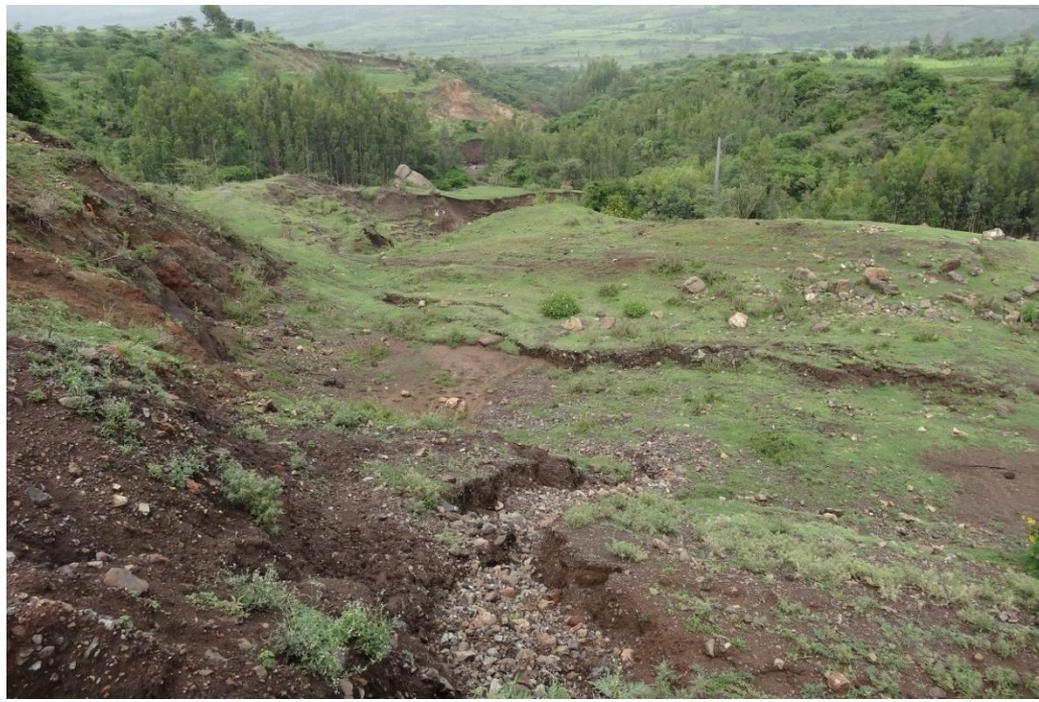
Backfilling and construction of retaining wall over a sliding mass.

- Could this be effective while the landslide extends upto about 800m downstream?

*Downslope view of the landslide along Kombolcha area.*

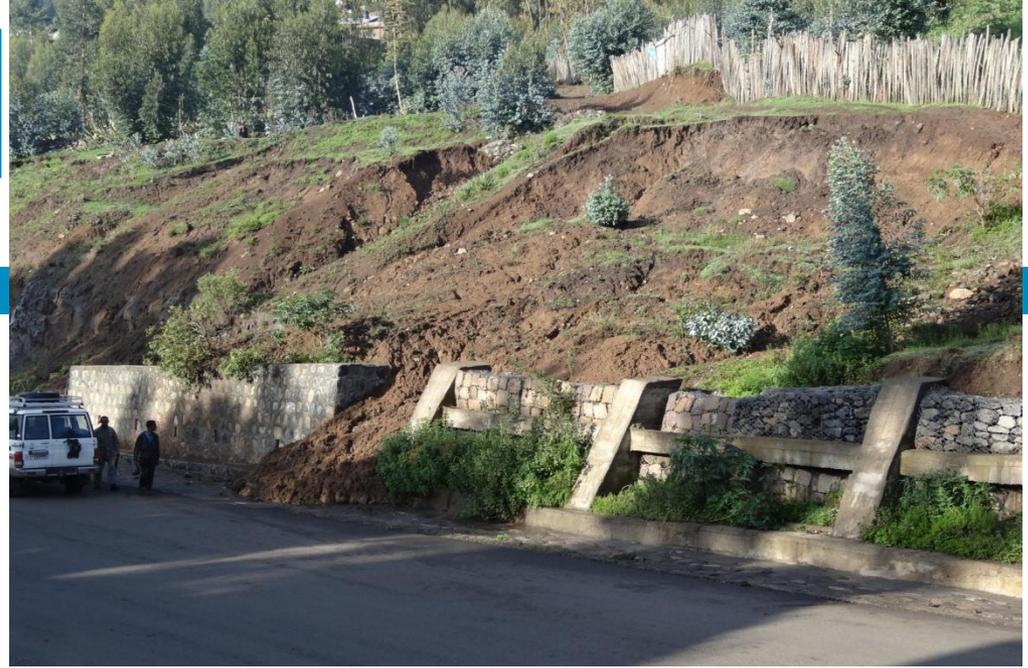
*Landslide in Dessie town;  
affecting retaining structures.*

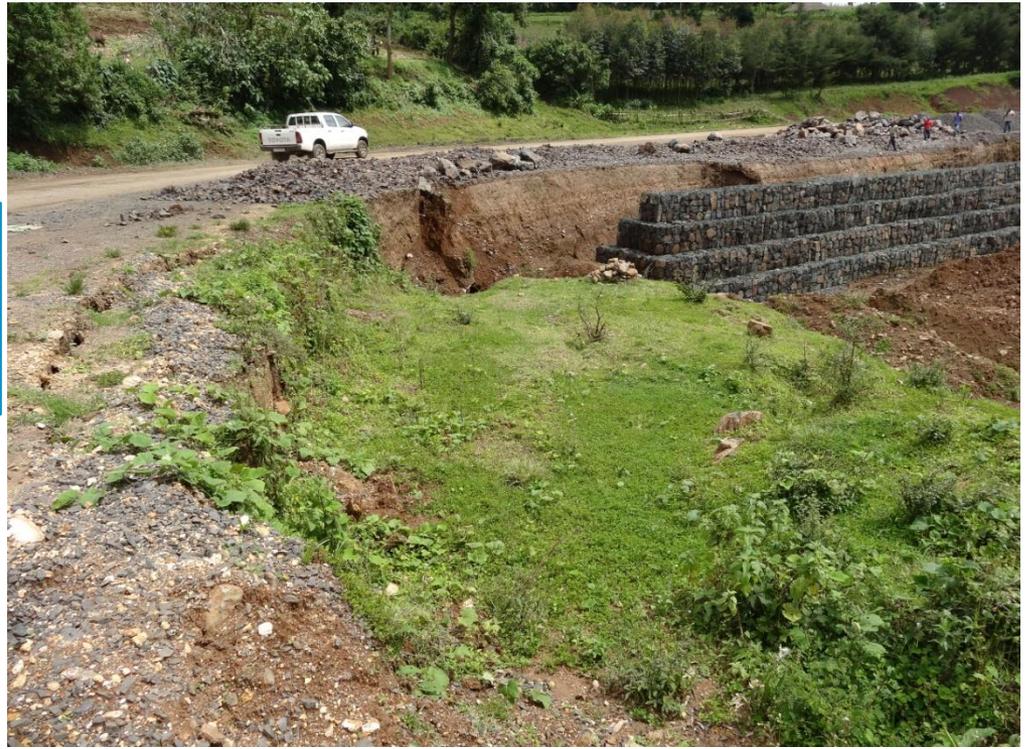
*Gabion retaining wall under  
construction over a sliding  
mass along Bonga-Mizan road.*

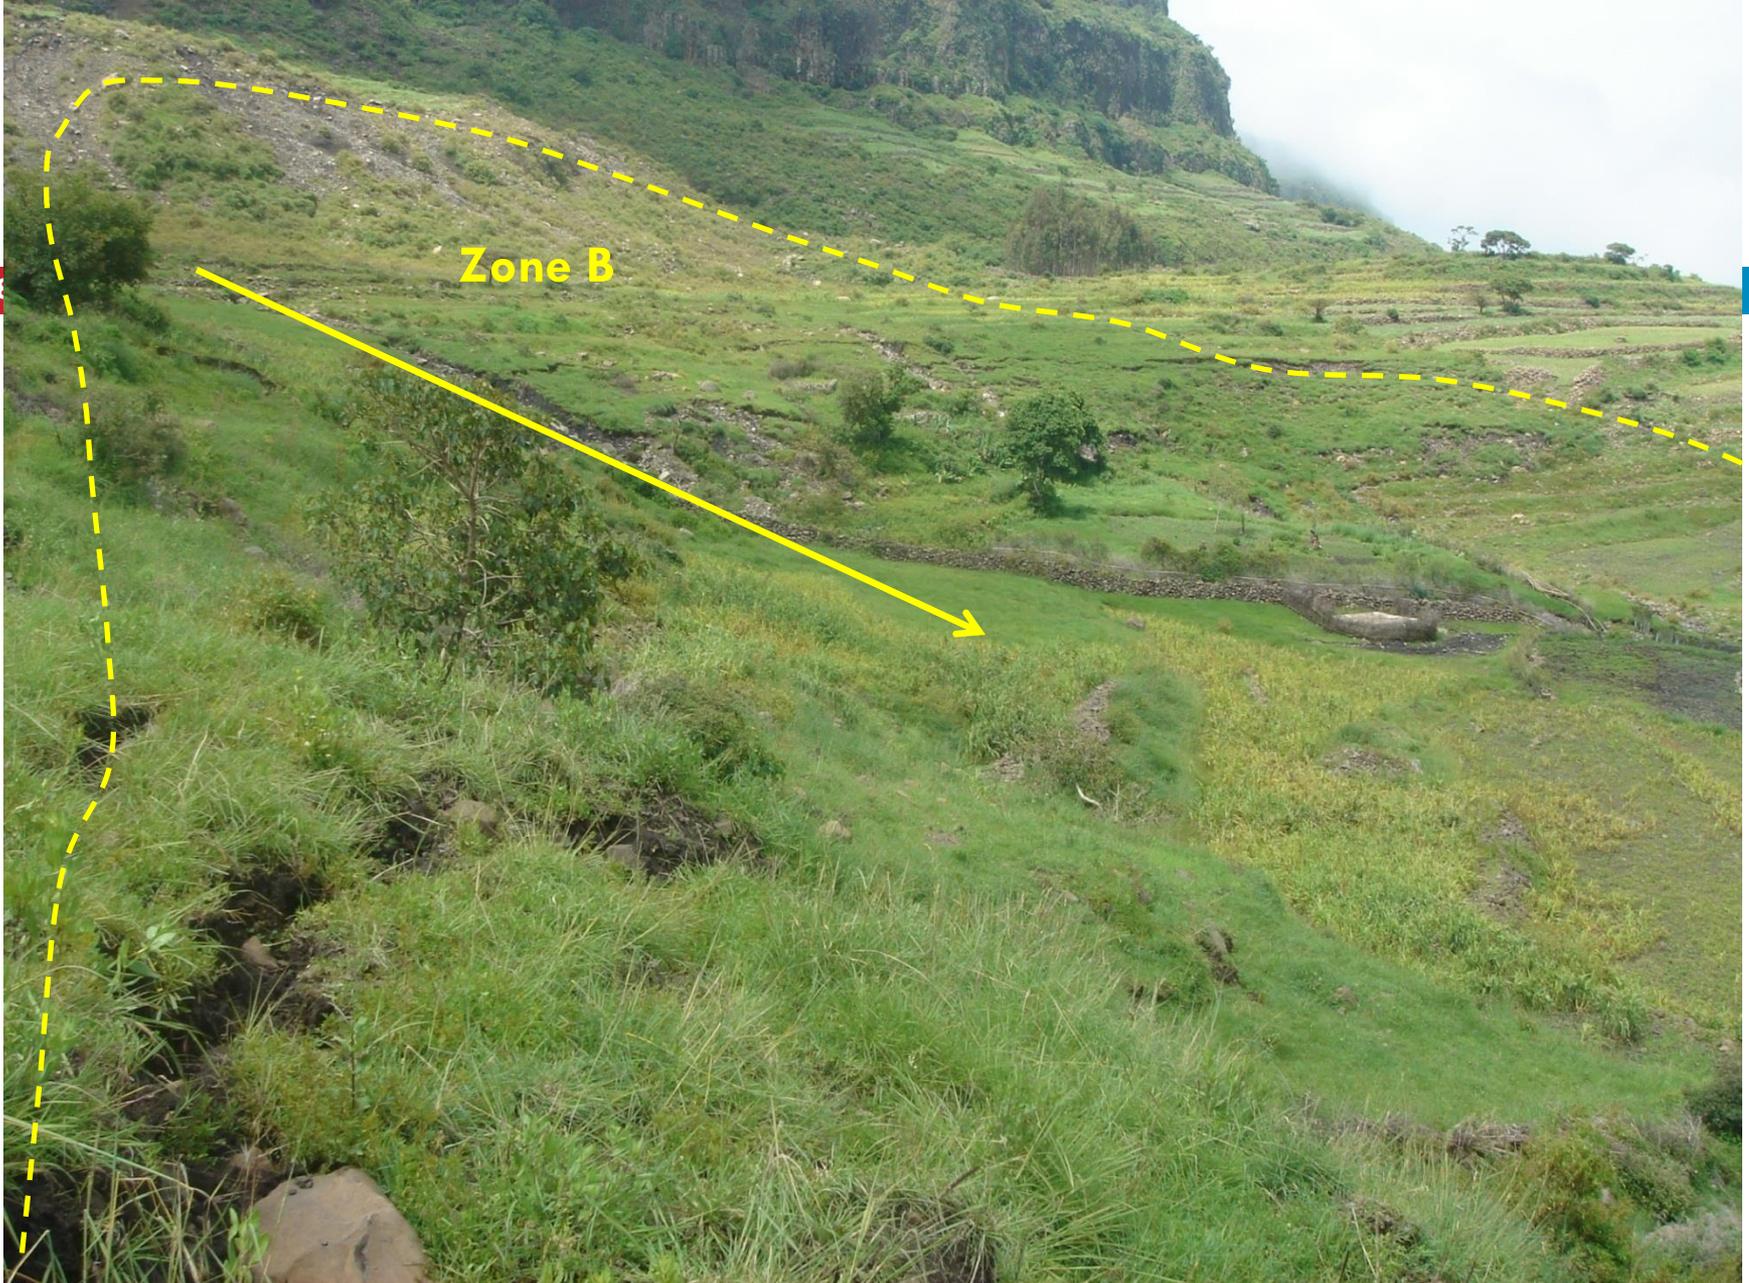
*Zone B: Debris/earth slide affecting farm land in Lemi area,*

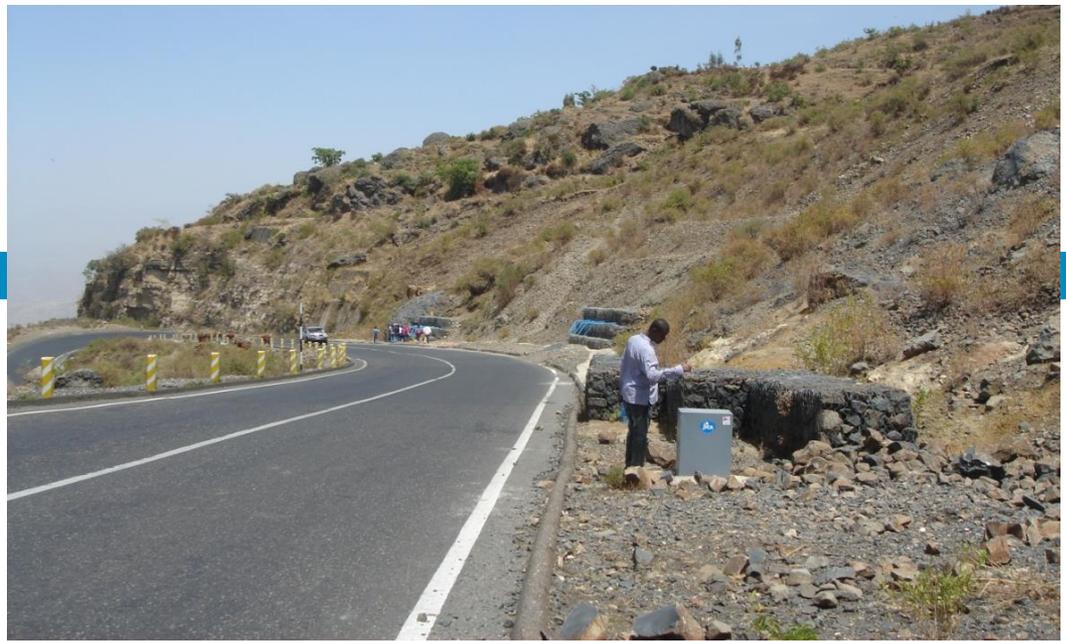
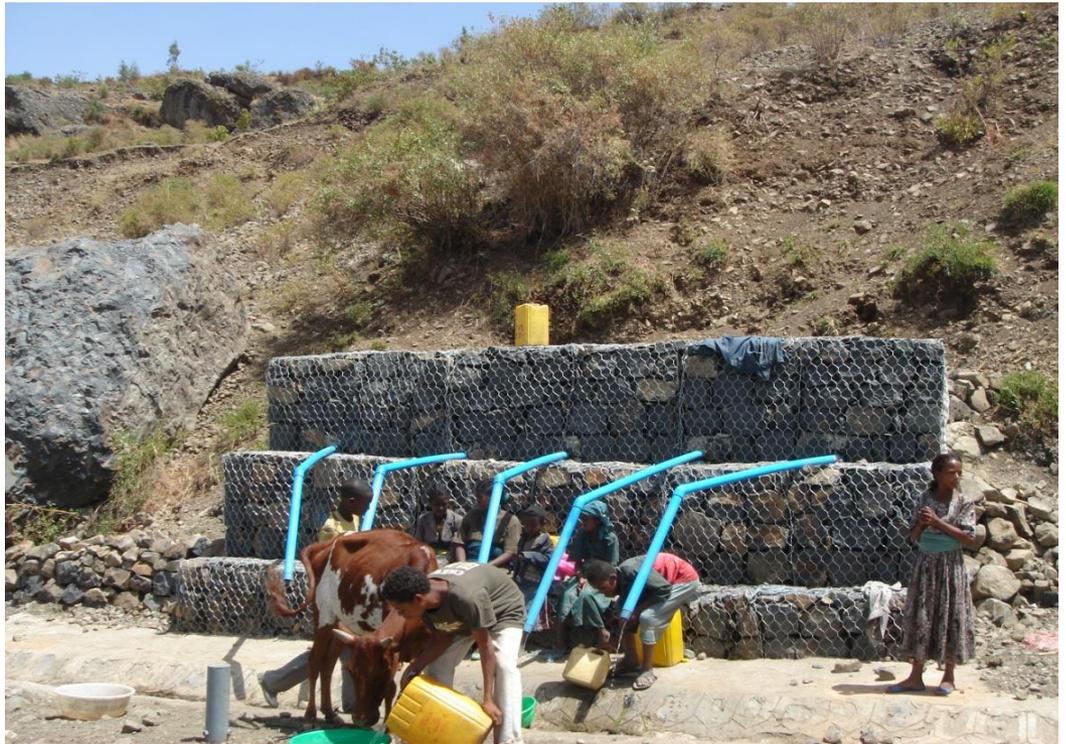
*Drainage based water harvesting is an option to be considered.*

*Example from the Blue Nile Gorge.*
