NEW ROADS FOR RESILIENCE

Reconnaissance report from Uganda

September 2016

"New Roads for Resilience: Connecting Roads, Water and Livelihoods"

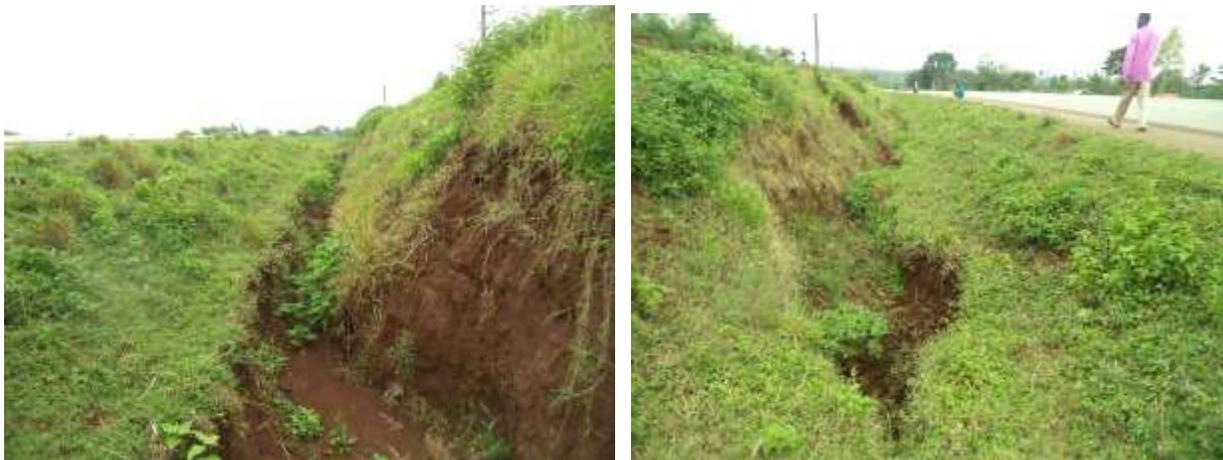
Erosion problems were also recorded along most of the roads, some were rillies while others were gullies as shown in the figure below. Due to erosion, many road structures like bridges have been damaged, drains have been silted, culverts have been carried away and this has become a big threat to road safety.

Figure 3-1 Gully formed due erosion along Tororo-Jinja Road in Busere village in Tororo District. (Threat of road collapsing)

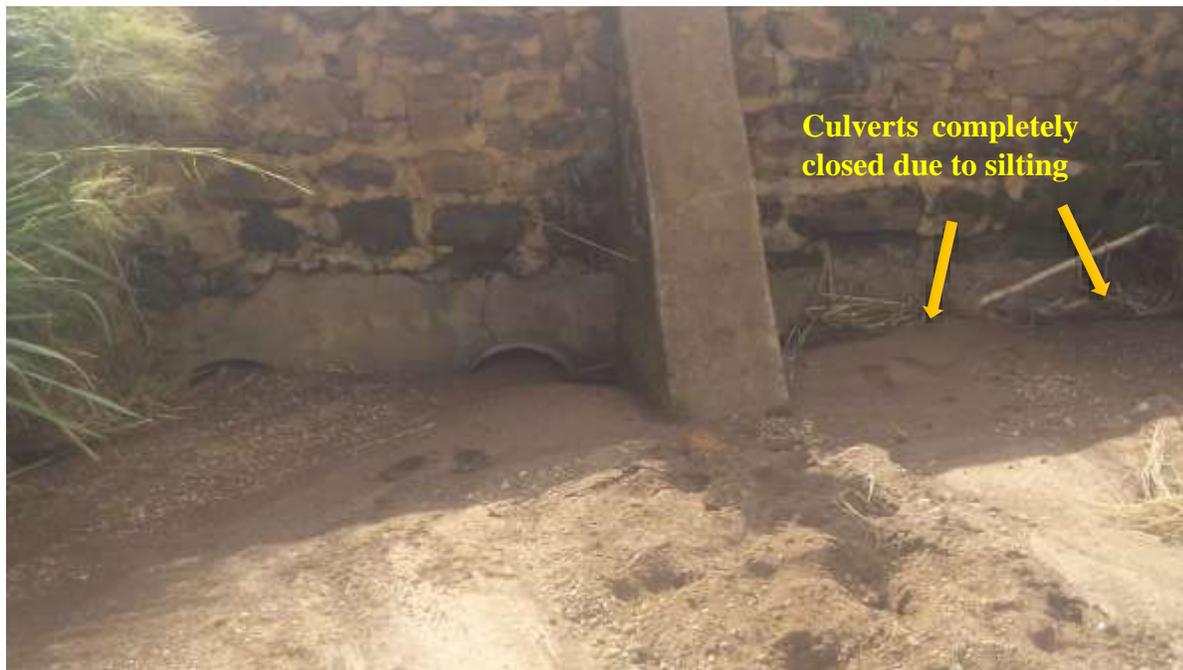
Various sedimentation/siltation problems were recorded from the field work. Mostly they were downstream of culverts. Sedimentation/siltation is caused by the debris carried by the running water along the roads. This blocks the culverts that are designed to convey the water from one side of the road to another to avoid flooding.

Figure 3-2 Siltation at Okurut Bridge located on the Road to Nakapiripirit District

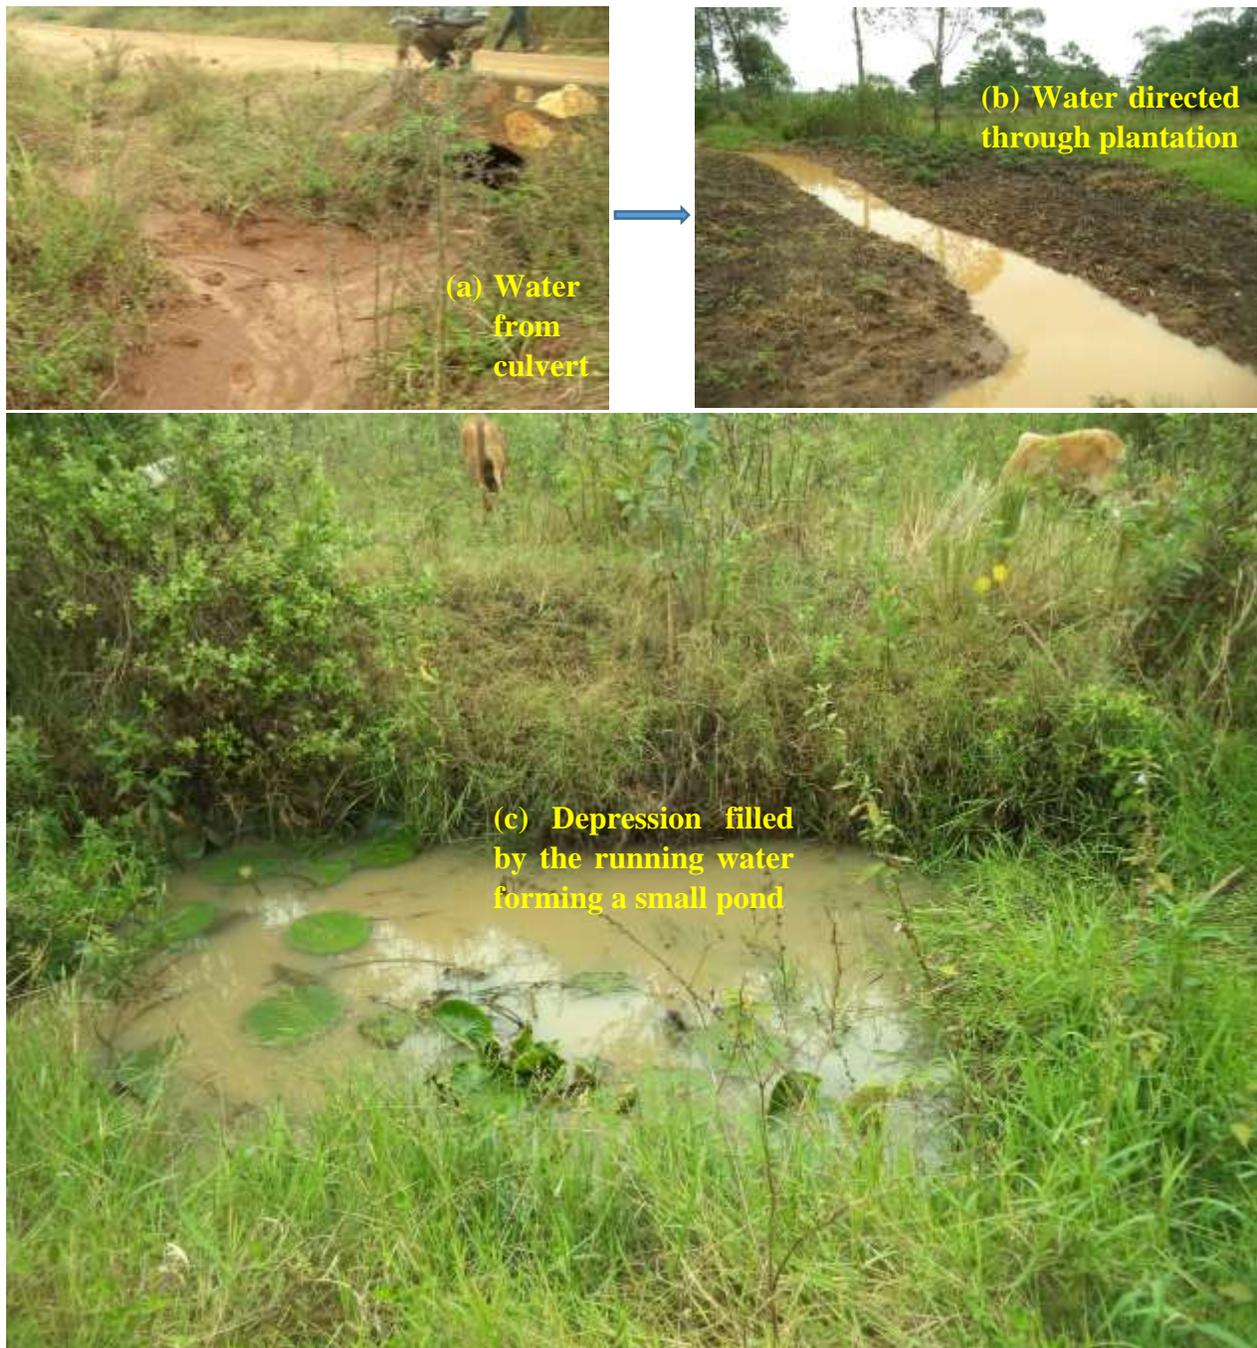
The existing water harvesting systems occur mostly accidentally. For example, the series of pictures below show a small pond naturally formed due to collection of water from a road catchment and this water is used for irrigation in the dry season. Also in some areas where earth for road construction was excavated (borrow pits) the depressions left behind are now collecting water from which cattle drink. Very few people have embraced water harvesting and many see the too much water as a threat to their crops.

Figure 3-3a, b and c: Naturally occurring water harvesting system
