**CONSULTANCY SERVICES FOR FIELD ASSESSMENT ON ROAD WATER  
MANAGEMENT & HARVESTING STRUCTURES ALONG THE 18.1KM ROAD  
REHABILITATED BY THE REACH PROJECT IN RUBANDA DISTRICT.**

Subcontract No. 2020/REACH/UGA/002

FIELD ASSESSMET REPORT ON WATER MANAGEMENT – REACH UGANDA PROJECT

13<sup>th</sup> February 2020

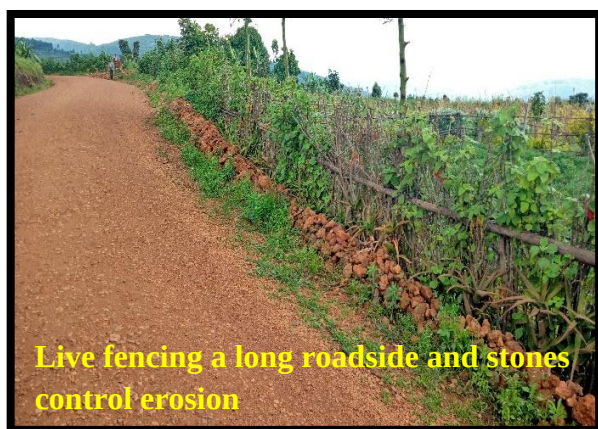
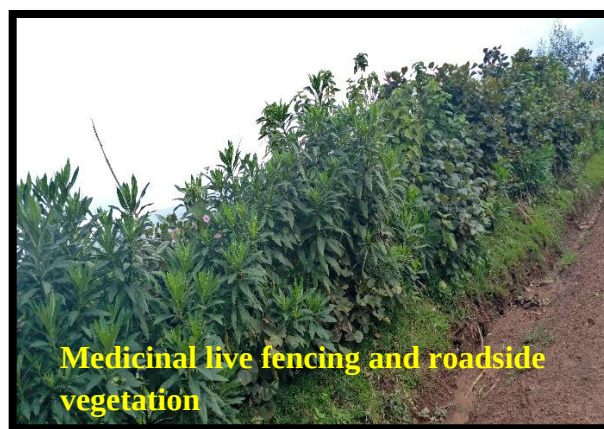
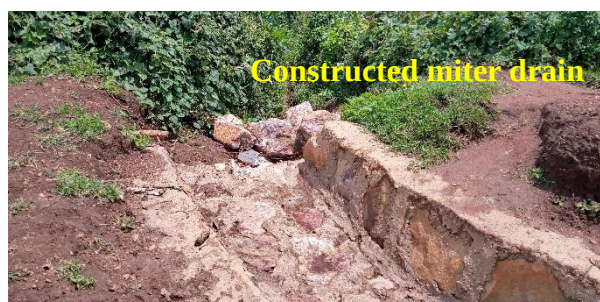
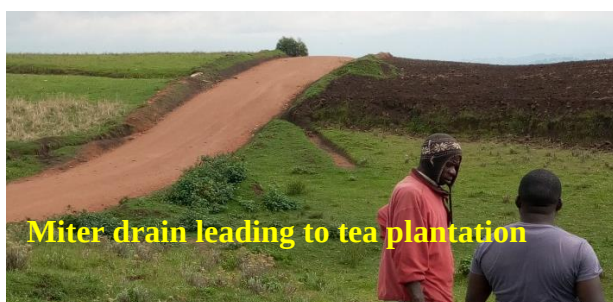
We noted a number of road protection interventions that included mitre drains, constructed side drains at certain locations and live fencing. For this particular community, the live fencing used along the road can be used for medicinal purposes which is a better option compared to vetiver grass. In some locations this was used together with locally available stones to control erosion as shown in the pictures below.

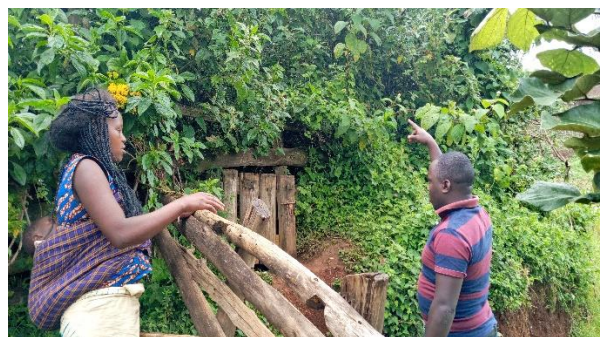
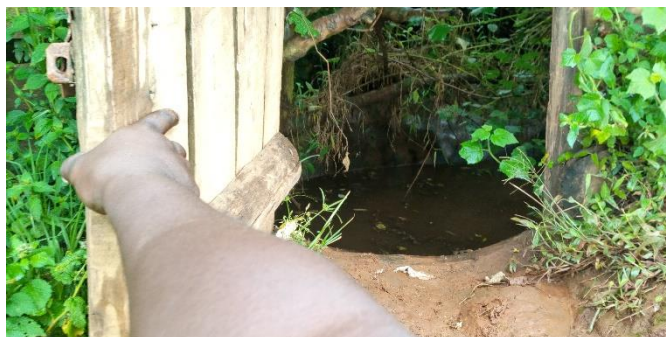
At some particular locations, we found water being harvested from roads into personal ponds commonly known as Ebisizi to the locals. These ponds measured about 3m wide 5 m deep with varying length. Ponds were surrounded with live fencing to protect kids from falling into them and had a cement lining at the bottom to avoid infiltration.

Figure 2-1A woman leads us to an existing water pond (Ebisizi) where they buy water

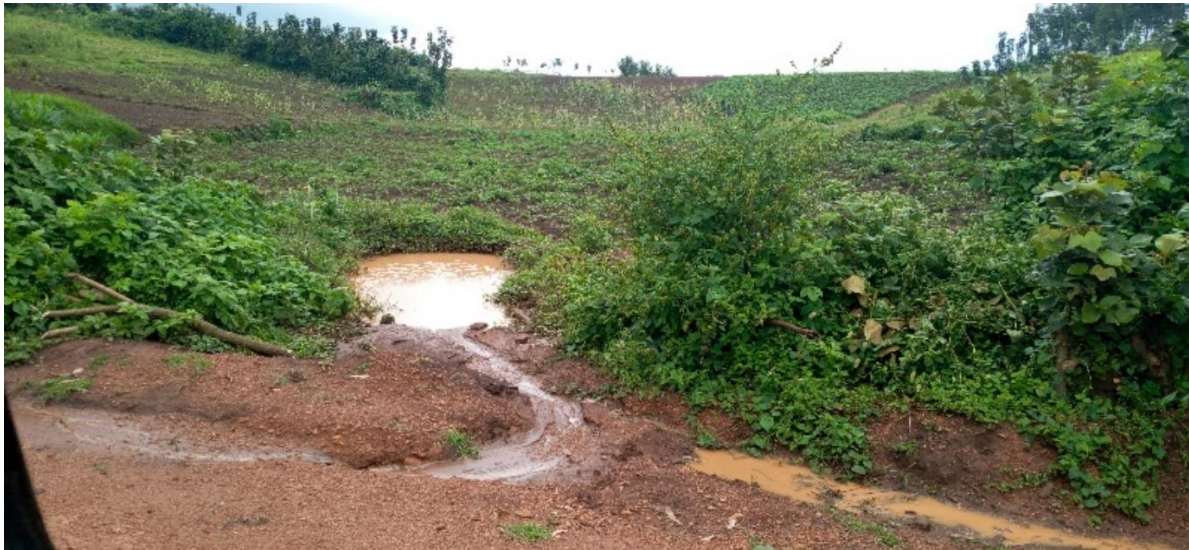
*Figure 2-2 A small pond created near the road, this can flood the road on heavy showers*

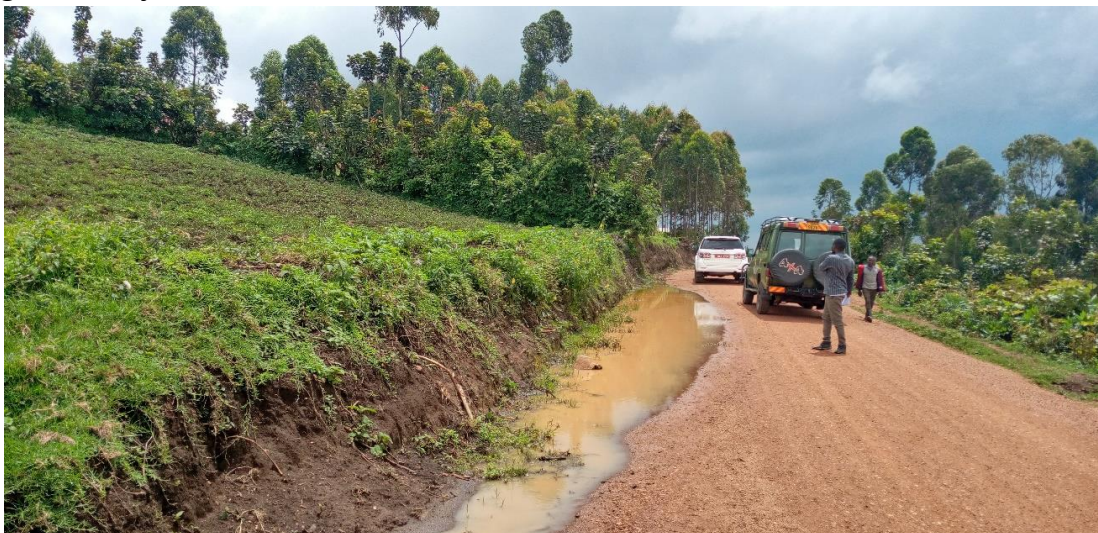
The existing drainage system was found incapacitated to accommodate the gross amount of water collected by the road catchments in the project area. This was due to insufficient side drains, cross culverts and/or rolling dips in some location which will lead to development of potholes and iterative flooding eventually as shown below.

*Figure 2-3 Waterlogging due to lack of cross culvert*

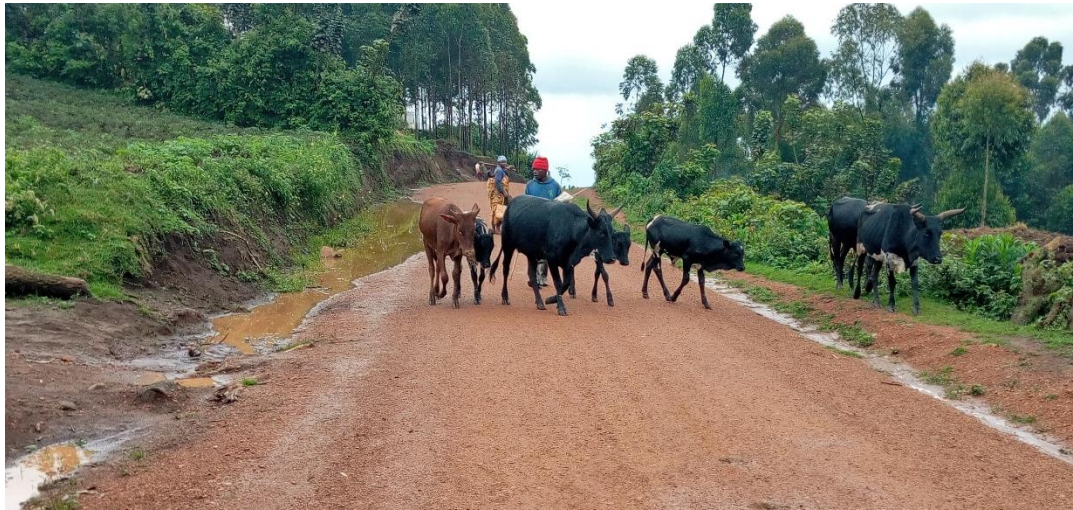
*Figure 2-4 Water logging along road section*

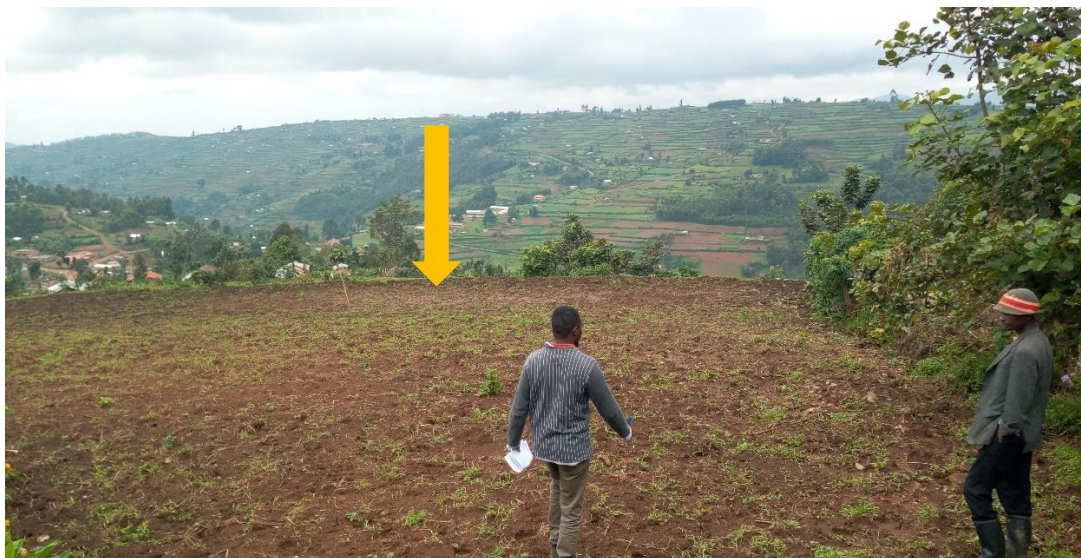
*Figure 2-5 Shows field that gets flooded by water from culvert, see arrow*

| Sn | Description | Proposed intervention | Eastings | Northings |
|---|---|---|---|---|
| 5 | Culvert silting the Irish and causing flooding in the farm/ gardens of Mr Tinomugisha Maxmus. | Culvert interventions, infiltration trenches along contours and silt traps. Plant trees and grass on both sides up to the 9+700 chainages | 822073.47 | 9868636.11 |

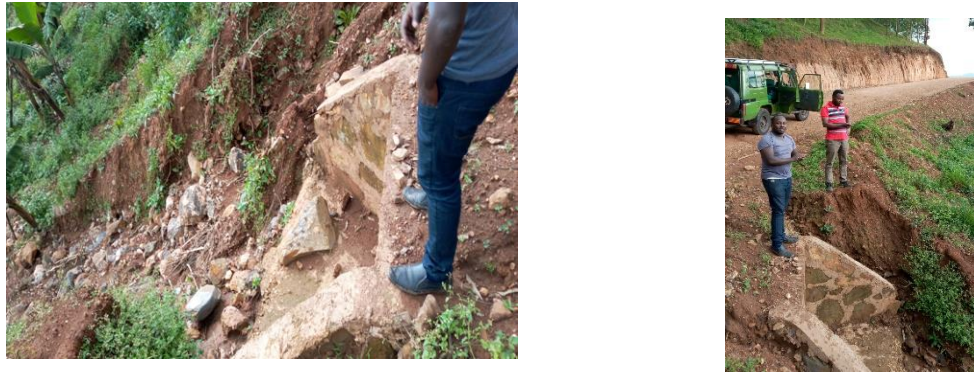
The road was also endangered by a number of erosional problems seen at various points along its length as shown in the figures below. The many erosion incidences have led to drains and culvert siltation, rillies, gullies and boulders' mobility that will damage the infrastructure and community safety. This has been greatly caused by the sharp topography of the project area and lack of scour checks on steep road slopes.

*Figure 2-6 Erosion at culvert outlet*

At various culvert outlets and mitre drains, a number of interventions including use diversion trenches that follow contours, with combination of infiltrations ditches, deep trenches and equal spreaders can be used to retain water o farms and reduce the runoff speed hence minimising erosion.

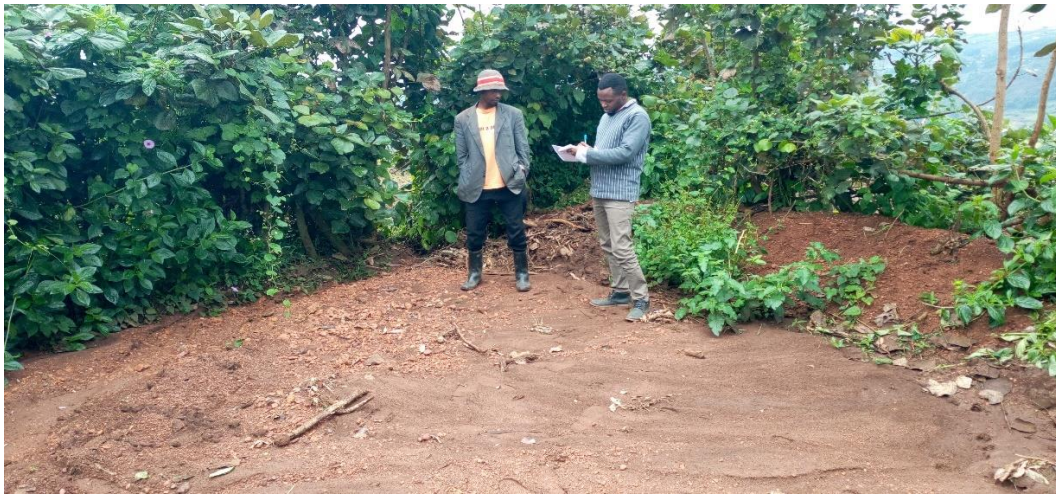
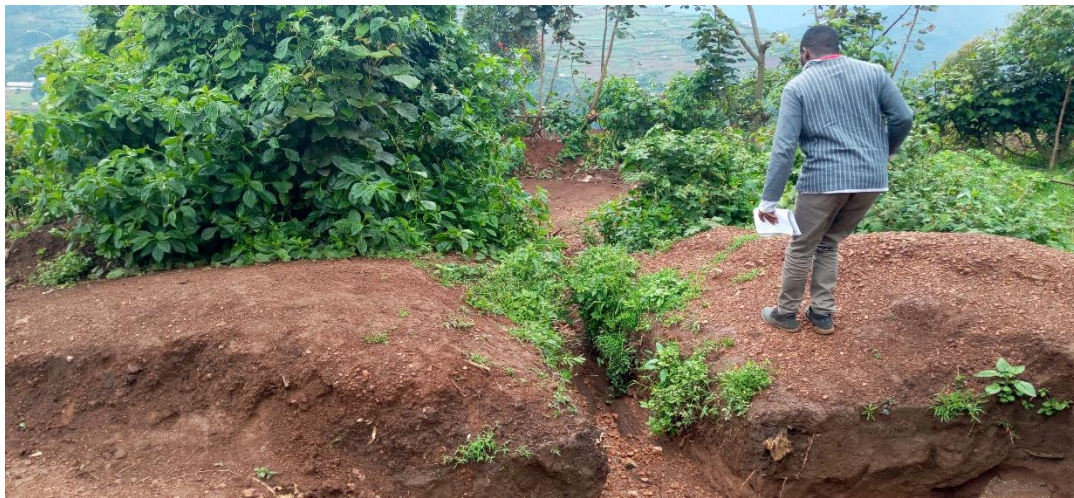
During our field assessments, extreme road-induced siltation occurrences were observed. Siltation is caused by the piling debris carried by running water along the road in relatively flat slopes. Along the project road in Rubanda district, the siltation was more pronounced at downstream culvert outlets which blocks them from conveying the water from one side of the road to another thus leading to road pondage.

*Figure 2-8 Silting at culvert outlet opposite Vision Primary School*

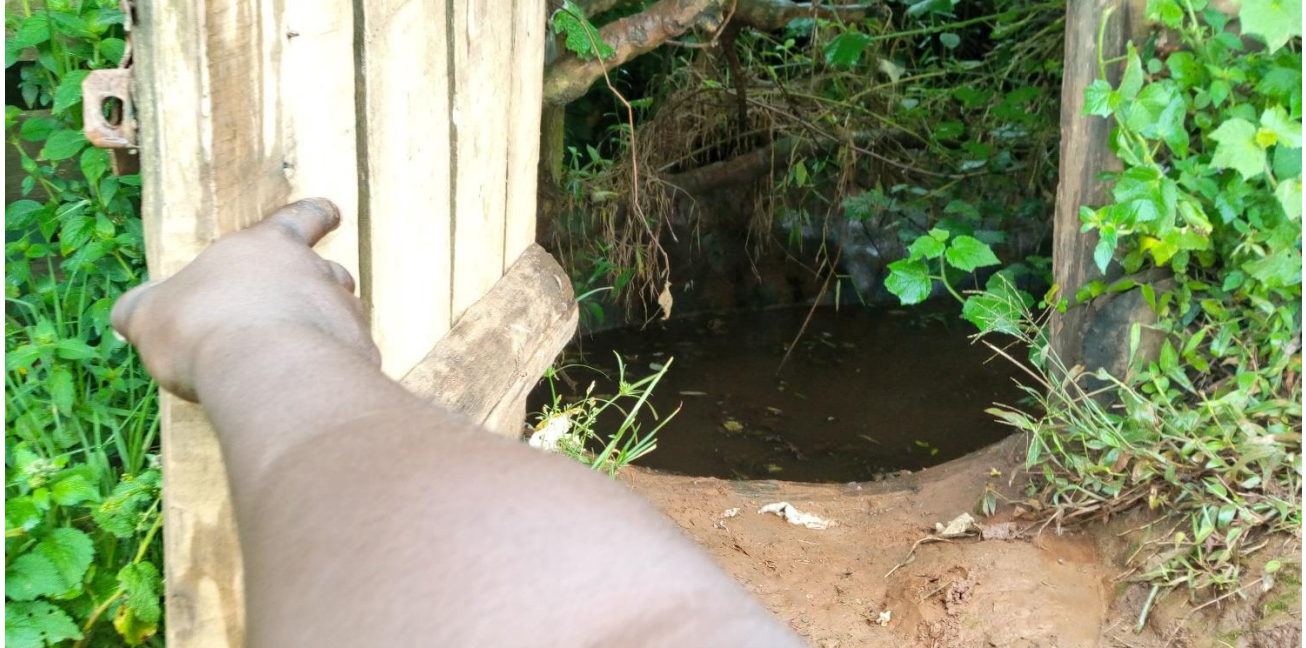
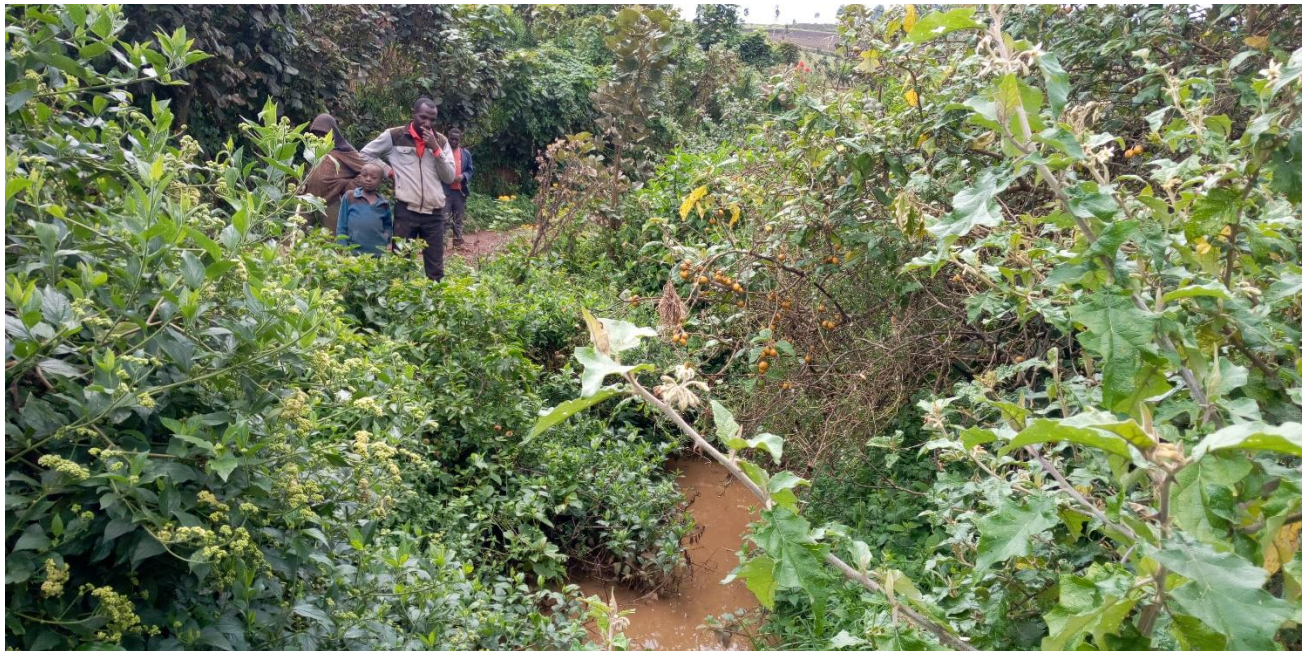
*Figure 2-9 Some of the existing water harvesting ponds along the road*

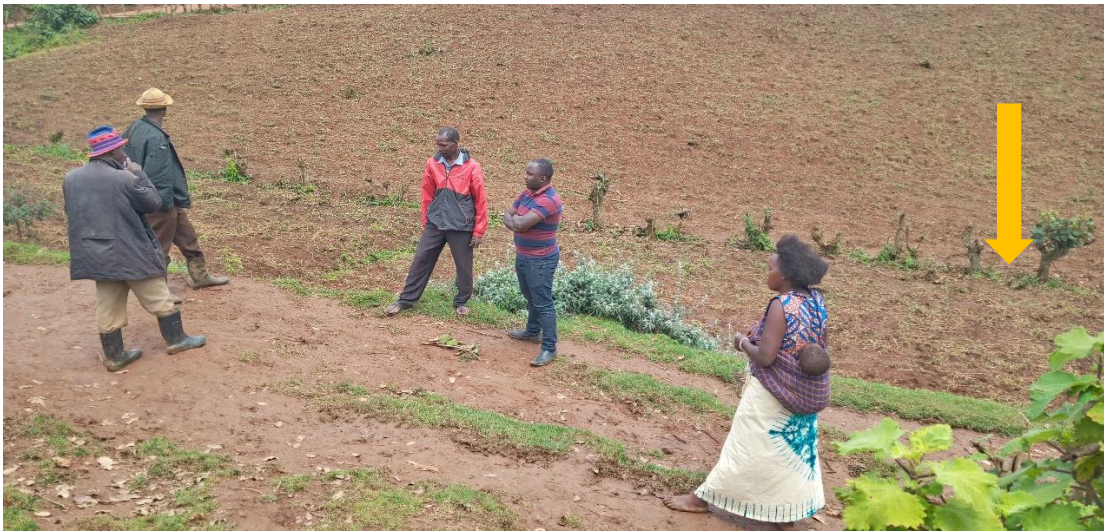
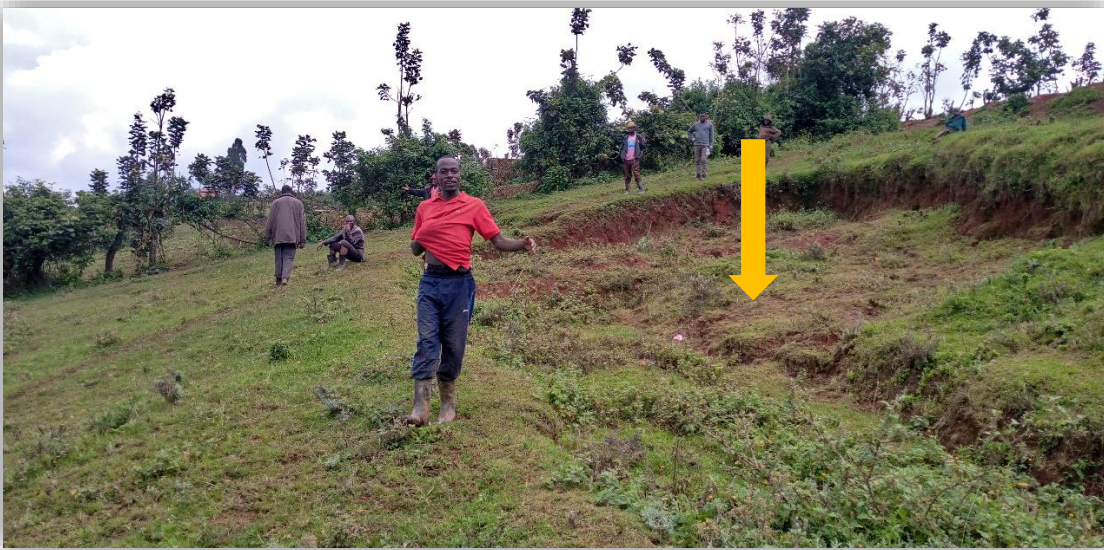
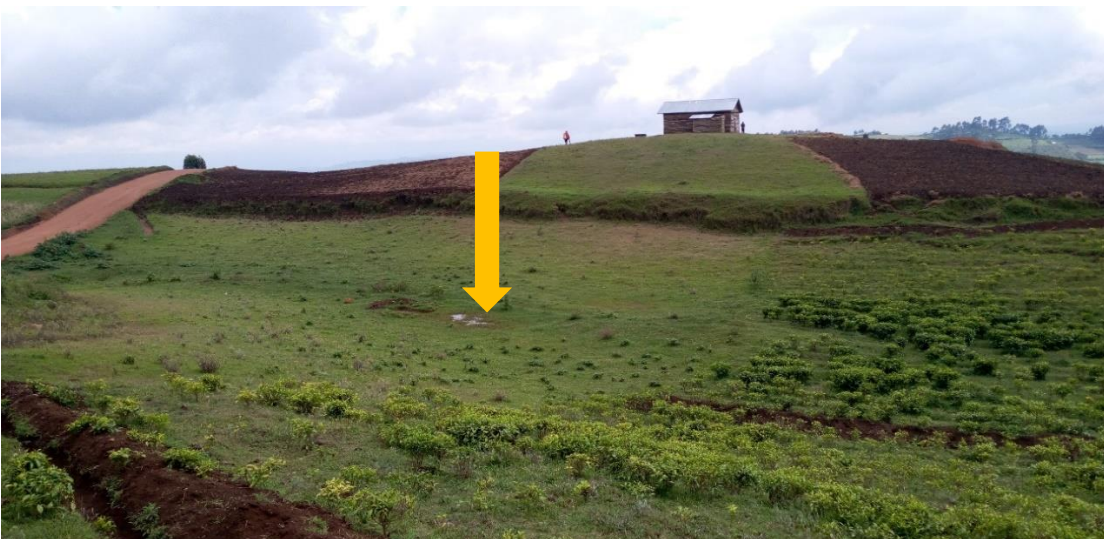
Figure 2-10 Picture above show some of the suggested locations for water ponds, arrows show exact points

1. A number of water-harvesting ponds can be constructed along the road to provide water for irrigation to grow crops like vegetables and feed animals. The community members through their leaders should acquire land where ponds are to be constructed. This ensure that water is used by the entire community and create ownership of the structures.
