Baseline Report

On socio-economic and environmental factors regarding mountain spring source utilization and management in four sites of Dhankuta district, Koshi Province, Nepal.

Roadside Spring Protection in
the Himalayas (RoSPro)

March 2024

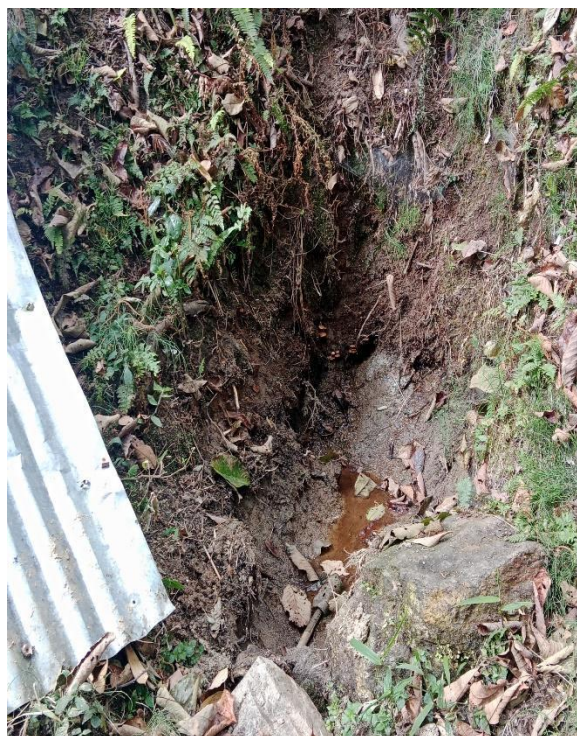
Figure 2: Roadside spring.

In Eastern Nepal the depletion of spring sources is also a pressing issue. In the Nibuwa-Tankhuwa Watershed a myriad of issues come to the fore that are part and parcel to this dire situation. A key issue is the decreasing water availability during dry seasons which is perceived to be impacted by declining discharge from springs and streams caused by both human and natural factors. In Dhankuta districts locals perceive the following factor to be influencing spring water availability. Climate change for instance is one factor, especially the erratic rainfall, changing seasonality patterns and increased temperatures. But human factors also play a big role, for example increasing number deep borewells in Dhankuta district leading to overexploitation of the water source, road infrastructure development changing flow patterns of sub-surface water; while at the same time demand for the same water has increased over time owing to population growth, and increased irrigation demand for farming. Also, erosion of topsoil and resulting sedimentation is mentioned as a factor.

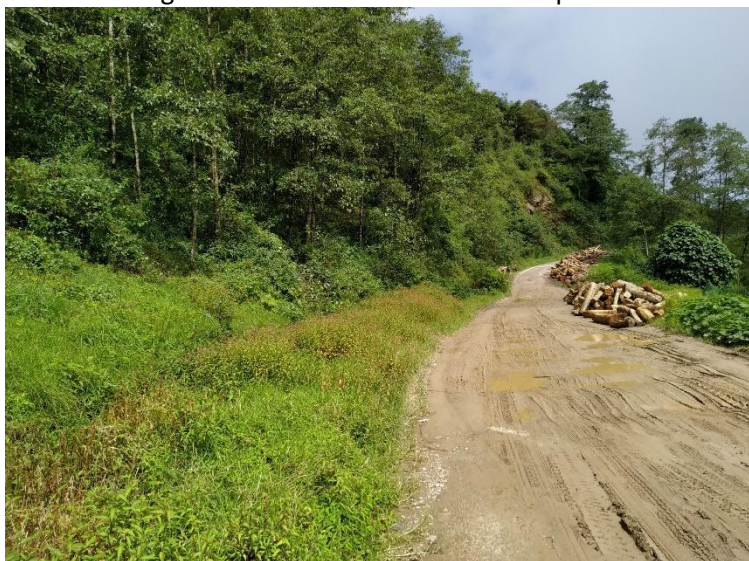
Figure 3: Road damage by water.

The rapid development of road networks in the region has exposed some of the spring sources which has affected its outflow, many times the rock that is cut during road construction changes the location of the spring's orifice. In short, this means a displacement of the spring outlet. In addition, during the road construction, the water-bearing strata are exposed causing the aquifers to leak. The spring that gets exposed during road construction depletes the aquifer system and places the fragile water supply of the area under threat. At the same time, a rock-cut can open up a new spring, however, since this is directly adjacent to the road this must be managed well to prevent seepage water from damaging the road. However, the intersection of springs and roads is not given sufficient attention and at present it causes more harm than good. An important issue is that roads have been constructed rapidly in the last 5 years especially, after the decentralization of government materialized in Nepal. Often, roads connecting rural communities with urban centers are constructed without involvement of a road engineer. The problems arise from here since road design does not consider sub-surface water flows, drainage patterns and the hydrogeological conditions among others. Leading to roads that have short longevity and catchments that are negatively affected.

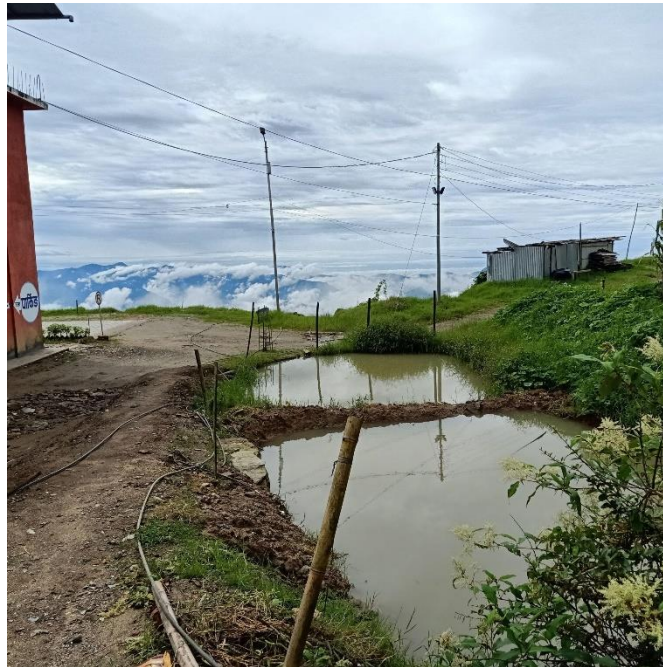
Figure 16: Two ponds near the Keshari Kharkha spring.

In Keshari Kharkha spring site, there are two ponds near the spring. These ponds (which also function as recharge ponds) receive water from Keshari Kharkha spring and rainwater water harvested from roof of CJRM building through pipe connections. Community members have been using the water from the ponds for irrigating a few nurseries, karesha bari, livestock purposes and in the development activities such as construction of buildings, roads etc.

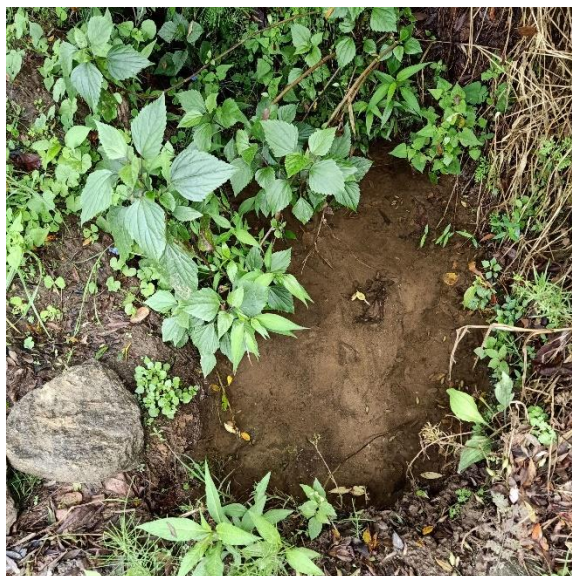
Figure 18: Intake constructed by the community people around the spring source.

People from Keshari Kharka indicate that over the past 10 years the sources of water in the spring have decreased by 25%, but they see a 2-5% increase in water level in the last year. According to them this may be due to proper management of the spring source as they have built a small intake near the spring for water collection.

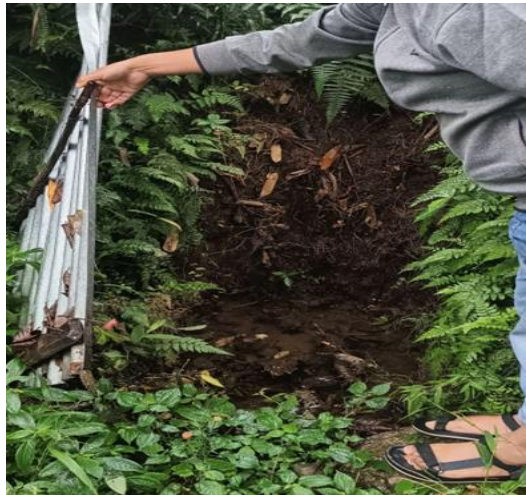
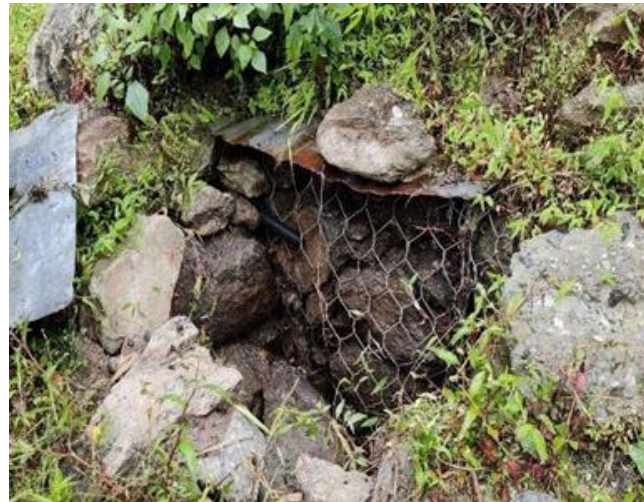
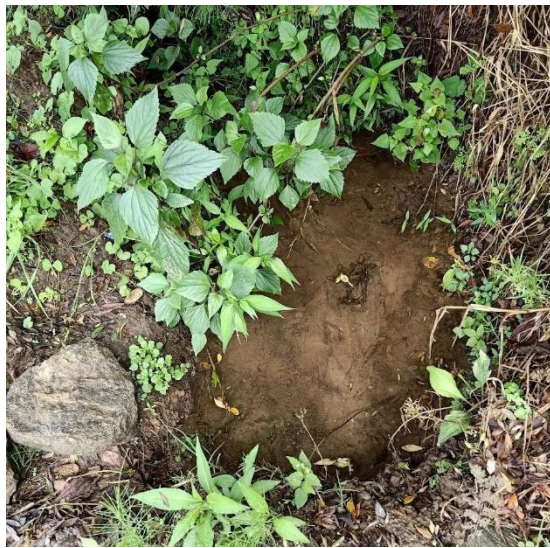
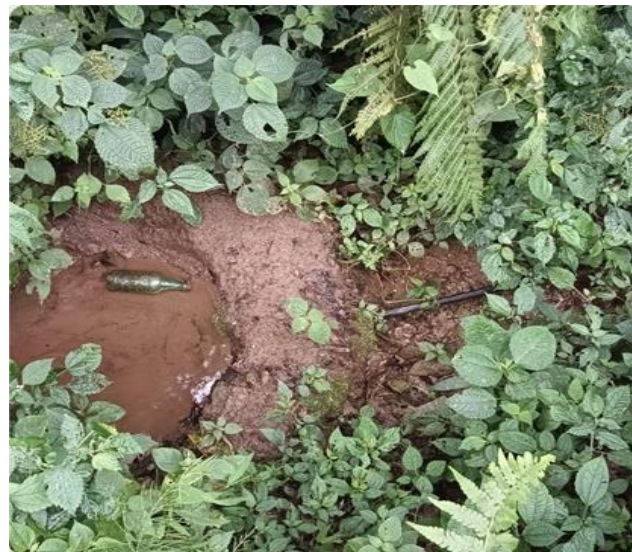
Figure 20: Spring source (a) Chanchaladevi Spring, (b) Bojhe Spring, (c) Keshari Kharkha Spring & (d) Dhoje Dharapani Spring

In the FGDs community members of different springs add that in the past the spring sources were not protected and conserved, while currently they cover the spring sources with iron sheets. This prevents the dirt and dry leaves from entering the source and prevents the interference of animals like dogs and monkeys in the spring water. They have experienced positive changes in water quality both in terms of smell and taste. Generally, people noticed that since they started cleaning and protecting the spring area and its surroundings, the quality of water has improved to some extent in terms of its turbidity, smell and taste. As of now they have not done any water quality testing.

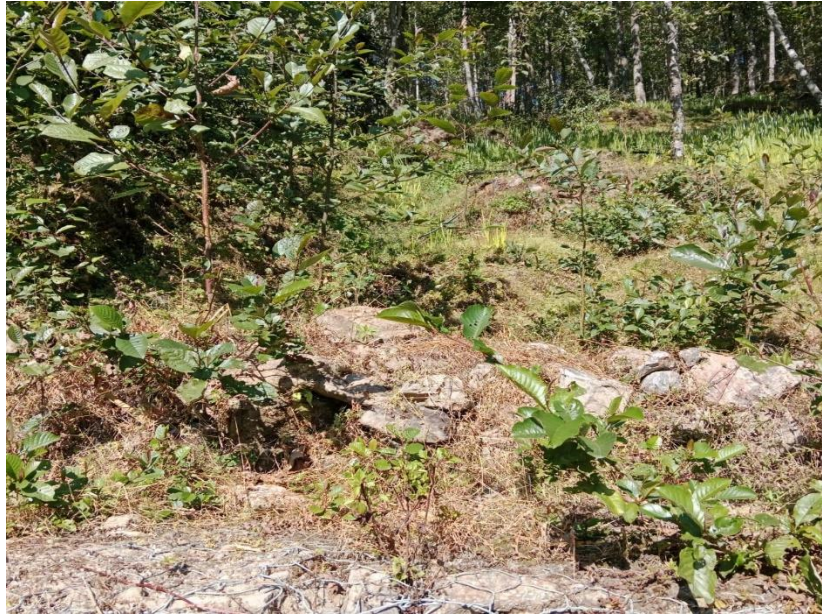
Figure 28: Small wall constructed adjoining to the spring to prevent it from the sediment carrying runoff in Bojhe.

In Dhoje Dhara Pani spring site, the past decade brought major climatic changes, including reduced snowfall, irregular rainfall, and higher temperatures. This has led to drying up of spring water sources, with rainwater from upstream roads introducing pollutants. Community members are actively taking measures like providing small drainage in roads, or small walls above the spring to mitigate the impact of rainwater from upstream roads.

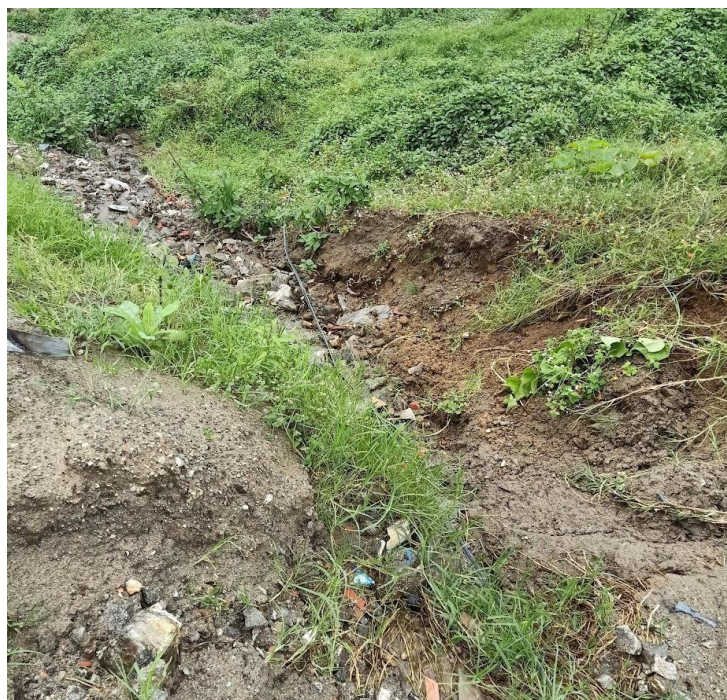
Figure 29: Gully formation down the road due to water from Keshari Kharka spring.

Keshari Kharka spring site also witnessed drastic climatic changes, with increased temperatures, irregular rainfall, and changes in rainfall intensity. The rise in water levels in nearby ponds during monsoon has led to gully formation. Unlike other spring sites, the community reported not to have taken any adaptive measures to cope with these climate impacts.

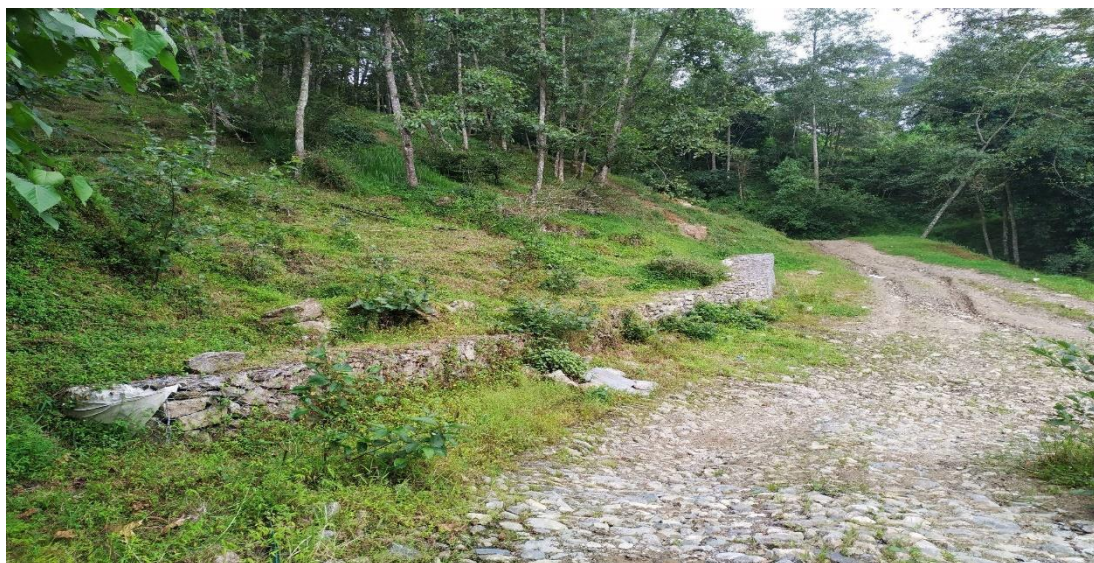
Figure 31: Adjacent Road with rubble soling in Bojhe spring site

The majority of the roads in the selected spring sites are feeder roads with gravel and sand surface while the road joining the Bojhe spring is rubble soling. These roads are mainly constructed through the user committee and village development committee and are also the responsible bodies for their repair and maintenance. The road serves as the village's conduit for the development of infrastructure and accessibility to numerous amenities and services like health, education, market and employment opportunities.

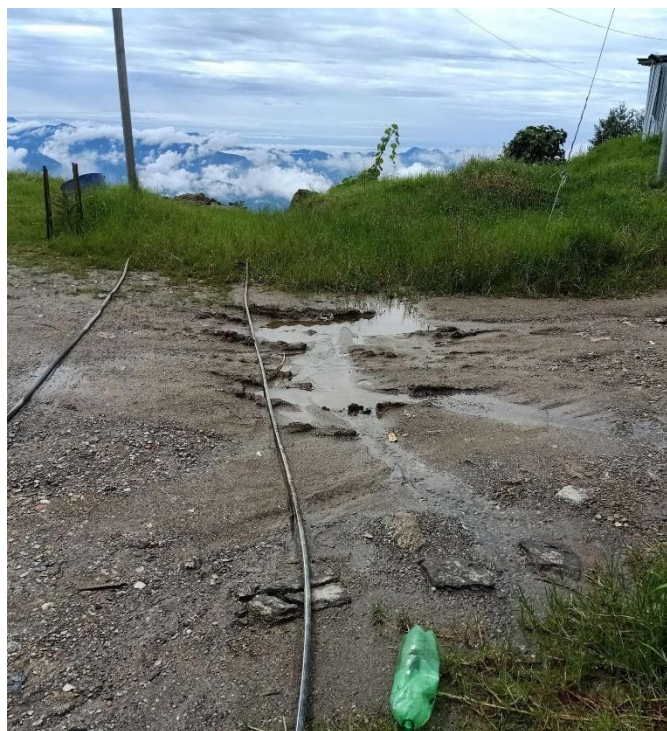
Figure 36: Road surface damage and gully formation at downstream side of keshari Kharka spring

The main impacts to the road caused by amongst others spring seepage water, are road surface damage, water seeping which creates erosion, road embankment damage, waterlogging and sedimentation. This leads not only to a negative impact to the road and its surroundings and agricultural fields, but it also means costs for maintenance and repairs of roads and adjacent lands and infrastructure. And furthermore, it means disturbance to the people who make use of the road to for instance market their produce or go to school.
