Hydrogeological mapping of springs in Dhankuta, Nepal

(Bojhepani and Chanchaladevi Mul Dhankuta 1,

Dhwoje and Kesharikharka of Chhathar Jorpati Rural Municipality 2)

2024

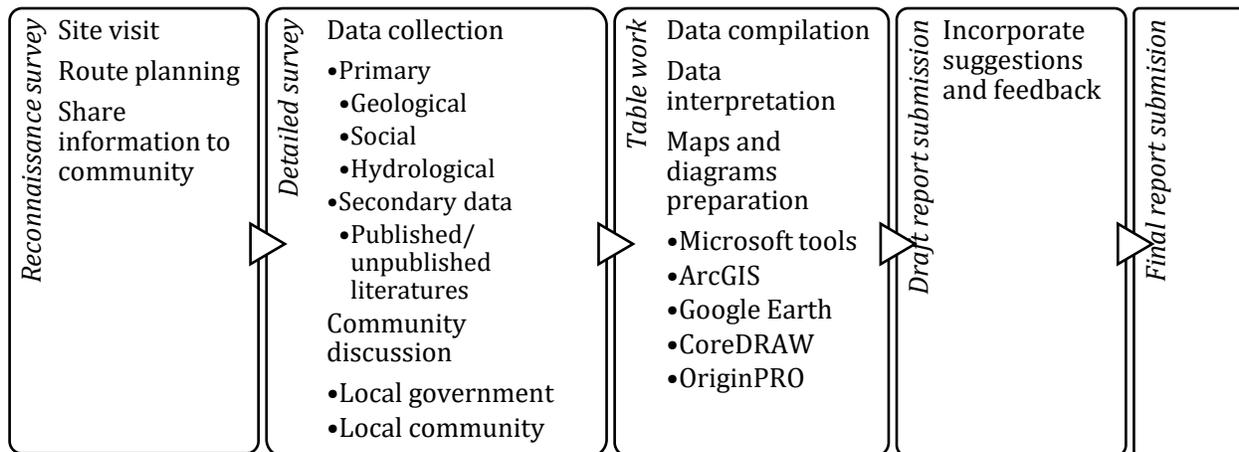
Figure 3: Flow chart of methodological approach.

The hydrogeological mapping of springs in Dhankuta Municipality and Chhathar Jorpati Rural Municipality, Dhankuta started informing the purpose of study and collecting data by interviewing community people with the help of representatives of local government and community resource person in a defined methodological framework (Figure 3). The coordinates of springs, rock exposures and land cover were collected using GPS. In the case of some restricted/unreachable places, information was collected by interpreting the Google Earth image. The present status of springs has also been assessed. The brief socio-economic status acquired by the opinions of the local people. Different photographs of the springs were taken throughout the field survey.

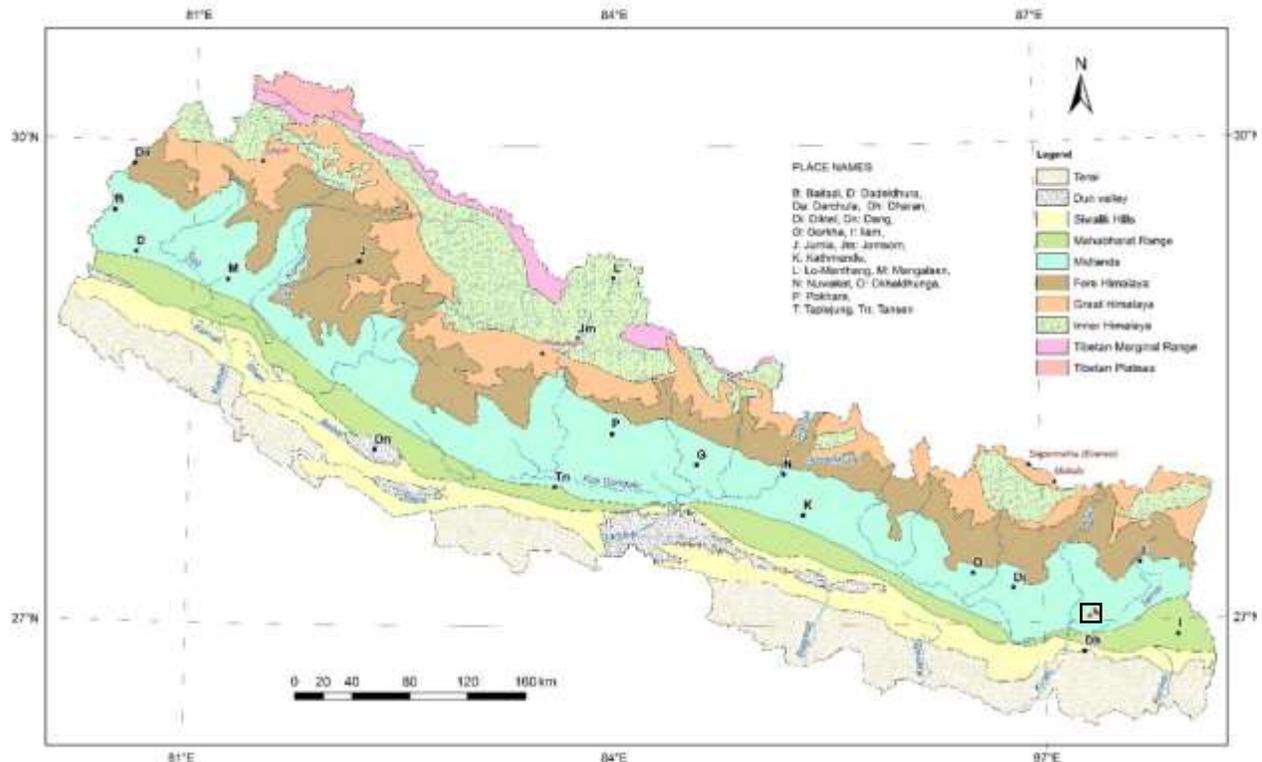
Figure 4: Physiography of Nepal (Hagen, 1969) highlighting the study area in Dhankuta Municipality 1 and Chhathar Jorpati Rural Municipality 2, Dhankuta under red patch inside rectangle.

The Dhankuta Municipality 1 and Chhathar Jorpati Rural Municipality 2 lies in the Midlands, consisting of gradually sloping hills, wide river valleys and tectonic basins in the central part of Nepal, encompass the scenic lowlands between the Mahabharat Range to the south and the high mountains to the north (Hagen 1969) (Figure 3).

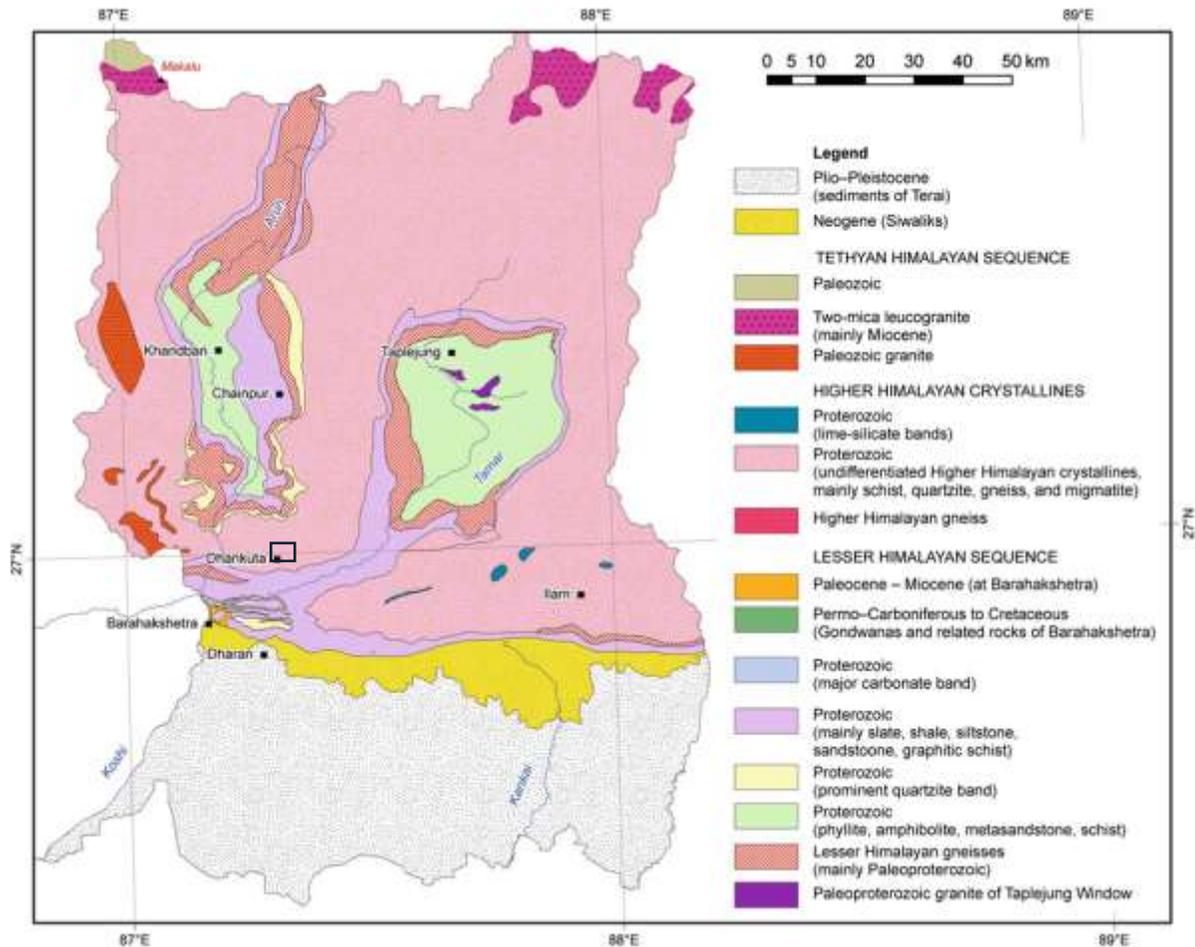
Figure 5: Study area marked with a small black rectangular box in simplified geological map of the Arun-Tamar region (Dhital, 2015).

The regional geology of the study area is solely lies on Higher Himalayan Crystallines (Figure 5) which consists of dark gray, blue-gray, and greenish gray kyanite schists, garnetiferous schists, actinolite schists, and quartzites, with banded and augen gneisses. The age of these group is Proterozoic (Dhital, 2015).

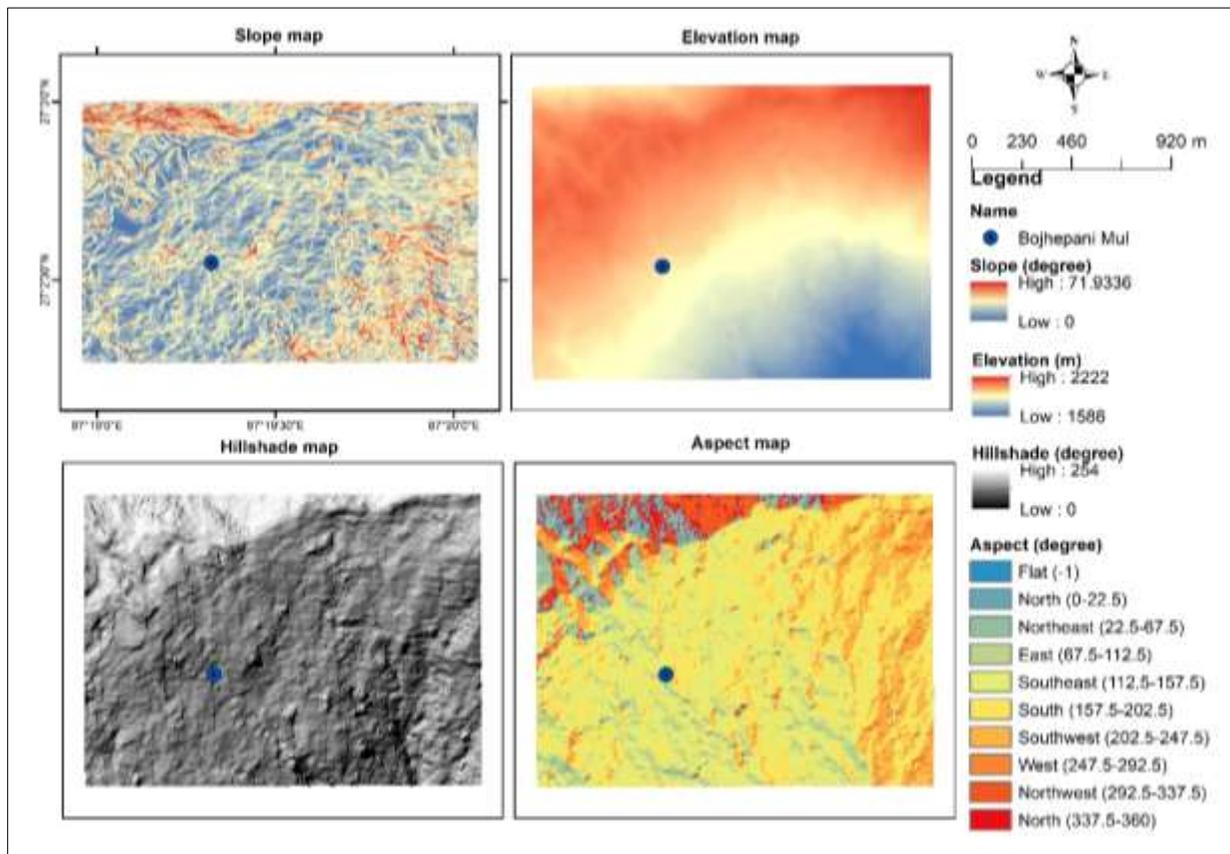
Figure 6: Bojhepani spring overlying in Slope, Elevation, Hillshade and Aspect maps.

The range of slope is gentle (0°) to steep slope (71.93°), steep slope is dominant in northwest and southeast remaining regions have moderate to gentle slope. The maximum elevation in the area is 2222 m in the northwest and minimum is 1586 m in southwest. Hillshade is a visual representation of a shaded relief, and the values are not dependent on the elevation itself but of the aspect and angle illumination. In hillshade map, a value of 0 represents areas completely in shadow (no light). Values ranging from 1 to 255 indicate increasing levels of illumination, with higher values corresponding to brighter, well-lit areas and lower values

indicating darker shadows. The dominant slope-aspect of the region is south and southeast whereas less portion has northern aspect (Figure 6).

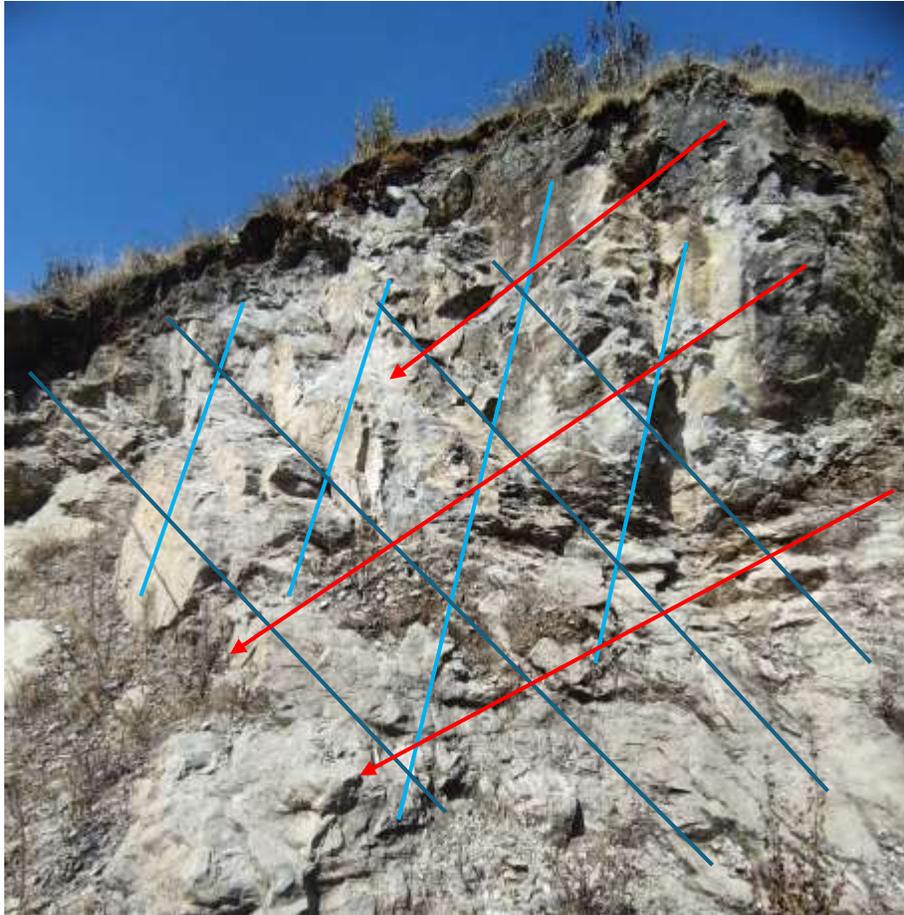
Photo 1: A representative cross-sectional view of rock exposure observed near No.1 camp gate.

A representative cross-sectional view of rock exposure observed near No.1 camp gate was taken for the visualization of real field conditions (Photo 1). Then a 3D conceptual model with rock discontinuities (color lines) and spring (blue arrow) in Bojhepani area created with the help of attitude data extracted from the available rock exposures in the area (Figure 7). Later, the data again plotted in the Google Earth which shows rock discontinuities in the Bojhepani area (Figure 8). Lastly, the recharge area delineated will be utilized for conservation activities (Figure 9).

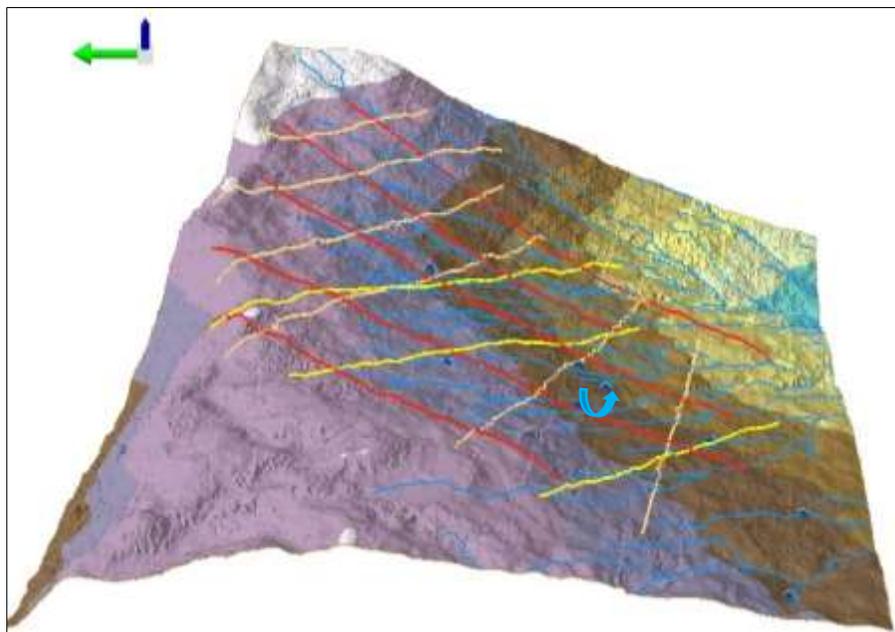
Figure 7: 3D conceptual model with rock discontinuities (color lines) near Bojhepani spring (blue arrow).

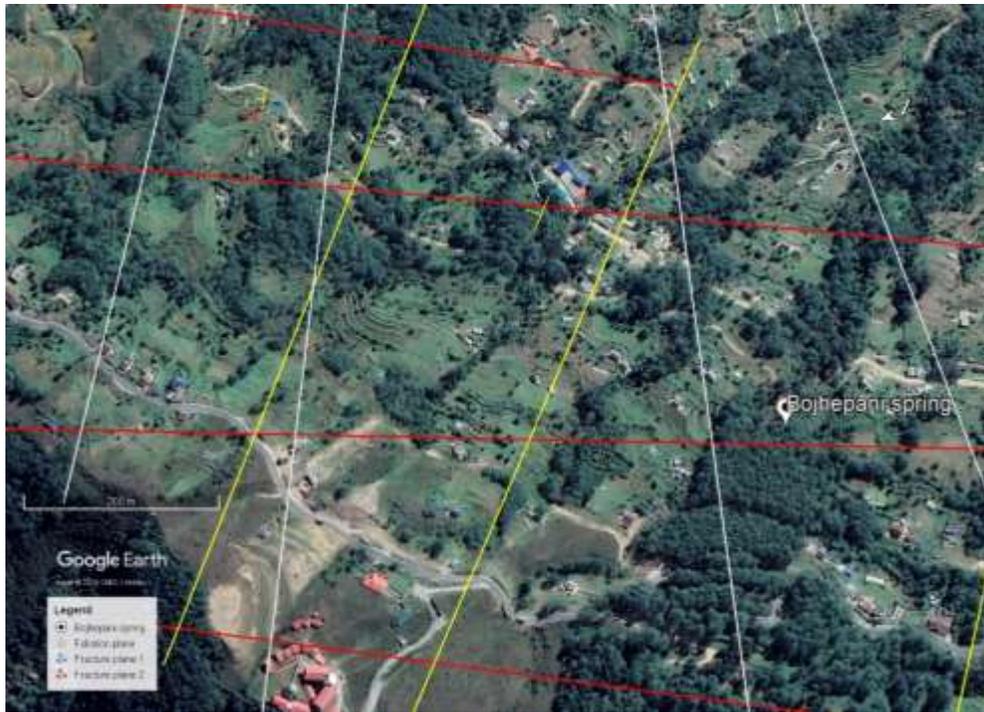
Figure 8: Google Earth image showing rock discontinuities (colorful lines) near Bojhepani spring.

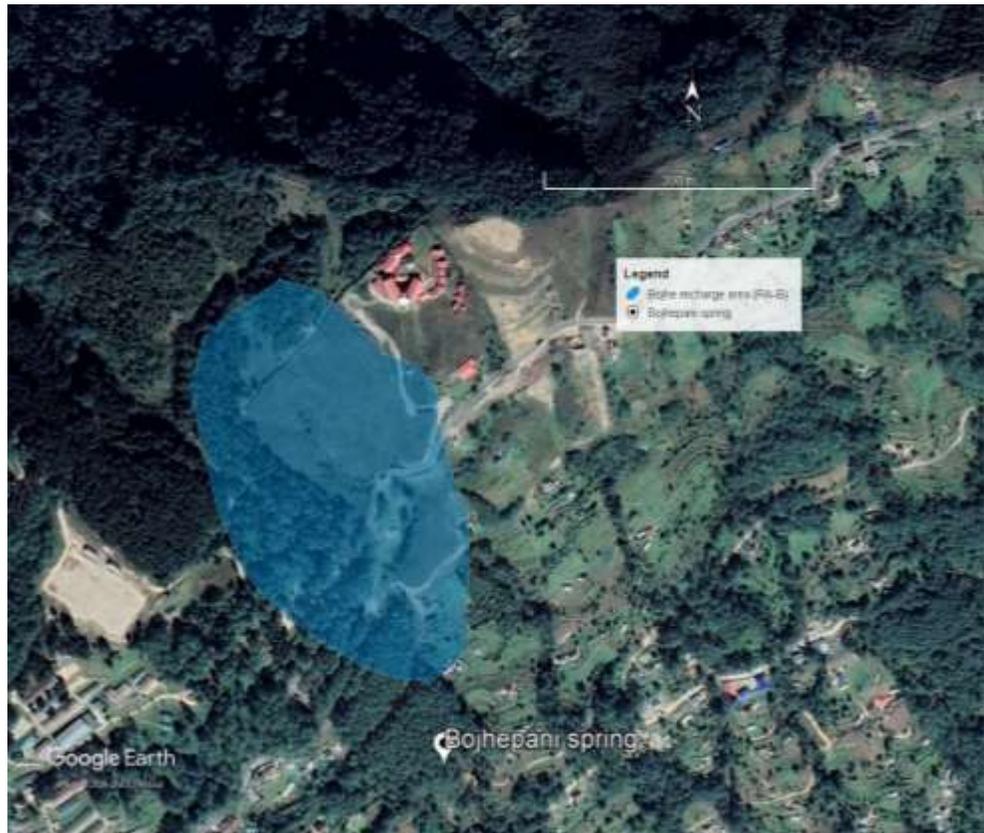
Figure 9: Estimated recharge zones for Bojhepani spring.

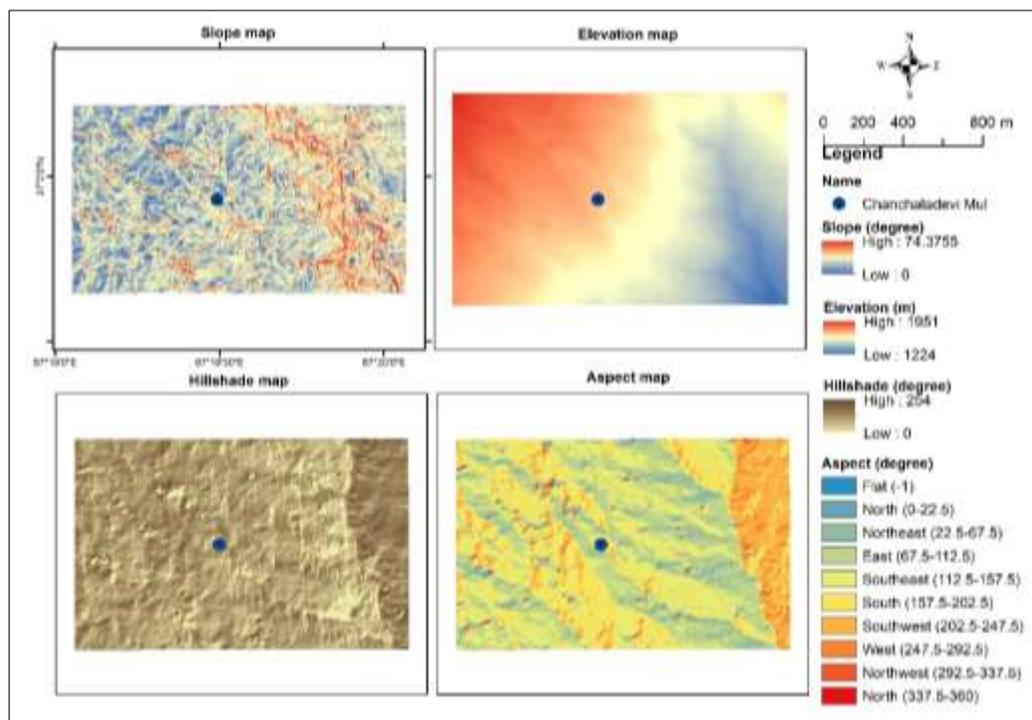
Figure 10: Chanchaladevi spring overlying in Slope, Elevation, Hillshade and Aspect maps.

The region exhibits a diverse topography, ranging from gentle slopes (0°) to steep slopes reaching 74.38° . Steeper slopes dominate the northwest-southeast trend, while the remaining regions have a mix of moderate and gentle slopes. The elevation also varies significantly, with the highest point reaching 1951 meters in the northwest and the lowest point at 1224 meters in the southwest. In terms of slope aspect, southeast to southwestern aspects are most prevalent across the region, with a minor portion facing north. This aspect distribution can influence factors like sun exposure and precipitation patterns (Figure 10).

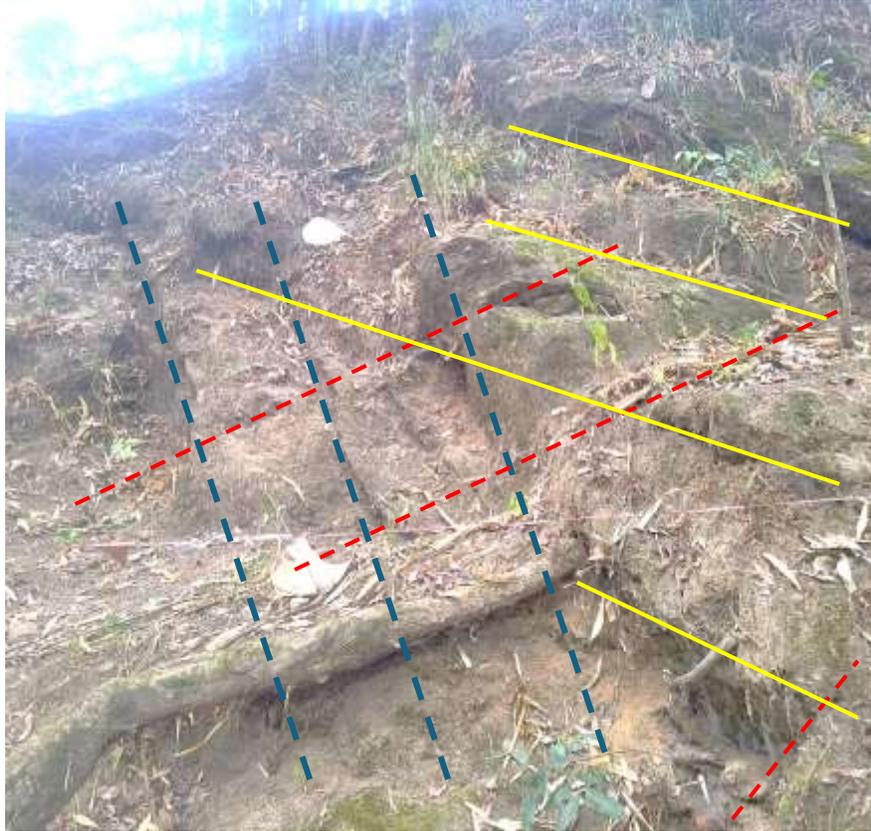
Photo 2: A representative cross-sectional view of rock exposure observed near Chanchaladevi temple.

A representative cross-sectional view of rock exposure observed near Chanchaladevi temple was taken for the visualization of real field conditions (Photo 2). Then a 3D conceptual model with rock discontinuities (color lines) and spring (blue arrow) in Chanchaladevi area created with the help of attitude data extracted from the available rock exposures in the area (Figure 11). Later, the data again plotted in the Google Earth which shows rock discontinuities and Chanchaladevi spring (Figure 12). Lastly, the recharge area delineated will be utilized for conservation activities (Figure 13).

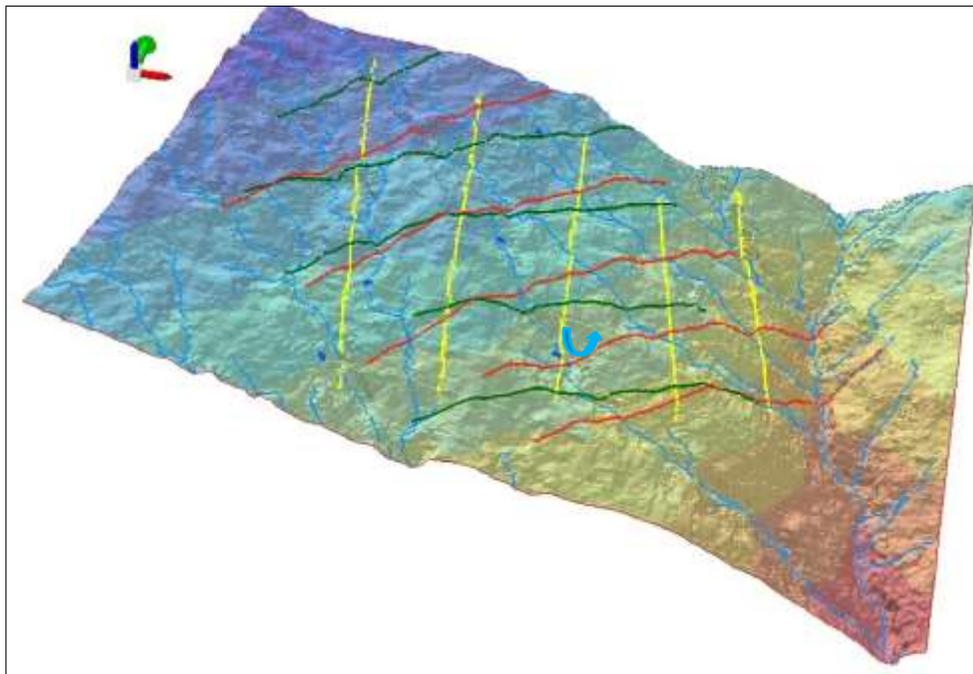
Figure 11: 3D conceptual model with rock discontinuities (colorful lines) near Chanchaladevi spring (blue arrow).

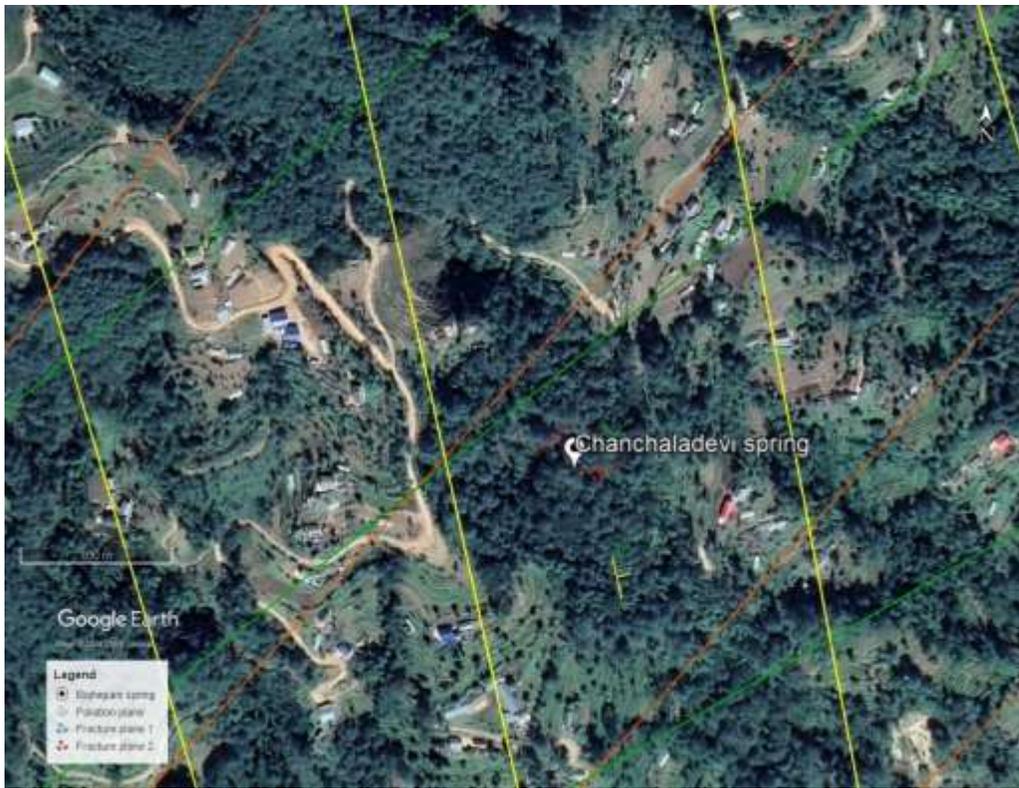
Figure 12: Google Earth image showing rock discontinuities (colorful lines) near Chanchaladevi spring.

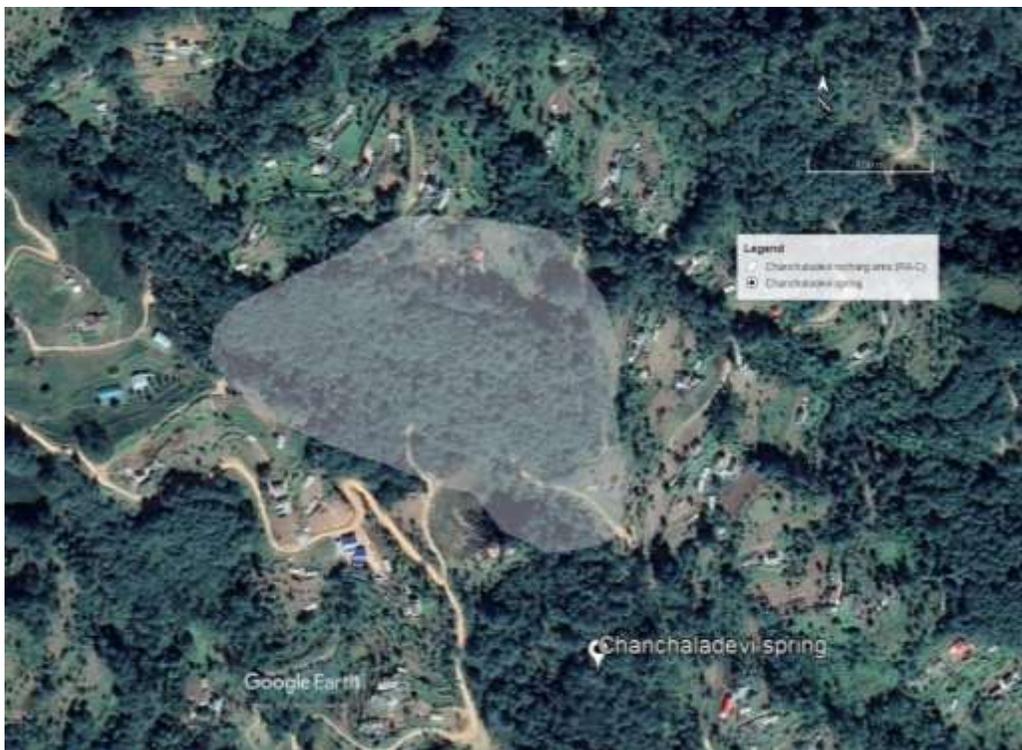
Figure 13: Estimated recharge zones for Chanchaladevi spring.

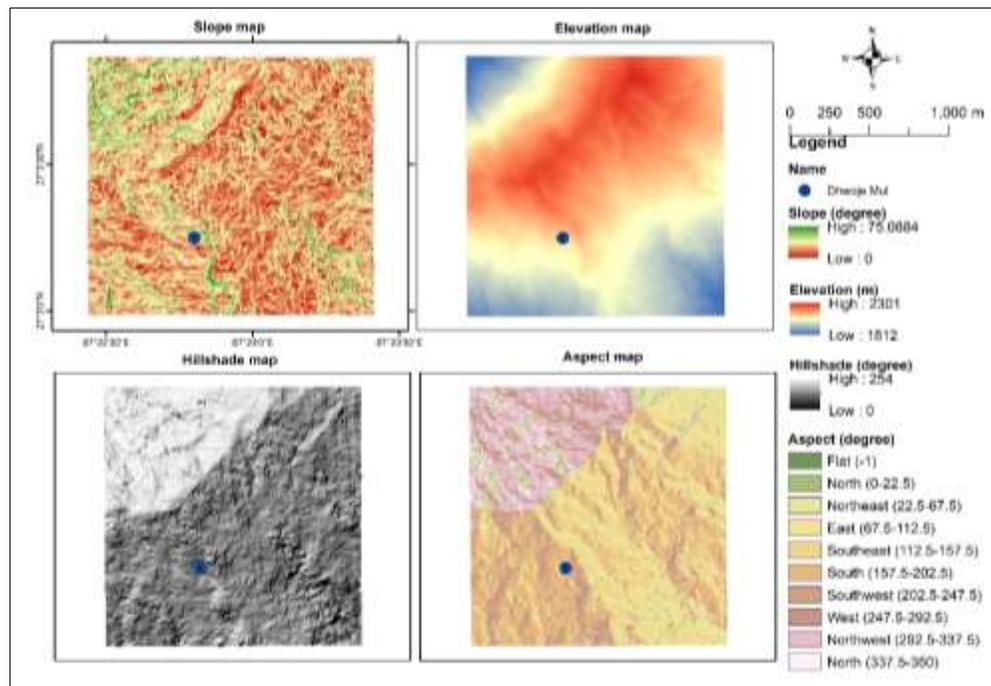
Figure 14: Dhwoje spring overlying in Slope, Elevation, Hillshade and Aspect maps.

The region showcases diverse topography, with slopes varying from gentle (0°) to steep (reaching 75.1°). Steeper slopes dominate in a northwest-southwest direction and some in southeast, while the remaining areas feature a mix of moderate and gentle slopes. Elevation also varies significantly, with the highest point reaching 2301 meters in the central part and the lowest point at 1812 meters in the downstream periphery of Dhwoje hill. In terms of slope aspect, eastern to southeaster aspects are most prevalent across the region, with a lesser portion facing northwest. This aspect distribution can influence factors like sun exposure and precipitation patterns (Figure 14).

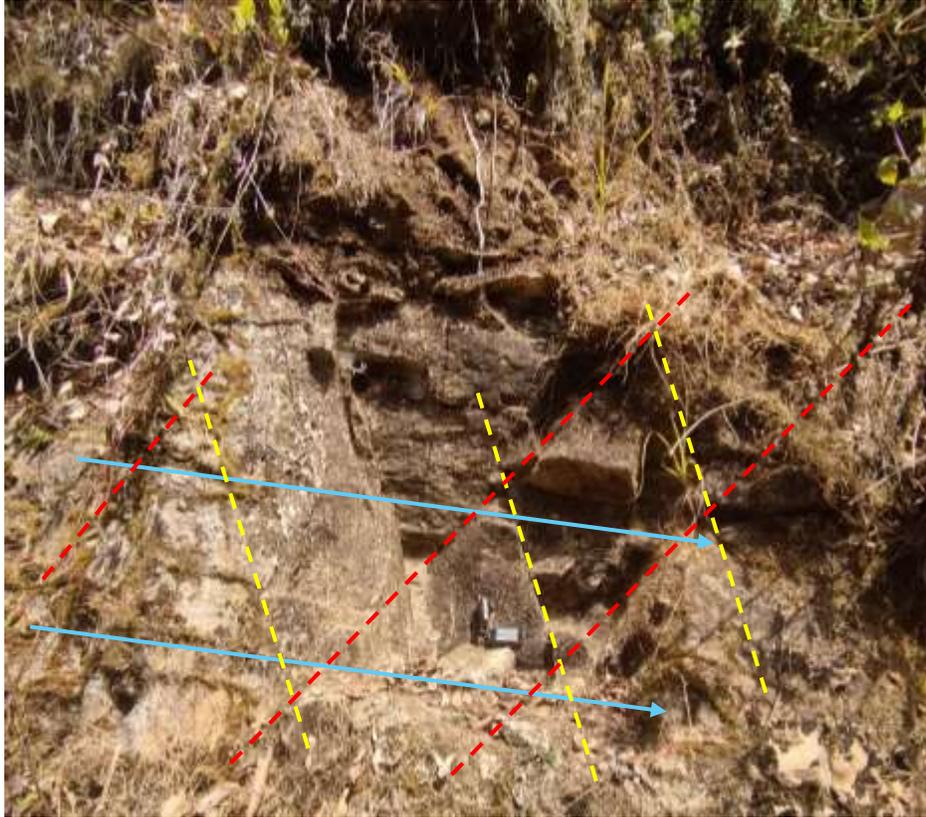
Photo 3: A representative cross-sectional view of rock exposure observed near Dhwoje Gumba.

A representative cross-sectional view of rock exposure observed near Dhwoje Gumba was taken for the visualization of real field conditions (Photo 3). Then a 3D conceptual model with rock discontinuities (color lines) and Dhwoje spring (blue arrow) created with the help of attitude data extracted from the available rock exposures in the area (Figure 15). Later, the data again plotted in the Google Earth which shows rock discontinuities and Dhwoje spring (Figure 16). Lastly, the recharge area delineated will be utilized for conservation activities (Figure 17).

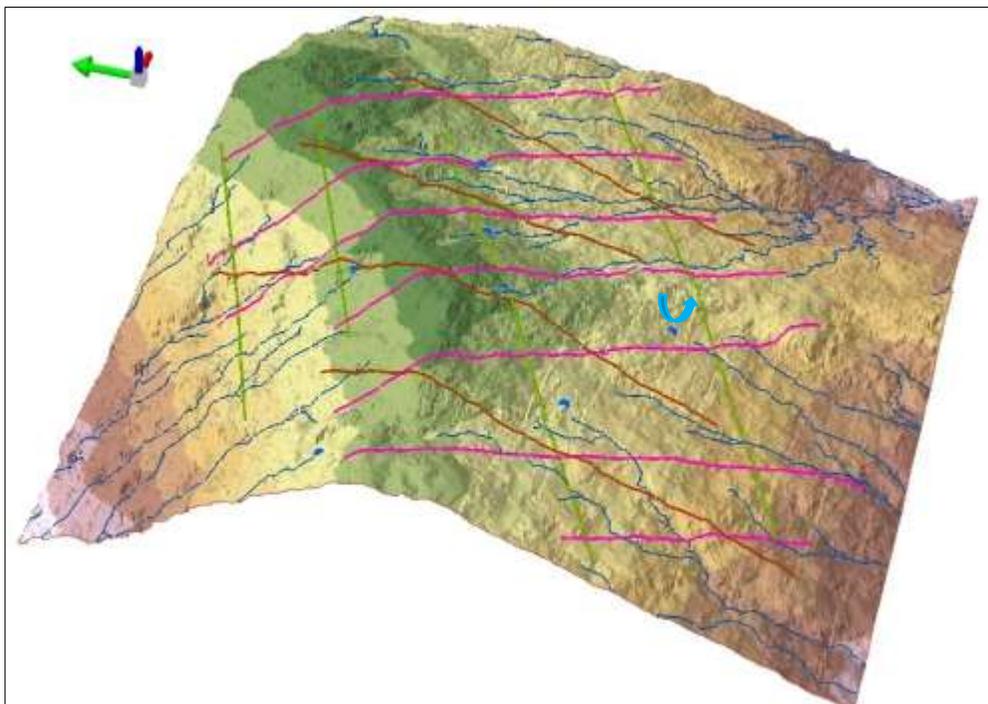
Figure 15: 3D conceptual model with rock discontinuities (colorful lines) near Dhwoje spring (blue arrow).

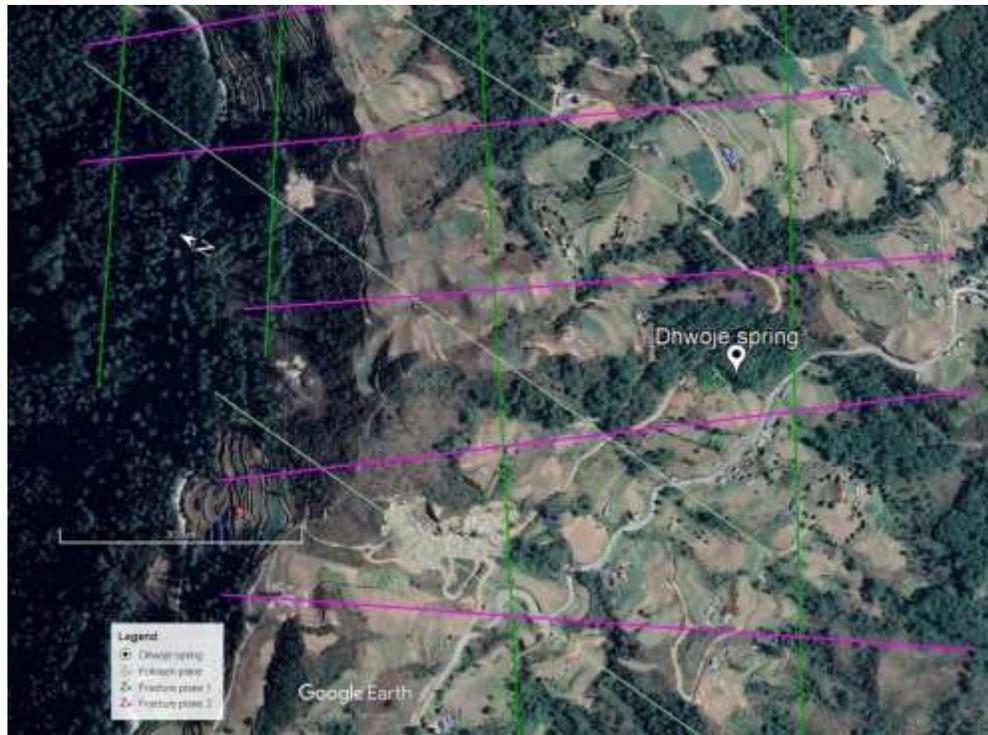
Figure 16: Google Earth image showing rock discontinuities (colorful lines) near Dhwoje spring.

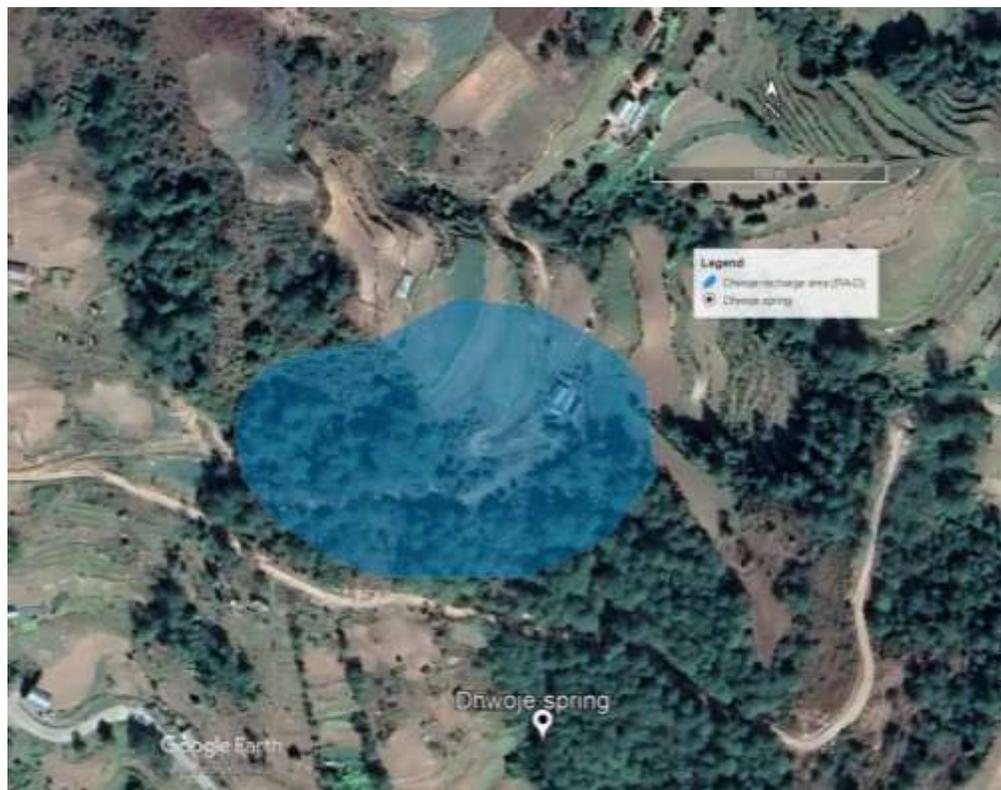
Figure 17: Estimated recharge zones for Dhwoje spring.

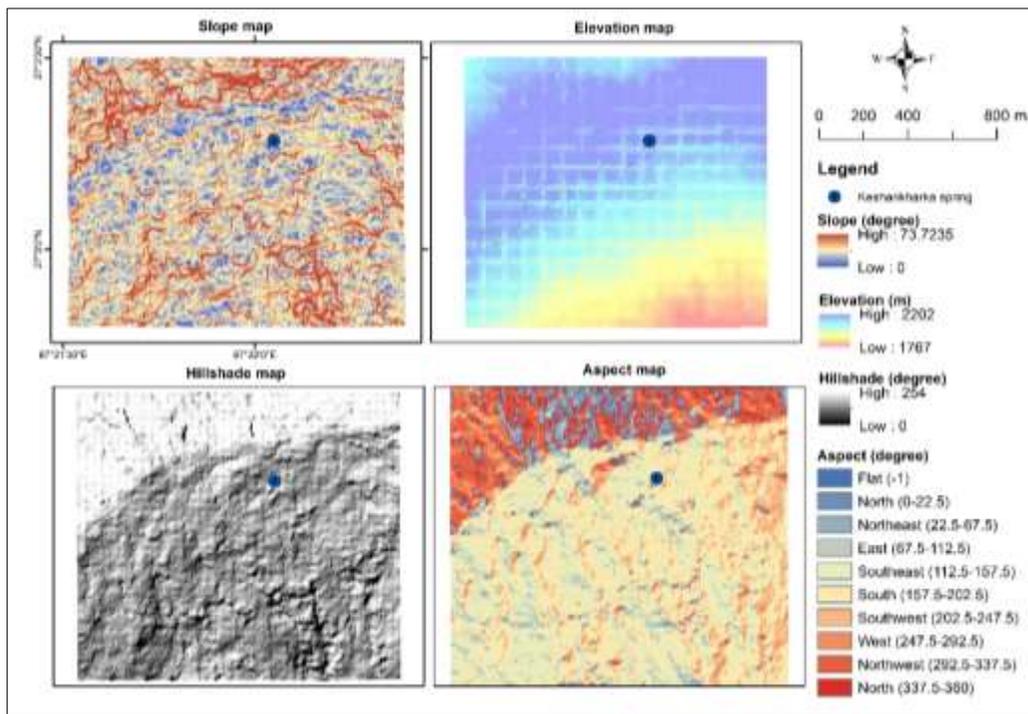
Figure 18: Kesharikharka spring overlying in Slope, Elevation, Hillshade and Aspect maps.

The landscape showcases a remarkable range in elevation and slope angles. Slopes vary dramatically, from completely flat (0°) to a challenging 73.72° . Steeper slopes are particularly dominant in a northwest-southeast direction, while the rest of the region features a mix of moderate and gentle slopes. This diversity extends to elevation as well, with a significant difference between the highest point in the northwest (2202 meters) and the lowest point in the southwest (1767 meters). Additionally, the dominant slope aspect falls between southeast and southwest, with a limited area facing north (Figure 18).

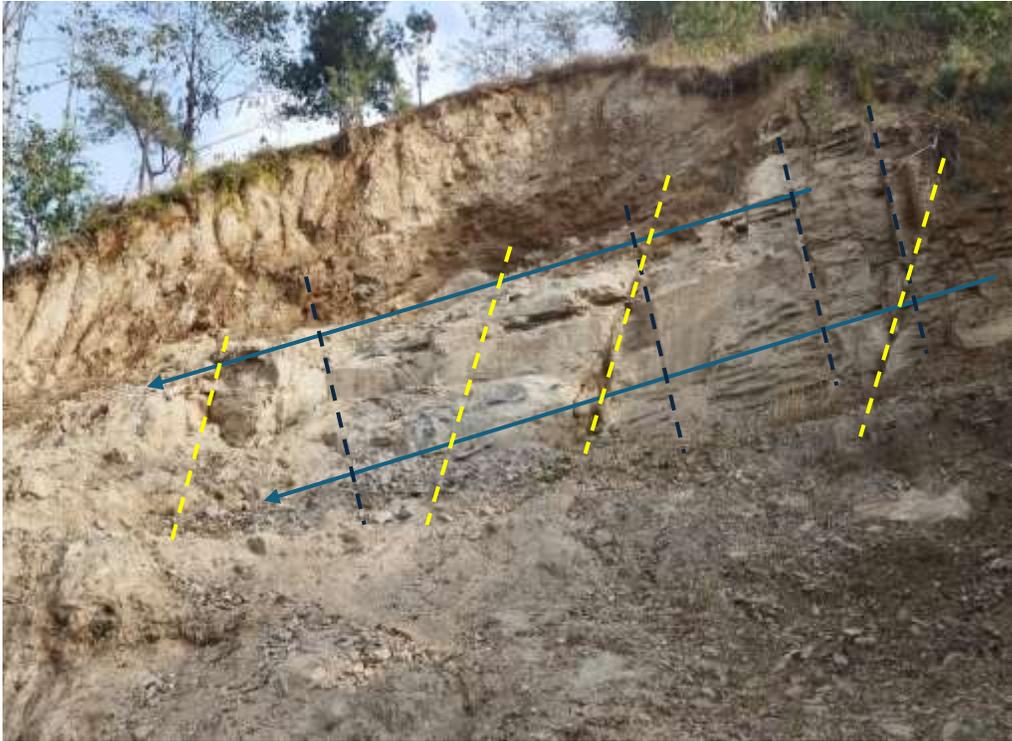
Photo 4: A representative cross-sectional view of rock exposure observed near Gurase ridgeline.

A representative cross-sectional view of rock exposure observed near Gurase ridgeline was taken for the visualization of real field conditions (Photo 4). Then a 3D conceptual model with rock discontinuities (color lines) and Kesharikharka spring (blue arrow) with the help of attitude data extracted from the available rock exposures in the area (Figure 19). Later, the data again plotted in Google Earth which shows rock discontinuities and spring in the Kesharikharka area (Figure 20). Lastly, the recharge area delineated will be utilized for conservation activities (Figure 21).

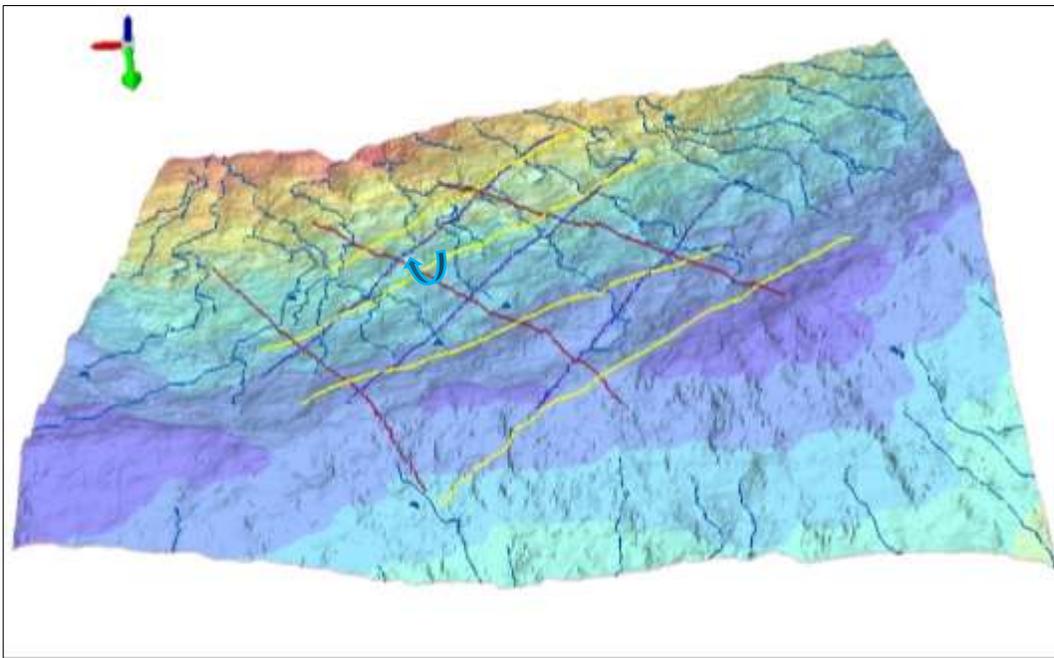
Figure 19: 3D conceptual model with rock discontinuities (colorful lines) near Kesharikharka spring (blue arrow).

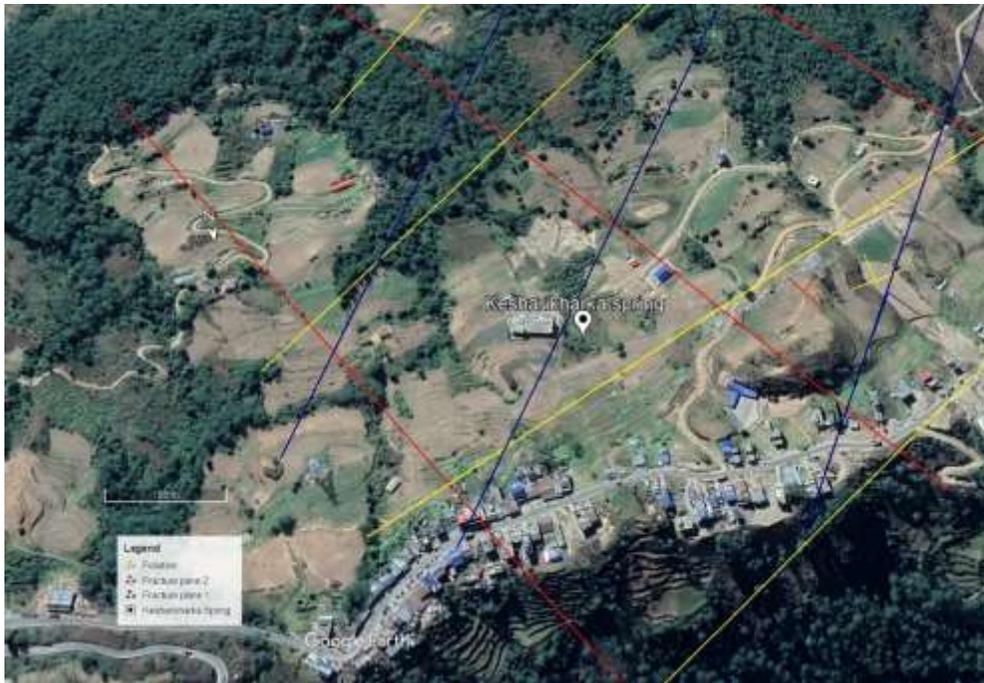
Figure 20: Google Earth image showing rock discontinuities (colorful lines) near Kesharikharka spring.

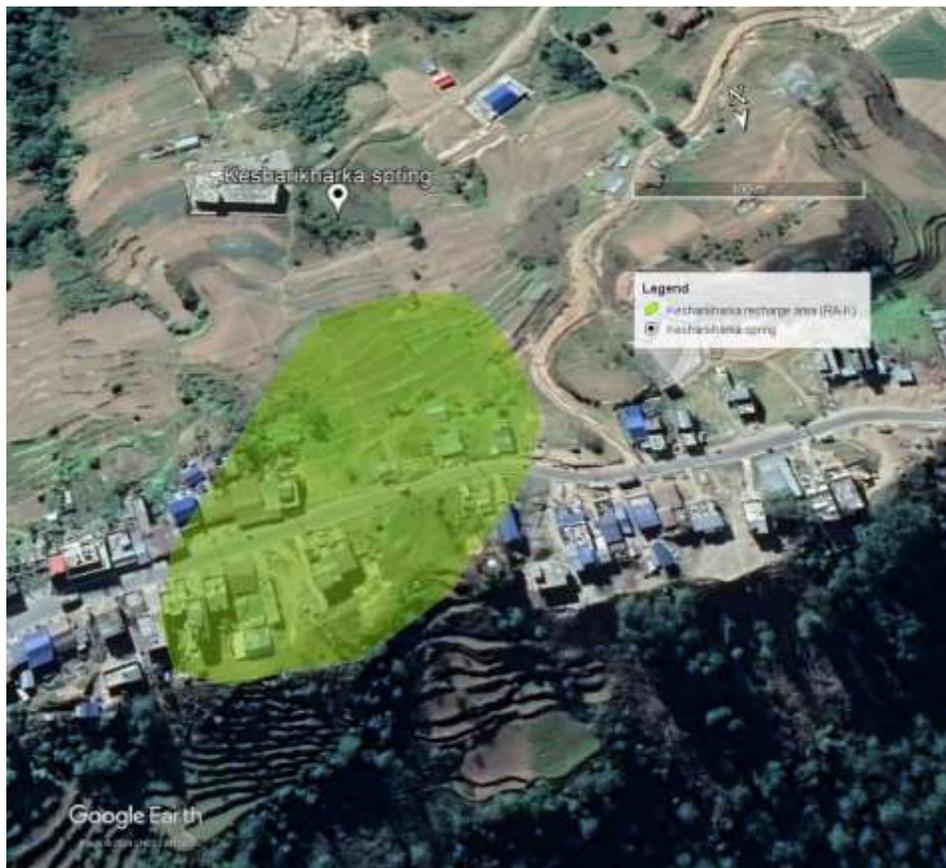
Figure 21: Estimated recharge zone for Kesharikharka spring.

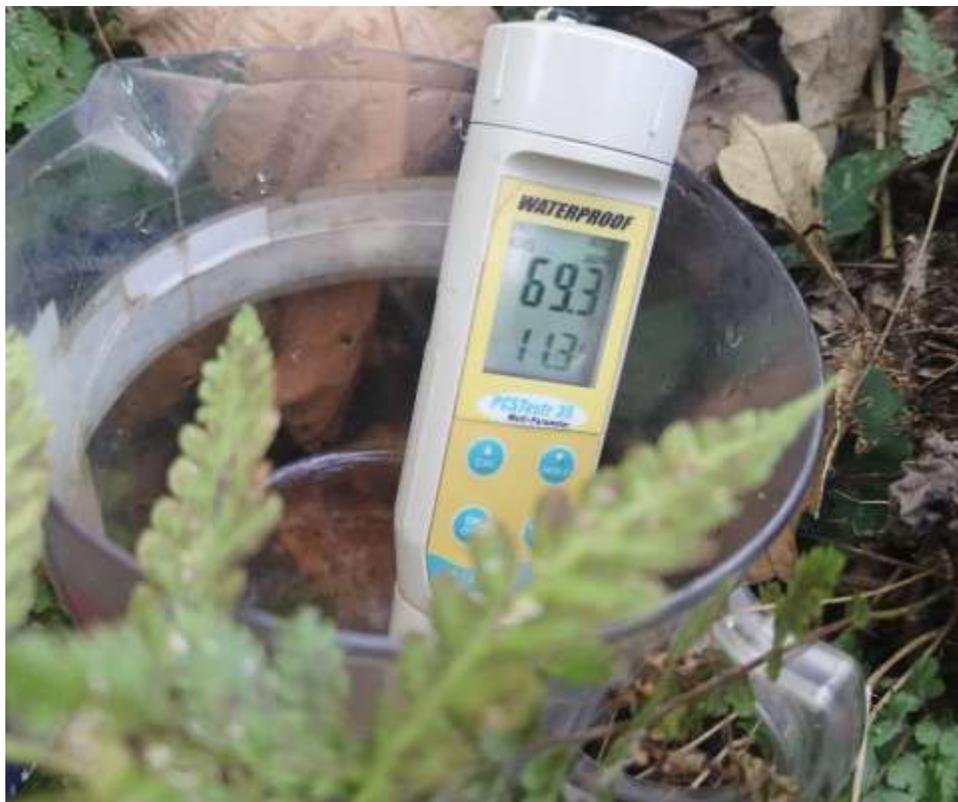
Photo IV: Measuring in-situ water quality parameters with the help of handheld PCSTestR.

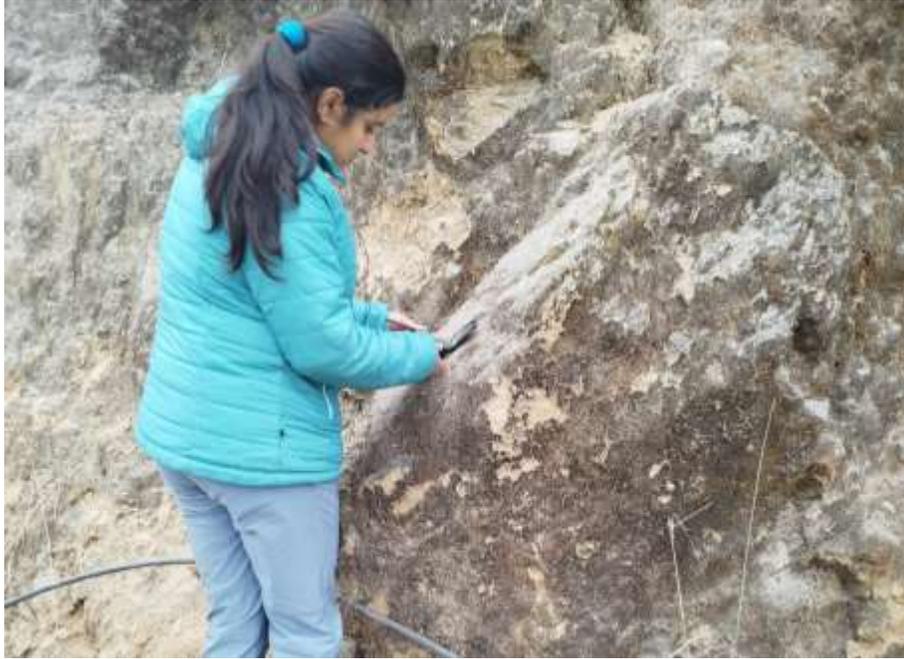
Photo V: Measuring the orientation of rock discontinuities in Dhwoje area with the help of Brunton compass.
