District Opportunity Report

- **Green Corridor
Demonstration Project
(GCDP)**
- **Grant No.: Grant 0977-TAJ**
- **Contract No. CS-04 Green
Roads Design Advisory**

*Joint Venture MetaMeta Research
B.V. & Muhandisoni Rohnamo LLC*

18 December 2025

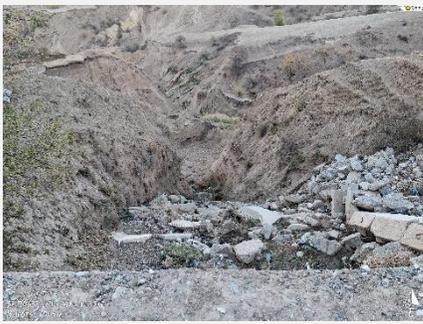
1	~ 1.1 km	38.70638 69.69480	Erosion of the slope at the outlet of the culvert	At the outlet of the reinforced concrete pipe, erosion of the slope is observed, which may lead to further avalanche formation and increased damage in the future.

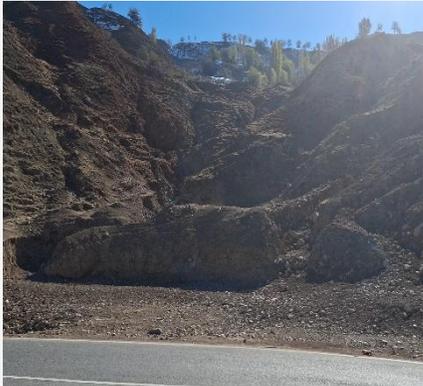
2	~ 1.6 km	38.70330 69.69847	Collapse-erosion process	Heavy rainfall caused erosion of the slope, resulting in the accumulation of a significant amount of debris. Rocks and soil may spill onto the roadside, posing a risk to traffic.

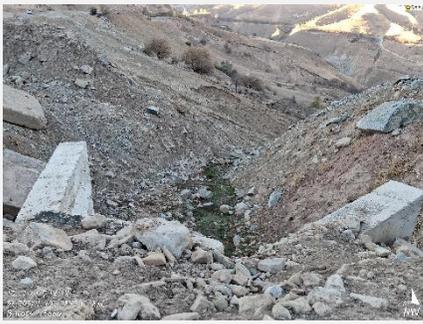
3	~ 1.6 km	38.70329 69.69857	Erosion of the slope at the outlet of the culvert	At the outlet of the reinforced concrete pipe, erosion of the slope is observed, which may lead to further avalanche formation and increased damage in the future.

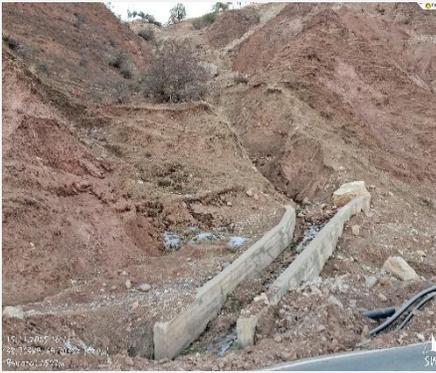
4	~ 2.1 km	38.70346 69.70279	Landslides and erosion on slopes	Heavy rains caused landslides, which may subsequently lead to mudslides that could obstruct traffic and wash away the road in this section.

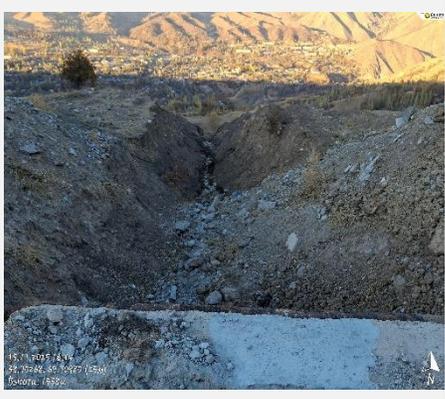
5	~ 2.1 km	38.70268 69.70980	Erosion of the slope at the outlet of the culvert	At the outlet of the reinforced concrete pipe, erosion of the slope is observed, which may lead to further avalanche formation and increased damage in the future.

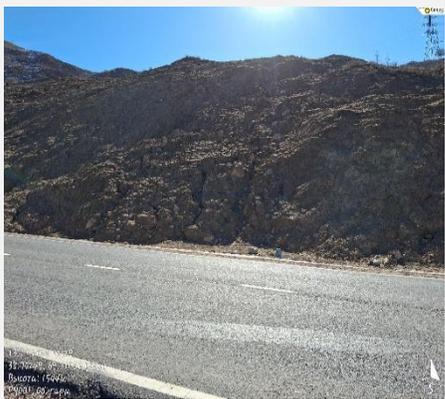
6	~ 2.75 km	38.70260 69.71012	Landslide process	After heavy rainfall, landslides are observed on the slope.

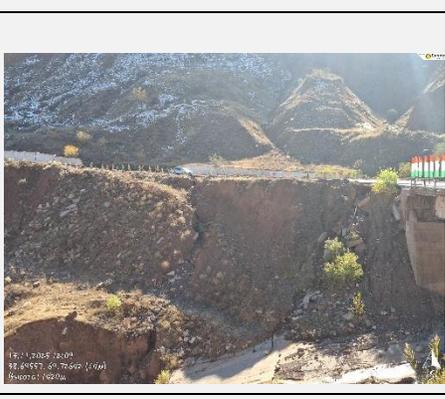
7	~ 7.3 km	38.69552 69.72632	Sliding and breaking off on slopes

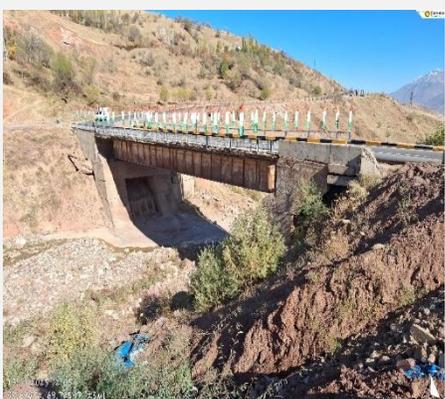
8	~ 7.3 km	38.69482 69.72597	Sliding and breaking off on slopes	On the right and left banks of the bridge, erosion and crumbling of the slope under the abutment can be observed - part of the soil has slid down towards the riverbed. During heavy rains and floods, the bridge may lose its support.

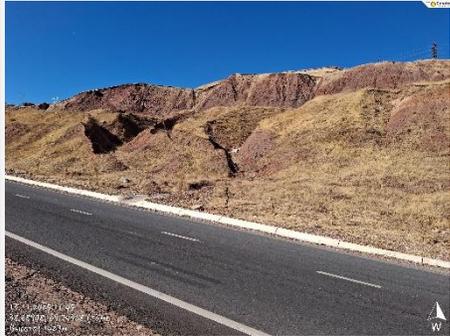
9	~ 9.1 km	38.68908 69.74368	Slope washout and erosion	Deep ditches formed on the slope. The mudslide came right up to the edge of the road.

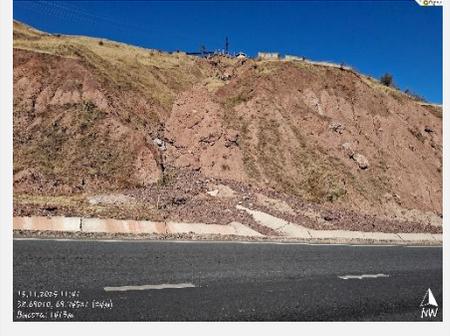
10	~ 9.4 km	38.69010 69.74521	Landslide process	Heavy rains caused landslides, resulting in the accumulation of a significant amount of debris. Rocks and soil partially spilled onto the roadside, posing a risk to traffic.

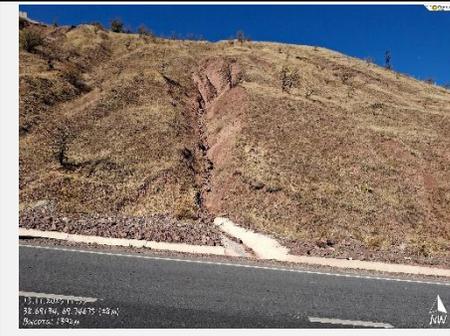
11	~ 9.6 km	38.69134 69.74675	Slope washout and erosion	Deep ditches formed on the slope. Mudslides reached the edge of the road. The presence/absence of minimal vegetation cover does not provide sufficient soil stabilization by the root system, which contributes to the progression of erosion and a decrease in slope stability.

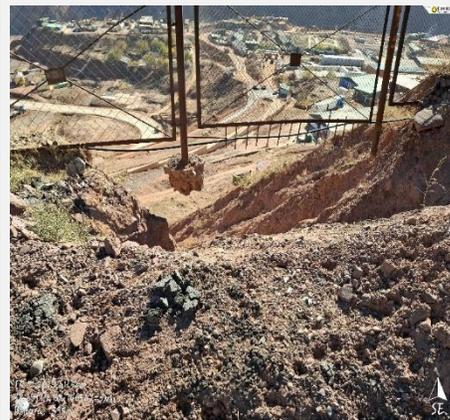
12	~ 9.7 km	38.69119 69.74656	Slope washout and erosion	Soil erosion and slope collapse occurred, resulting in part of the fence support base being washed away and left hanging in the air. Slope erosion can cause a reduction in the width of the roadside and destruction of the road section.

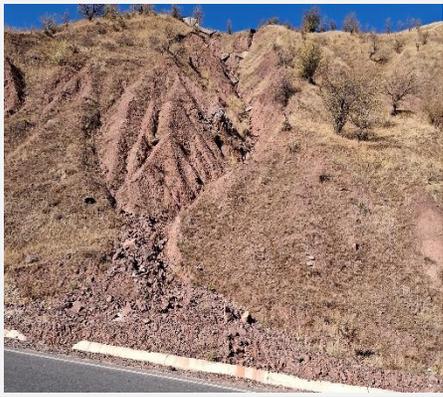
13	~ 9.7 km	38.69110 69.74648	Slope washout and erosion	Deep ditches formed on the slope. Mudslides reached the edge of the road. The presence/absence of minimal vegetation cover does not provide sufficient soil stabilization by the root system, which contributes to the progression of erosion and a decrease in slope stability.

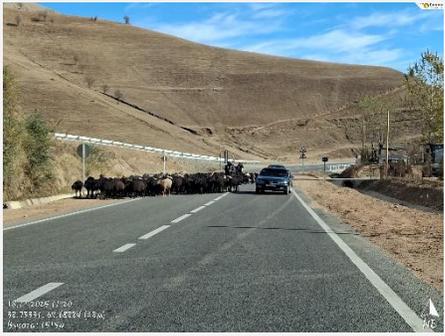
State Road Obigarm-Nurobod					
#	Distance from point zero	GPS Coordinates	Type of issue	Description and community remarks	Photo
0	0		N.A.	N.A.	N.A.
1	~ 2.9 km	38.73331 69.68884	Domestic animals on the roads	Livestock moves along the road and damages the roadside vegetation, creating obstacles and potential hazards for traffic.

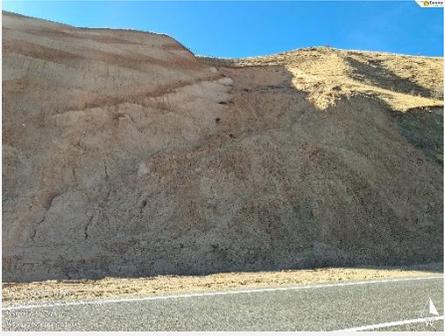
2	~ 10.0 km	38.76828 69.70103	Slope slippage and erosion	Heavy rains caused landslides, which may subsequently lead to mudslides that could obstruct traffic and wash away the road in this section.

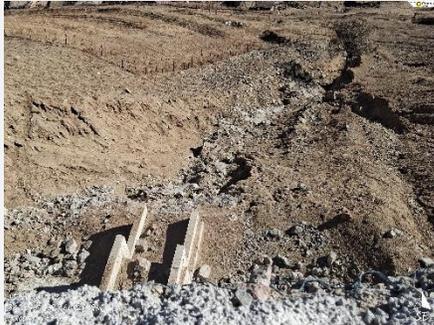
3	~ 20.4 km	38.80465 69.76610	Erosion of the slope at the outlet of the culvert	At the outlet of the reinforced concrete pipe, erosion of the slope is observed, which may lead to further avalanche formation and increased damage in the future, which could damage houses located at the bottom of the slope.

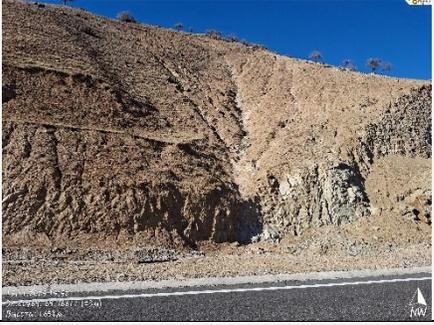
4	~ 20.4 km	38.80469 69.76611	Slope slippage and erosion	After heavy rainfall, landslides are observed on the slope.

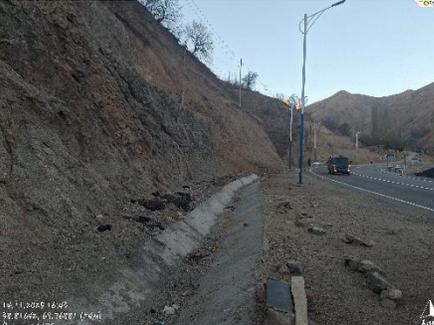
5	~ 21.8 km	38.81642 69.76881	Construction waste on the roadside	After the renovation work, construction waste was dumped on the roadside.

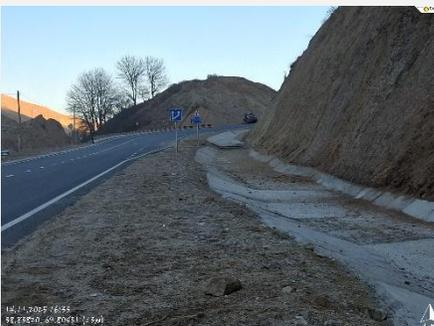
6	~ 26.6 km	38.83820 69.80431	Soil erosion and erosion on slopes	The slope has a very steep angle, which increases the likelihood of landslides. Traces of recent soil displacement, lack of vegetation and uneven surface are visible. Repeated rainfall may cause mudslides.

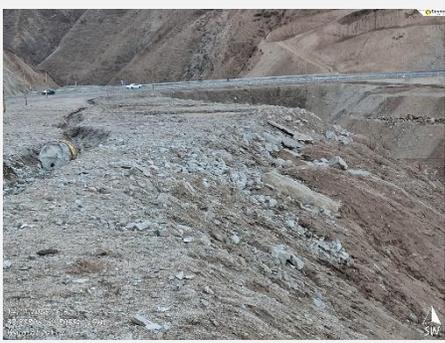
7	~ 26.7 km	38.83806 69.80332	Construction waste on the roadside	There is rubbish on the slope that was left behind after renovation work.

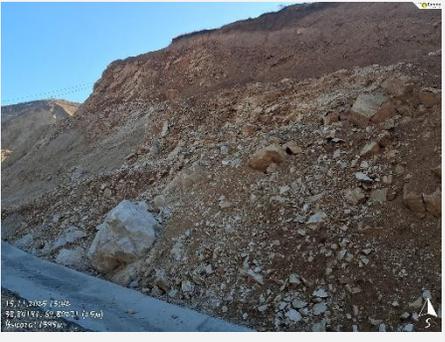
8	~ 27.7 km	38.84191 69.80271	Collapse-erosion process	Heavy rainfall caused erosion of the slope, resulting in the accumulation of a significant amount of debris. Rocks and soil may spill onto the roadside, posing a risk to traffic.

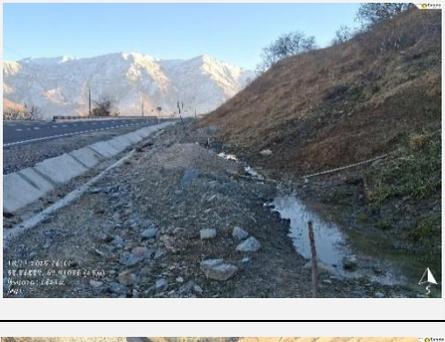
9	~ 45.2 km	38.86889 69.91036	Flooding of the slope due to lack of drainage	Flooding is observed on the roadside. The absence of a drainage system may lead to flooding and destruction of the road surface.

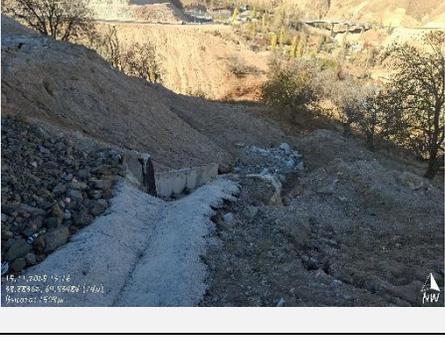
10	~ 49.1 km	38.88362 69.93484	Erosion of the slope at the outlet of the culvert	At the outlet of the reinforced concrete pipe, erosion of the slope is observed, which may lead to further avalanche formation and increased damage in the future.

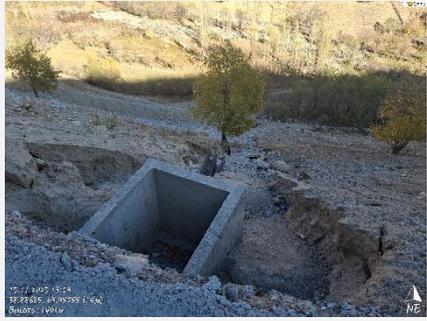
11	~ 51.9 km	38.88685 69.95055	Erosion of the slope at the outlet of the culvert	At the outlet of the reinforced concrete pipe, erosion of the slope is observed, which may lead to further avalanche formation and increased damage in the future.

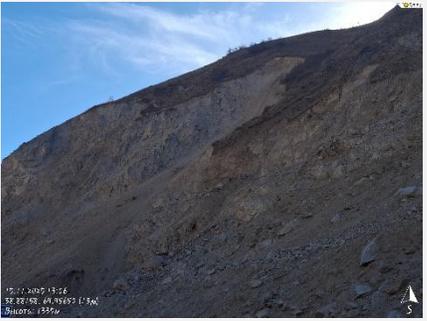
12	~ 52.6 km	38.88158 69.95650	Landslide process	Heavy rains caused landslides, which may subsequently lead to mudslides that could obstruct traffic and wash away the road in this section.

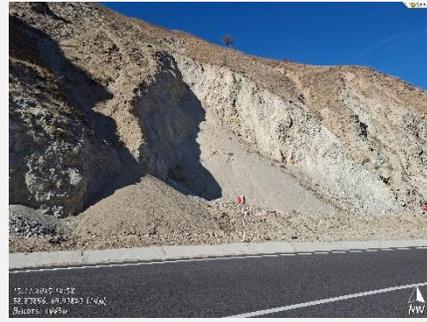
13	~ 55.9 km	38.87856 69.97827	Landslide process	Heavy rains caused landslides, which may subsequently lead to mudslides that could obstruct traffic and wash away the road in this section.

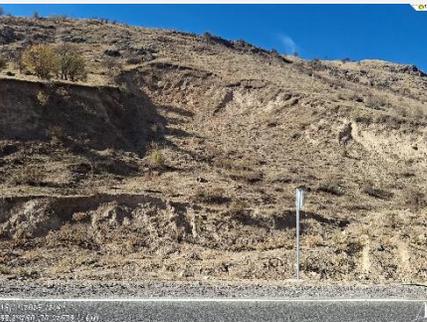
14	~ 62.014 km	38.89250 70.02573	Soil erosion and erosion on slopes	Deep ditches formed on the slope. Mudslides reached the edge of the road. The presence/absence of minimal vegetation cover does not provide sufficient soil stabilization by the root system, which contributes to the progression of erosion and a decrease in slope stability.

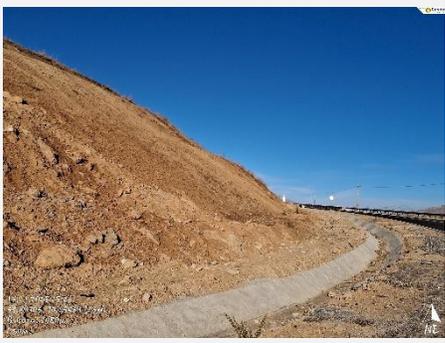
15	~ 65.7 km	38.89703 70.05439	Slope washout and erosion	The slope has a very steep angle, which increases the likelihood of landslides. Traces of recent soil displacement, lack of vegetation and uneven surface are visible. Repeated rainfall may cause mudslides.

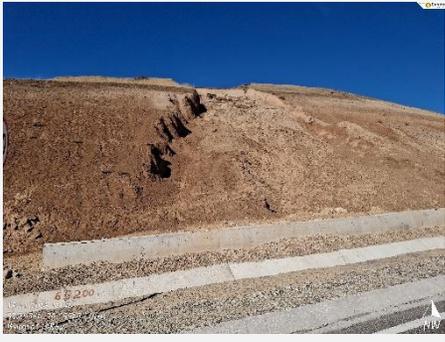
16	~ 65.8 km	38.89742 70.05527	Slope slippage and erosion	Heavy rains caused landslides, which may subsequently lead to mudslides that could obstruct traffic and wash away the road in this section.

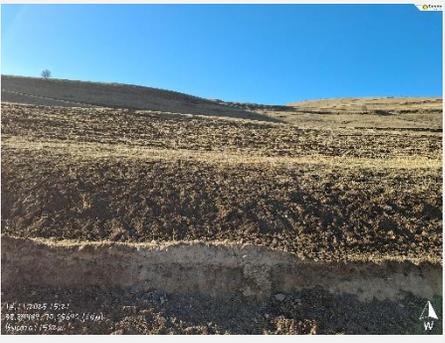
17	~ 66.0 km	38.89949 70.05690	Slope slippage and erosion	After heavy rainfall, landslides are observed on the slope.

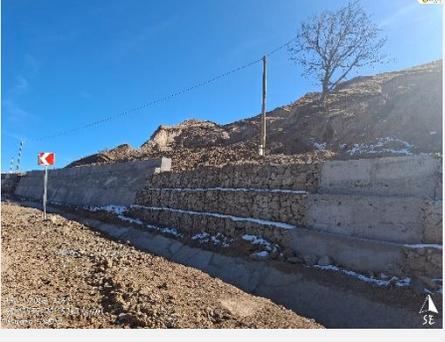
18	~ 67.1 km	38.90535 70.05767	Slope slippage and erosion	After heavy rains, landslides formed on the slope, and there is a risk that subsequent mudflows could damage the gabion wall and lead to its partial or complete destruction.

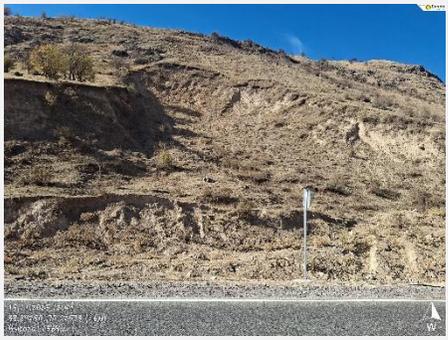
19	~ 71.8 km	38.91486 70.08239	Slope slippage and erosion	After heavy rainfall, landslides are observed on the slope.

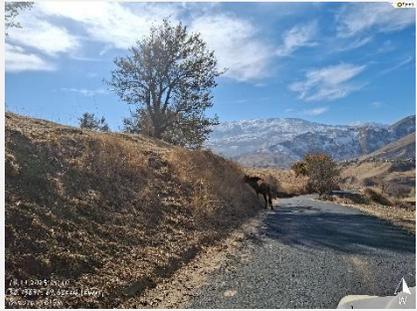
Non-state road to the village of Dehqonobod					
#	Distance from point zero	GPS Coordinates	Type of issue	Description and community remarks	Photo
0	0		N.A.	N.A.	N.A.
1	~ 880 m	38.73631 69.68224	Cow on the road	The cow is on the right side of the road, which may obstruct traffic and damage green areas.

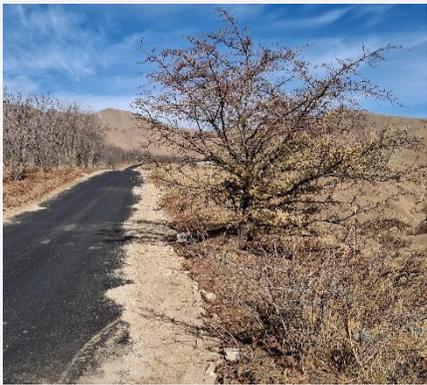
2	~ 1.3 km	38.73983 69.68295	Tree on the roadside	The tree on the right-hand side of the road may obstruct traffic in the future.

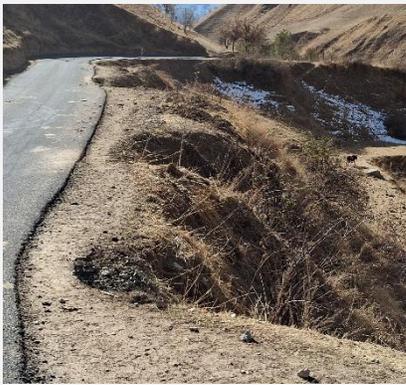
3	~ 2.8 km	38.75251 69.68363	Slope erosion	Due to heavy rains, the slopes have been washed away and the newly laid asphalt may be damaged. Local residents cannot walk along this roadside.

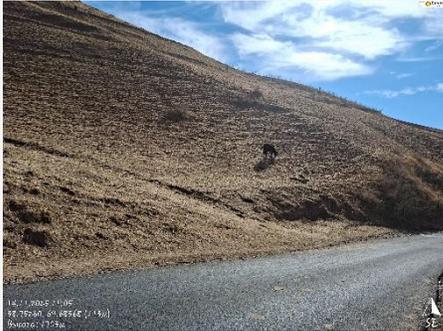
4	~ 2.8 km	38.75260 69.68368	Landslide process	After heavy rainfall, landslides are observed on the slope.

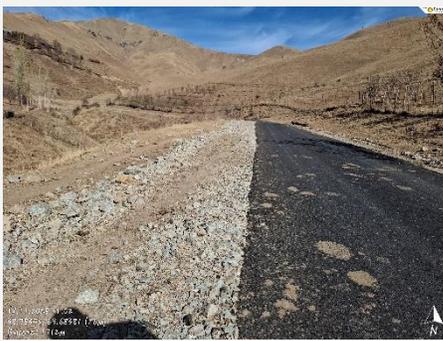
5	~ 2.9 km	38.75479 69.68350	Cow dung and large stones on the road	Cow dung on the road can damage new asphalt. Large stones have been thrown onto the roadside.

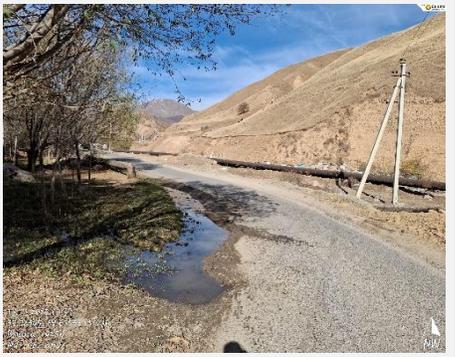
1	~ 0.9 km	38.72345 69.67536	Waterlogging due to lack of drainage	The flooding on the left side of the road is caused by a lack of proper drainage. This makes it difficult to drive on the road and, over time, leads to damage to the road surface.

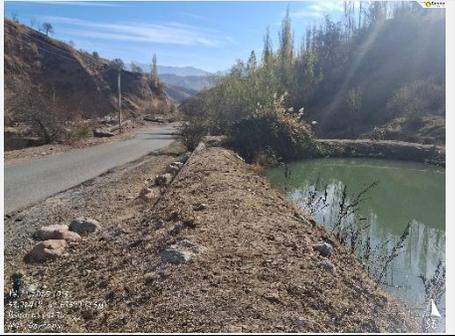
2	~ 1.0 km	38.72419 69.67397	The pond on the left side of the road	The pond is located on the left side of the road. During heavy rains, water from the pond flows onto the road, which may damage the road in the future and increase the load on the road.

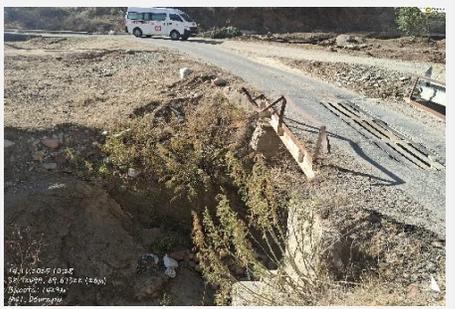
3	~ 1.1 km	38.72480 69.67315	Destruction of bridge support	The bridge supports have been damaged by severe landslides. Crossing the bridge is dangerous for road vehicles and there is a possibility that the bridge could collapse.

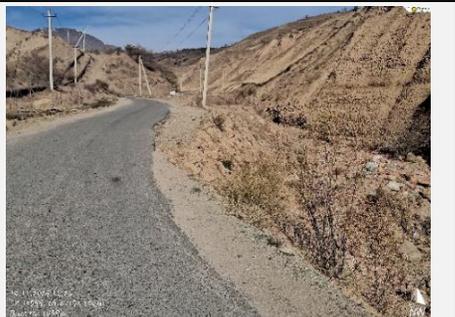
4	~ 1.3 km	38.72599 69.67252	Sliding and slope failure	On the right side of the road, erosion and crumbling of the embankment can be observed. During heavy floods, the road may be destroyed.

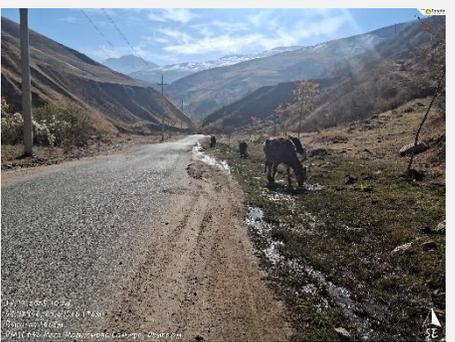
5	~ 1.8 km	38.72936 69.67016	Cows along the road	Domestic animals left unattended on the left side of the road make driving unsafe.

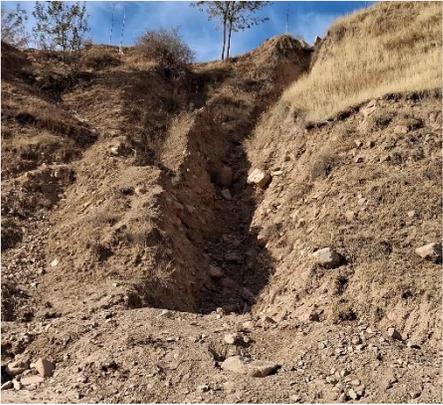
6	~ 2.7 km	38.73198 69.66673	Slope washout and erosion	Deep ditches formed on the slope. Mudslides reached the edge of the road. The presence/absence of minimal vegetation cover does not provide sufficient soil stabilization by the root system, which contributes to the progression of erosion and a decrease in slope stability.

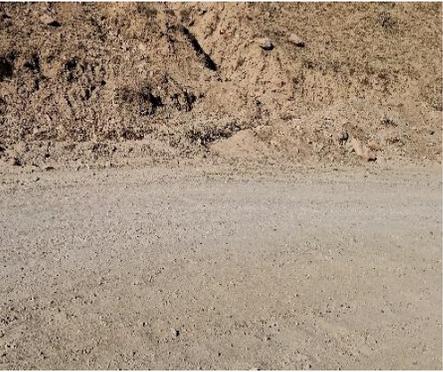
7	~ 2.7 km	38.73182 69.66677	Unpaved section	Due to land issues, some sections of the road do not have asphalt pavement.

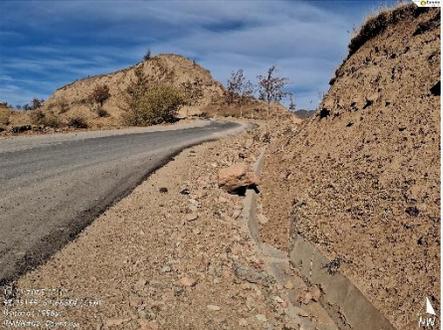
8	~ 2.8 km	38.73135 69.66684	The trough is full due to a landslide.	On the right side of the road, there is a partial collapse of the embankment. Loose soil from the slope has slid towards the drainage channel and partially blocked it. The blocked channel will cause water to flow onto the road and damage the surface.

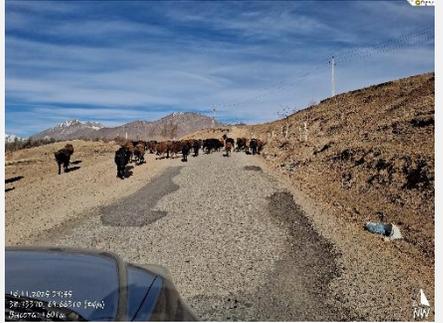
9	~ 3.2 km	38.73370 69.66310	Domestic animals on the roads	Domestic animals are moving along the road, which may hinder traffic.

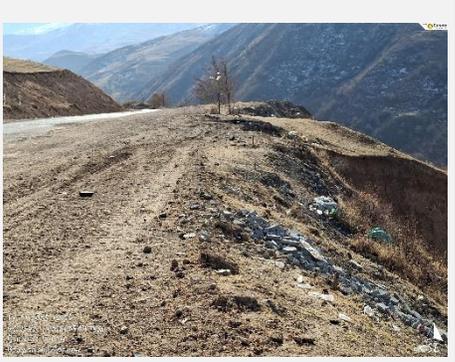
10	~ 3.3 km	38.73421 69.66258	Litter on the roads	There is rubbish on the embankment on the left side of the road.

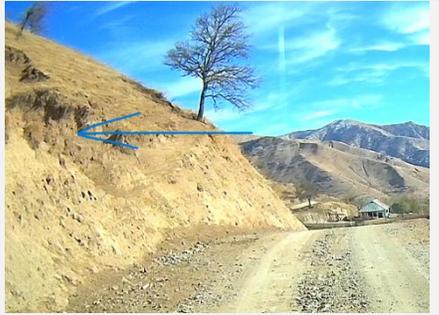
Non-state road to the village of Sangi surkh					
#	Distance from point zero	GPS Coordinates	Type of issue	Description and community remarks	Photo
0	0		N.A.	N.A.	N.A.
1	~ 400 m	38.79362 69.75510	Erosion and erosion of the slope	On the left side of the road, there is a deep ditch on the slope. The absence of vegetation cover provides insufficient soil anchorage.

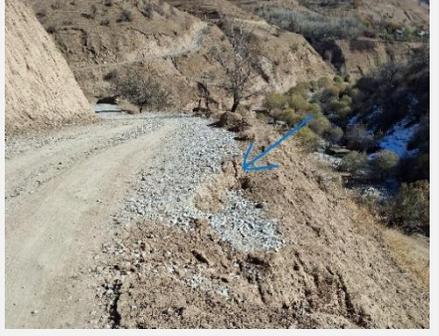
2	~ 1.1 km	38.79324 69.76116	Landslide process	After intense precipitation, landslides occur on the slope. If this continues, the slope may collapse, blocking movement for local residents.

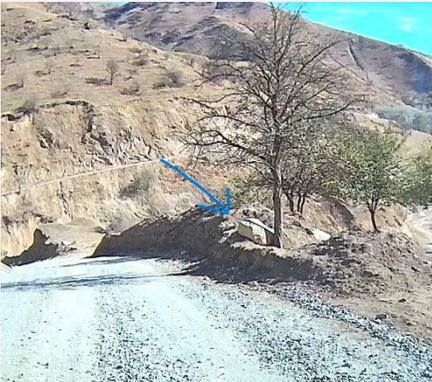
3	~ 1.2 km	38.79360 69.76275	Dry ground, stone near the tree and deterioration of vegetation conditions	Due to dry soil conditions, trees cannot grow. The few trees that were planted are deteriorating without proper care. A large stone next to one tree is damaging it and preventing its development.

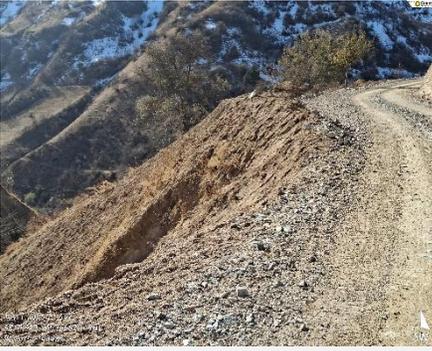
4	~ 1.8 km	38.79327 69.76667	Slope erosion and erosion	Erosion and slope crumbling are visible on the left side of the road. Heavy rains may further damage the road.

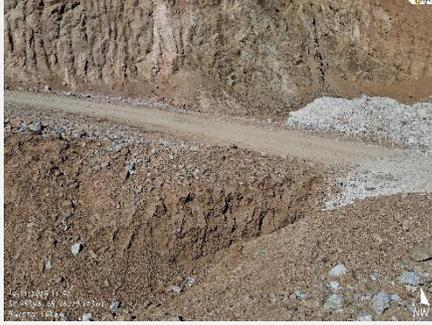
5	~ 1.9 km	38.79346 69.76719	Drake skidding and the absence of a reinforced concrete pipe	A mudflow destroyed the road. A reinforced concrete pipe for water drainage is missing in this section. The damaged area is filled with gravel.

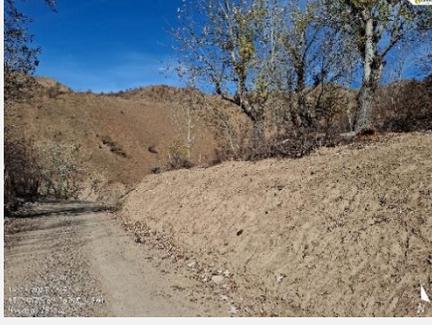
6	~ 2.0 km	38.79279 69.76748	Vertical slope and withered trees	The slope is vertical and the soil is compact, preventing water absorption. It is not possible to plant trees on such a slope. Several dried trees are visible at the top.

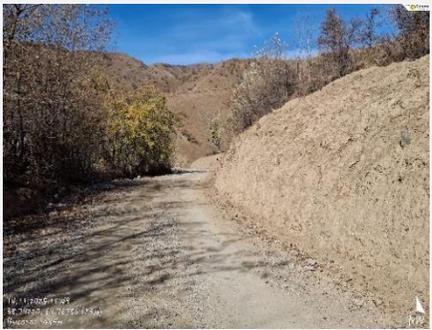
7	~ 2.1 km	38.79220 69.76786	Vertical slope	The slope is vertical and the soil is too hard to absorb rainwater, making tree planting impossible.

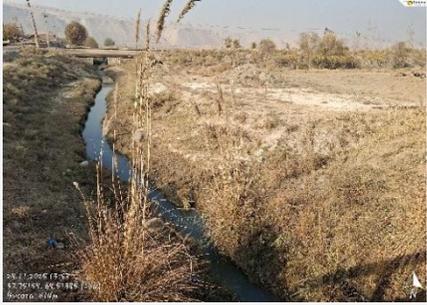
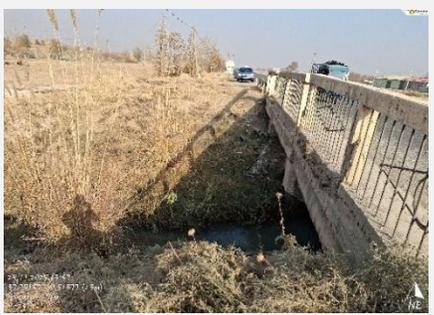
State Road Guliston-Kulob					
#	Distance from point zero	GPS Coordinates	Type of issue	Description and community remarks	Photo
0	0		N.A.	N.A.	N.A.
1	~ 2.0 km	37.75159 69.51385	Improper maintenance of the drainage canal and territory	The channel bed has not been cleared of vegetation, as a result of which the water continues to stagnate, and the capacity of the canal is significantly reduced.

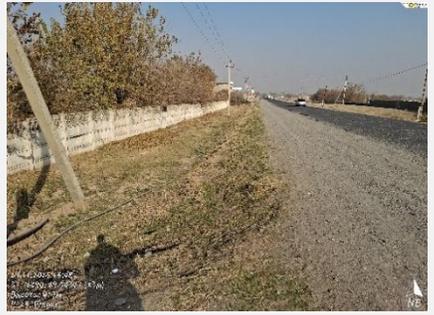
3	~ 5.2 km	37.76890 69.54347	Unused area suitable for landscaping	On the left side of the road, there is an area that can be used for planting trees and other vegetation in the future.

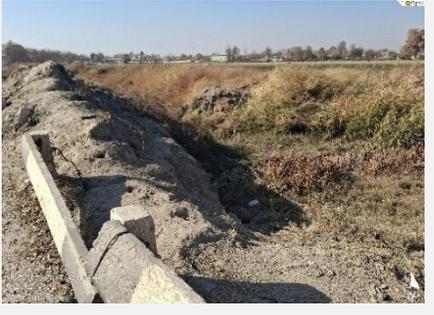
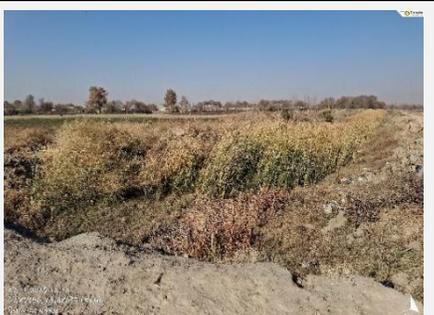
4	~ 7.4 km	37.80902 69.68642	Improper maintenance of the drainage canal and territory (garbage + uncleared vegetation).	After cleaning the canal bed, all the collected garbage was thrown onto the edge of the roadway. In addition, the channel bed has not been cleared of vegetation, which is why the water continues to stagnate and the capacity of the canal deteriorates.

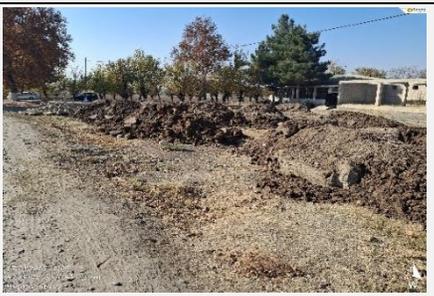
6	~ 10.9 km	37.83178 69.71307	Construction waste	Construction work was carried out on the territory, after which all the resulting construction waste was stored on the edge of the roadway. This worsens the condition of the surrounding area and violates landscaping standards.

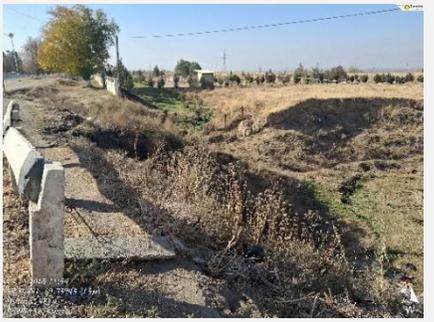
7	~ 13.6 km	37.84441 69.73943	Improper maintenance of the drainage canal and discarded household garbage on the slopes of the canal	There is household garbage on the slopes and the channel bed. In addition, the channel bed has not been cleared of overgrown vegetation, as a result of which the water stagnates, the normal flow is disrupted and the capacity of the canal decreases.

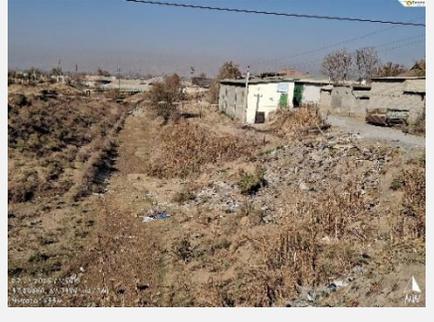
9	~ 15.4 km	37.85685 69.75347	Erosion and slide of the road slope, discarded garbage	On the left side of the road, erosion and crumbling of the slope is observed. In case of heavy precipitation, there is a risk of further destruction of the slope and possible damage to the roadway. In addition, there is discarded garbage on the roadside, which can increase the risk of environmental pollution.

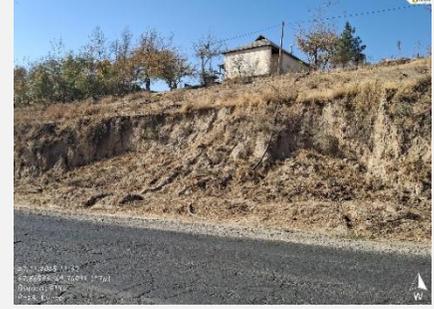
10	~ 16.6 km	37.86533 69.76091	Landslide process	After heavy rains, landslides formed, which in the future mudslides can impede traffic and wash away the road in this area.

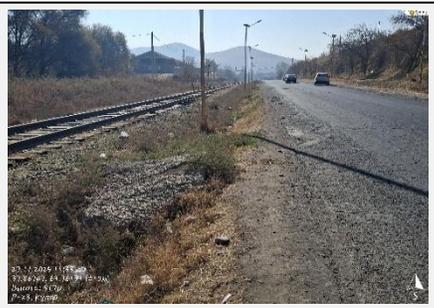
11	~ 16.9 km	37.86747 69.76139	Dried concrete on the roadside and the condition of vegetation	On the left side of the road, on the side of the road, there is dried concrete, which was probably thrown out by concrete mixers. This worsens the condition of vegetation in this area and disrupts the ecological improvement.

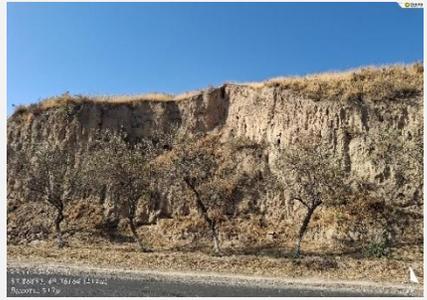
12	~ 17.0 km	37.86837 69.76164	Erosion and erosion Slope	The surrounding area has a vertical slope, which increases the likelihood of scree. Traces of soil displacement, lack of vegetation and uneven surface are visible. With intense rains, mudflows are possible, which can damage trees.

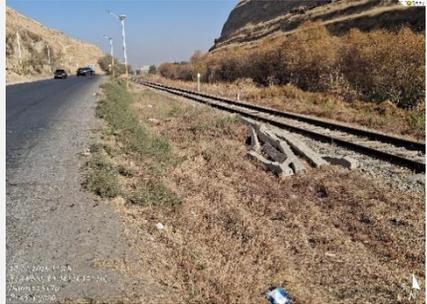
13	~ 17.1 km	37.86900 69.76176	Erosion and landslide of the road slope	On the right side of the road, there is a slide of the slope. There is a risk of further destruction of the slope and possible damage to the roadway. In addition, discarded concrete sleepers of the railway are observed on the roadside.

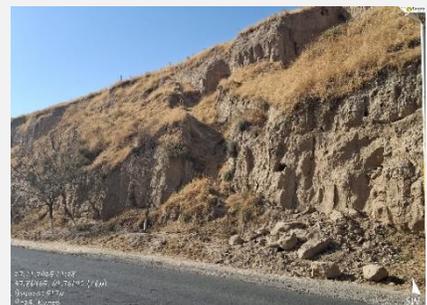
14	~ 17.2 km	37.86965 69.76190	Landslide process	After heavy rains, landslides formed, which caused the accumulation of a significant amount of detrital material. Stones and soils have partially come to the side of the road, which poses a risk to the road.

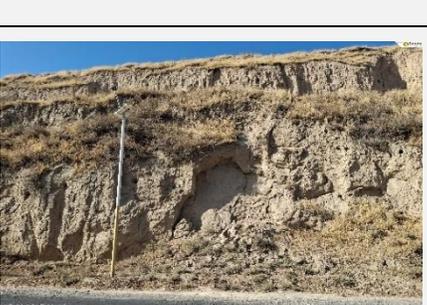
15	~ 17.2 km	37.87041 69.76208	Erosion and erosion of the slope	As a result of heavy rains, the slope is destroyed, which increases the risk of further scree and poses a threat to traffic on the road.

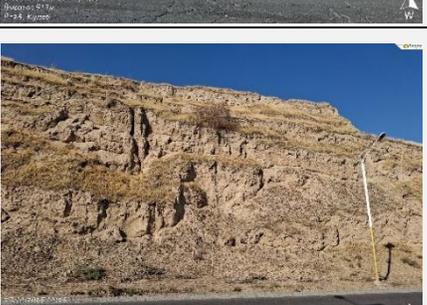
16	~ 17.4 km	37.87192 69.76271	Landslide process and vertical slope	After intense precipitation, there are landslide processes on the slope. The adjacent territory has a vertical slope, rainwater can lead to the emergency formation of the slope.

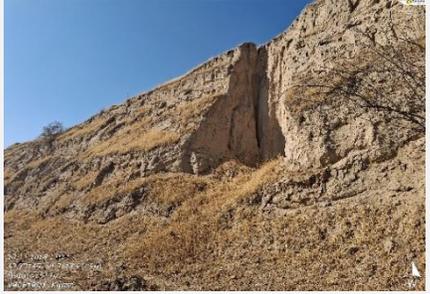
17	~ 17.5 km	37.87235 69.76289	Erosion and erosion Slope	Deep ditches formed on the slope. The presence/absence of a minimum vegetation cover does not provide sufficient soil fixation by the root system, which contributes to the progression of erosion and a decrease in slope stability.

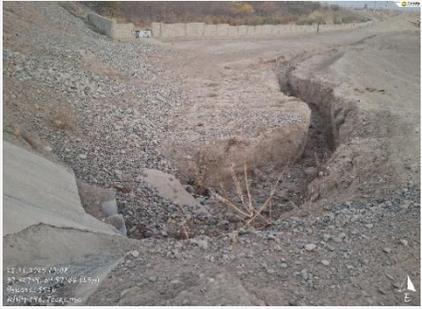
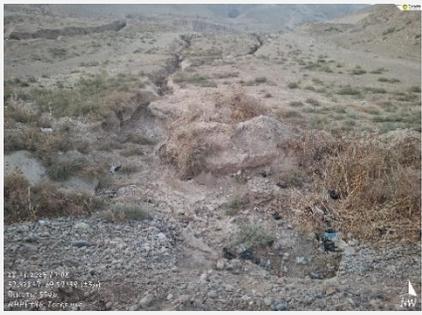
State Road Hulbuk-Temurmalik-Kangurt					
#	Distance from point zero	GPS Coordinates	Type of issue	Description and community remarka	Photo
0	0		N.A.	N.A.	N.A.
1	~ 17.9 km	37.92799 69.57144	Slope erosion at the inlet and outlet of the culvert	At the inlet and outlet of the culvert, erosion of the slope is observed, which may cause further damage in the future and increase in the volume of damage.

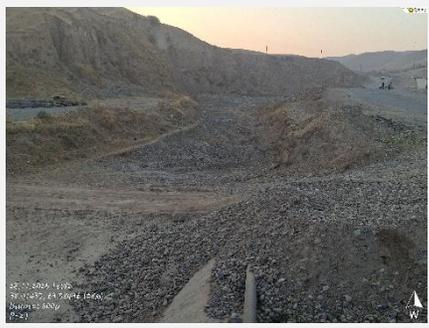
3	~ 28.2 km	38.01435 69.58496	Riverbed along the road is used for building materials	The riverbed is used as a quarry of building material, as a result of which there is a destruction of the road slope.

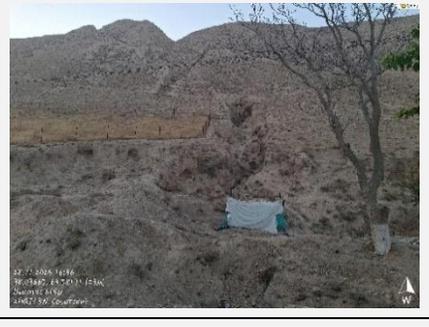
4	~ 30.8 km	38.03662 69.58171	Erosion and erosion of the slope	Deep ditches formed on the slope. The presence/absence of a minimum vegetation cover does not provide sufficient soil fixation by the root system, which contributes to the progression of erosion and a decrease in slope stability.

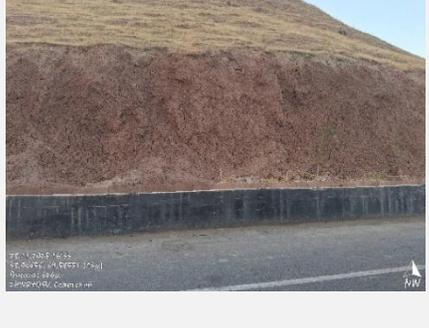
5	~ 31.7 km	38.04456 69.58551	Landslide process	After intense precipitation, landslide processes are observed on the slope. In case of their recurrence, the reinforced concrete channel can be filled with displaced soil masses and lose its capacity.

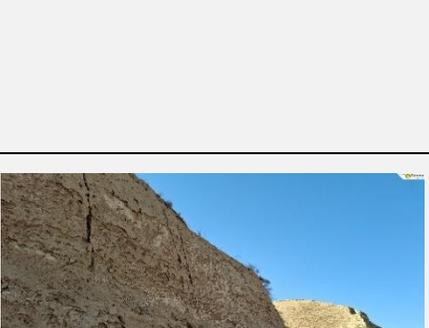
6	~ 35.0 km	38.07083 69.57998	Landslide process and vertical slope	After heavy rainfall, landslides have been observed on the slope. The slope is nearly vertical, and the lack of vegetation increases the risk of further slope failure.

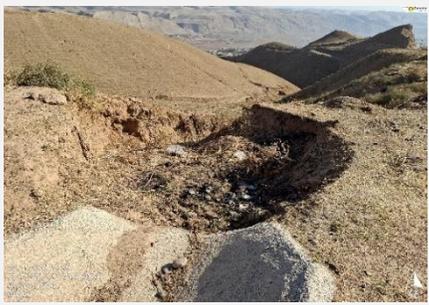
7	~ 35.3 km	38.07298 69.57905	Erosion of the slope after water leaves the concrete ditch	After the water exits the concrete ditch, it erodes the slope, which can lead to further gully formation and eventually damage the ditch.

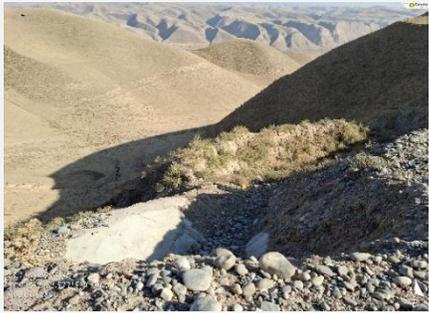
8	~ 36.0 km	38.07839 69.57715	Erosion of the slope at the outlet of the culvert and destruction of the road	At the outlet of the culvert, slope erosion is evident, which may lead to further gully development and increased deformation over time. Due to the intense water flow, the roadway was previously damaged and later restored through re-asphalting.

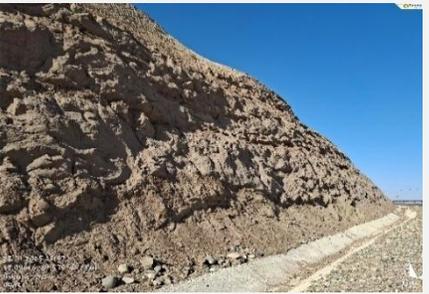
10	~ 37.9 km	38.09616 69.57514	Slope Slide and Erosion	After intense precipitation, collapse and crumbling are observed on the slope.

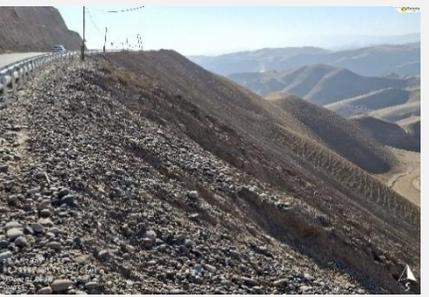
11	~ 39.1 km	38.10588 69.57630	Water erosion process	On the presented site, there is an intense water-erosion activity, manifested in the form of deep gullies, soil displacements and partial destruction of the slope. Signs of landslide processes and further destabilization of the slope surface are recorded.

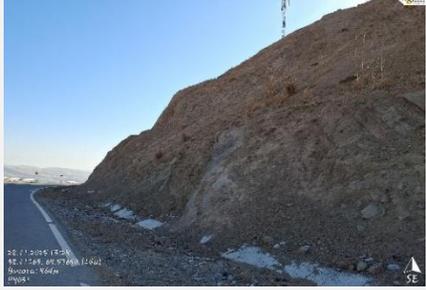
13	~ 39.7 km	38.11063 69.57650	Landslide process	After heavy rains, landslides and filling of tank ditches formed, which in the future mudslides can impede traffic and wash away the road in this area.

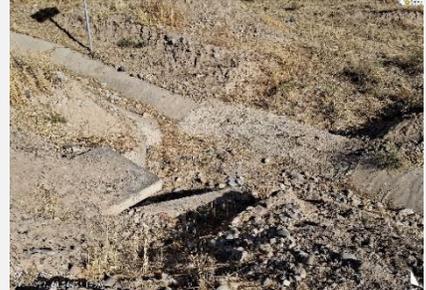
14	~ 53.2 km	38.22096 69.56450	Erosion of the slope at the outlet of the culvert and destruction of the road	As a result of the intense water flow, the roadway was destroyed and then restored by re-asphalting.

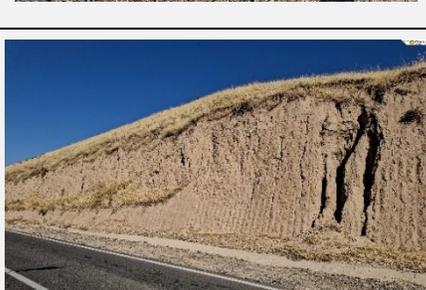
16	~ 55.0 km	38.2355869. 56104	Erosion and erosion Slope	Due to the lack of upland ditches, deep ditches have formed on the slope. The lack of a minimum vegetation cover does not provide sufficient soil consolidation by the root system, which contributes to the progression of erosion and a decrease in the stability of the slope.

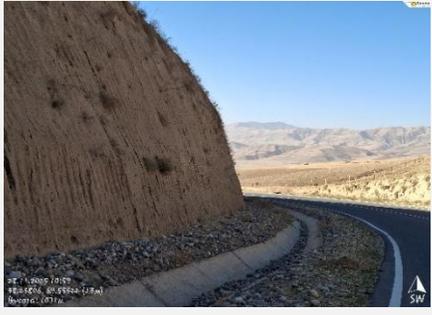
17	~ 55.6 km	38.2380669. 55522	Erosion and erosion of the slope	The surrounding area has a vertical slope, which increases the likelihood of scree. Traces of fresh displacement of the soil, lack of vegetation and uneven surface are visible.

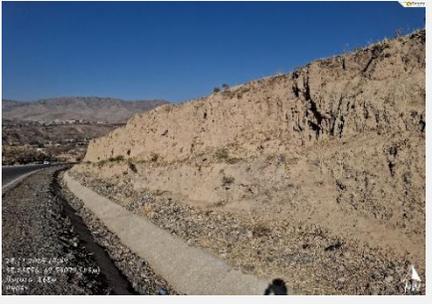
18	~ 58.1 km	38.2385669. 53079	Erosion and erosion Slope	Deep ditches formed on the slope. The presence/absence of a minimum vegetation cover does not provide sufficient soil fixation by the root system, which contributes to the progression of erosion and a decrease in slope stability.

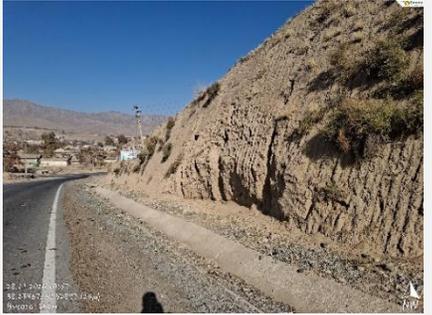
19	~ 58.3 km	38.23967 69.52897	Erosion and erosion Slope	The slope has an excessively steep slope, which increases the likelihood of scree. On the surface, you can see traces of fresh excavation made by local residents. With repeated precipitation, there is a risk of ravage formation and mudflows.

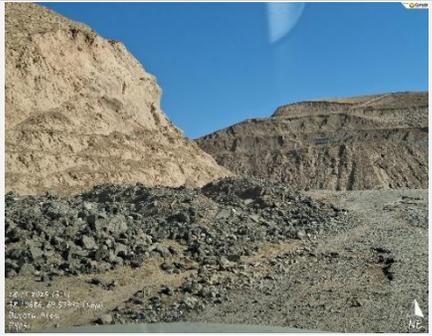
Non-state road to the village of Oftobrya Temurmalik District					
#	Distance from point zero	GPS Coord-inates	Type of issue	Description and community remarka	Photo
0	0		N.A.	N.A.	N.A.
1	~ 400 m	38.1068669. 57392	Construction debris on the side of the road	After the reconstruction of the Khulbuk–Temurmalik–Kangurt highway, construction debris was deposited along the roadside leading to the village.

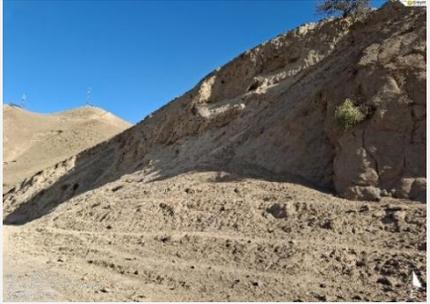
2	~ 457 m	38.1072369. 57362	Landslide process	Following heavy rains, landslides have occurred, and future mudflows could block traffic and potentially wash out this section of the road.

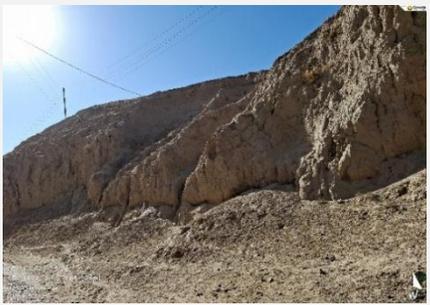
3	~ 1.1 km	38.11222 69.57262	Erosion and erosion Slope	The very limited vegetation cover offers insufficient root stabilization, accelerating erosion and reducing slope stability

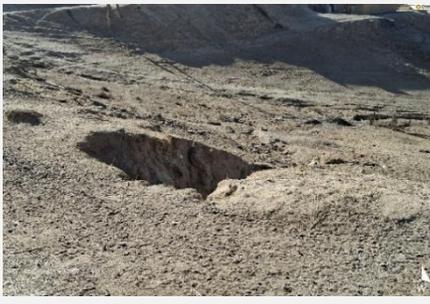
4	~ 1.15 km	38.11288 69.57287	Slope erosion	The damage on the slope continues to grow over time.

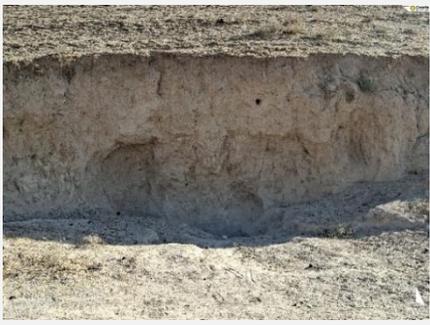
6	~ 2.18 km	38.1213869. 57717	Destruction and death of green spaces due to unfavorable soil conditions	The soil is very dry, so trees do not grow well. Even the trees that were planted with effort slowly die without proper care. The steep slopes also cause the roots to be exposed, which makes them dry out faster.

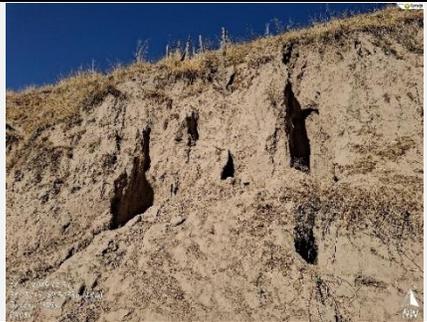
2	~ 350 m	38.1511569. 57357	Landslide process	After heavy rain, soil movement and small landslides occur. In the future, mud or soil could block the road or even damage it.

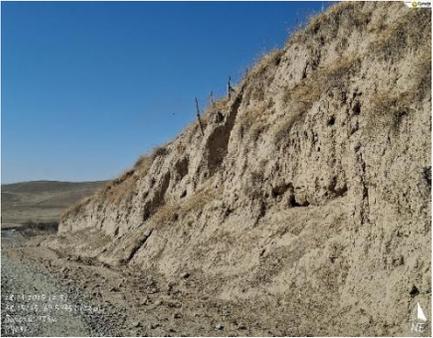
3	~ 443 m	38.15145 69.57448	Vertical slope	The slope is almost vertical, and water from rain causes small ravines to form. Planting trees is not possible because of the steepness.

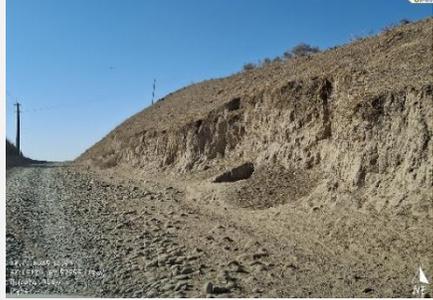
4	~ 545 m	38.1518969. 57555	Erosion and erosion Slope	The slope is very steep, which increases the risk of rock or soil falling. Fresh digging by local residents can be seen, which may also weaken the slope.

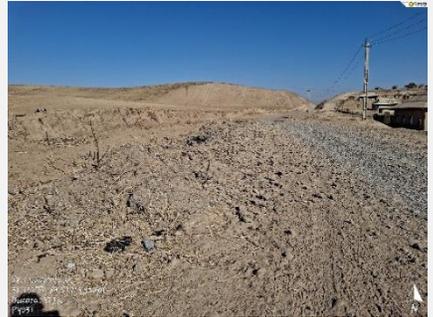
5	~ 722m	38.1527769. 57719	Unpaved part of the road	This part of the road is unpaved. Local residents report that it becomes difficult to use, especially in autumn and spring when it is wet and muddy.

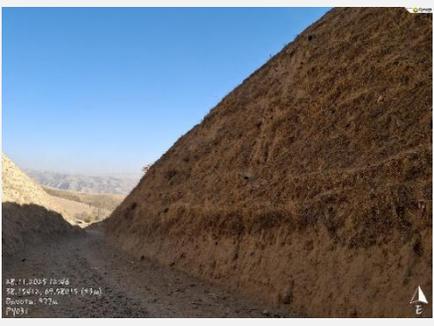
6	~ 1.02 km	38.1541269. 58015	Erosion and erosion on slopes	The slope is steep and erosion continues because there is not enough vegetation to hold the soil in place.

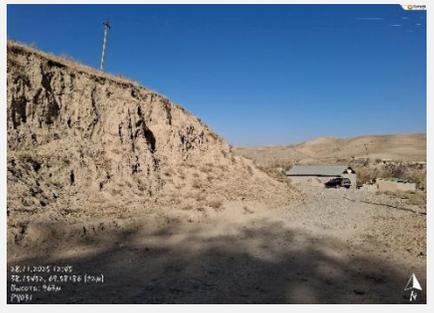
7	~ 1.18 km	38.1545269. 58186	Erosion and erosion of the slope	Deep erosion channels are forming. Because the slope has little vegetation, the soil is not stable and erosion keeps increasing.

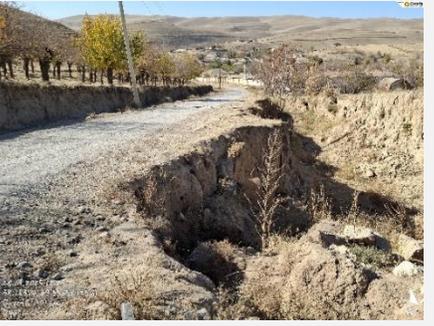
2	~ 1.22 km	38.1830869. 56207	Slope Landslide and Erosion	After heavy rains, landslides occur here. In the future, mudflows could block the road or wash it away.

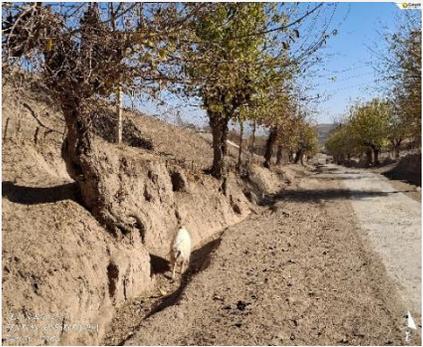
3	6~ 1.80 km	38.1813869.56818	Destruction and death of green spaces due to unfavorable soil conditions	Due to very dry soil and steep slopes, trees do not take root well and many die without proper care. Roots are exposed and dry out.

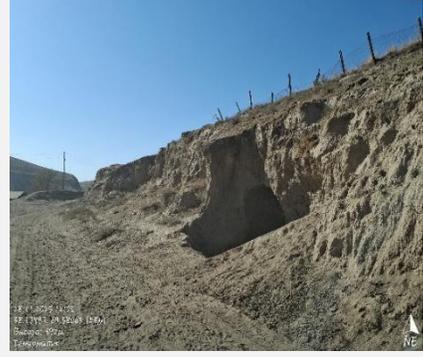
5	~ 2.98 km	38.1799769.58065	Erosion and erosion Slope	The slope is extremely steep, increasing the risk of falling rocks. Fresh digging by residents is visible. With repeated rainfall, mudflows are likely.

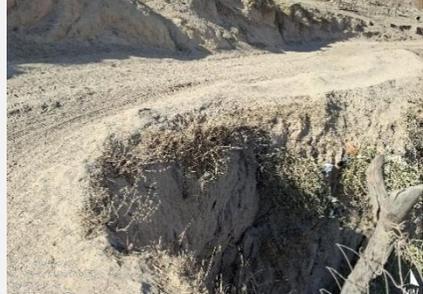
6	~ 3.14 km	38.1812669.58051	Slope erosion and erosion	Ongoing erosion is visible on the right side of the road. With heavy rains, damage could worsen.

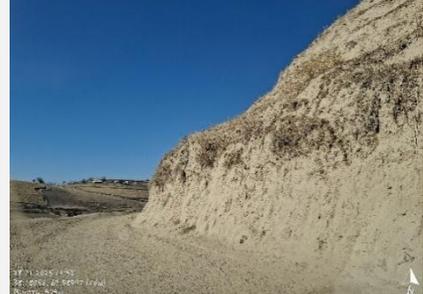
7	~ 4.01 km	38.1809669.58597	Erosion and erosion Slope	There is very little vegetation, so the soil is loose and continues to erode, reducing slope stability.

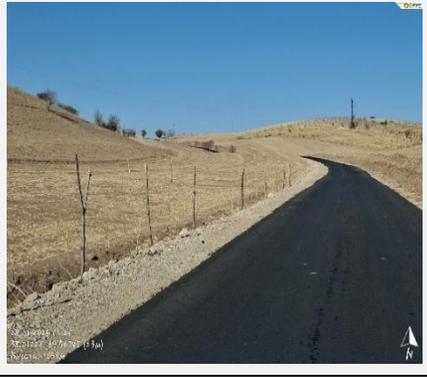
2	~ 274 m	38.2147069.56492	Absence of roadside ditches	There are no ditches along the road. Water from rainfall flows directly onto the road, causing damage.

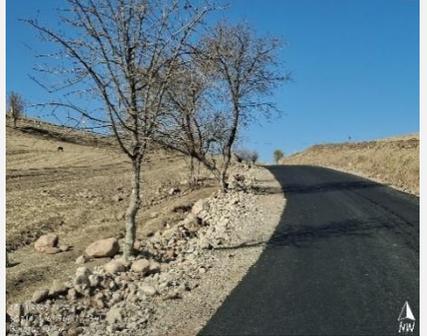
3	~ 275 m	38.2147069.56491	Large stones on the side of the road	Dry soil prevents trees from growing well. Trees that were planted struggle to survive, and nearby stones block their growth and damage them.

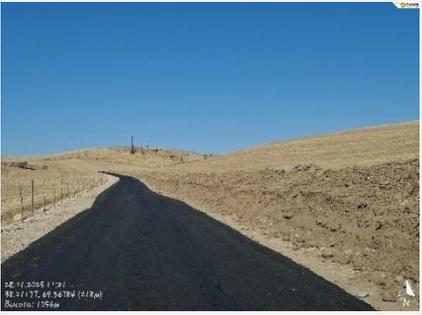
4	~ 697 m	38.2117769. 56784	Erosion and erosion of the slope	A deep ditch has formed on the left side of the road. Minimal vegetation means the soil is not well anchored, increasing erosion.

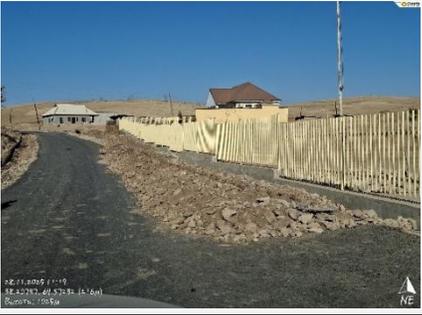
5	~ 1.28 km	38.2079769. 57232	Construction debris on the road	After repair work, construction waste was left on the road, making it difficult for villagers to move along it.

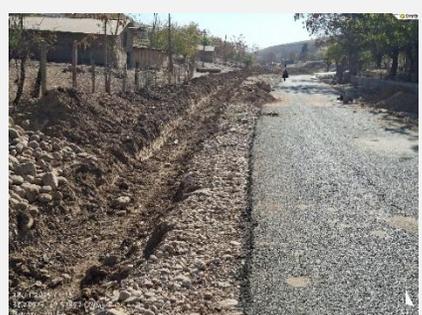
6	~ 1.65 km	38.2051369. 57457	Roadside destruction	Deep ditches along the roadside are not reinforced. During rainfall, mudflows wash away the new asphalt.

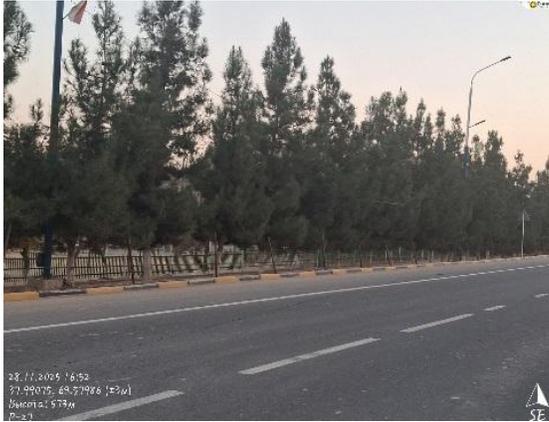
Figure 7: Roadside Tree Planting in Vose district (1).

- **Best Practices and Challenges:** The Khulbuk-Temurmalik-Kangurt road (first half) demonstrates best practices in green corridor development, including drip irrigation and fencing to protect vegetation from livestock. However, water scarcity in other sections limits the success of roadside planting. The Gulistan-Kulyab road also shows progress but faces challenges such as runoff, soil salinization, and the decline of roadside trees due to insufficient infrastructure and potable water.
