District Opportunity Report

- **Green Corridor
Demonstration Project
(GCDP)**
- **Grant No.: Grant 0977-TAJ**
- **Contract No. CS-04 Green
Roads Design Advisory**

*Joint Venture MetaMeta Research
B.V. & Muhandisoni Rohnamo LLC*

18 December 2025

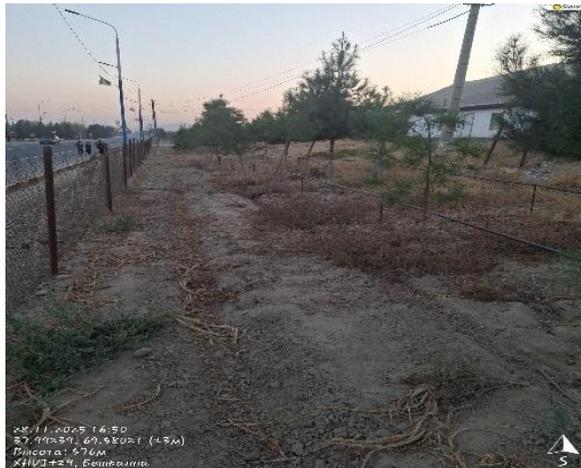
Figure 9: Drip irrigation system used to water roadside agricultural activities.

- **Best Practices and Challenges:** The Khulbuk-Temurmalik-Kangurt road (first half) demonstrates best practices in green corridor development, including drip irrigation and fencing to protect vegetation from livestock. However, water scarcity in other sections limits the success of roadside planting. The Gulistan-Kulyab road also shows progress but faces challenges such as runoff, soil salinization, and the decline of roadside trees due to insufficient infrastructure and potable water.

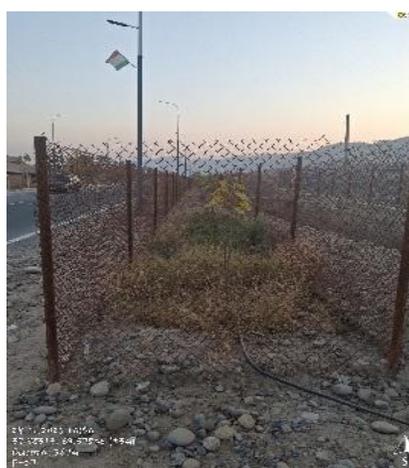
Figure 10: Fencing along roads to protect vegetation from livestock.

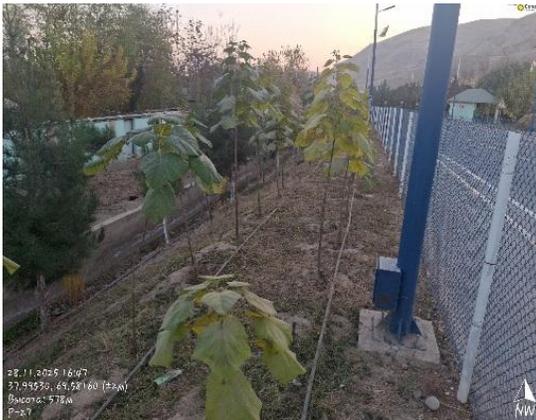
Figure 11: Due to water scarcity, drip irrigation is used to support agricultural activities along the roadside in Vose District.

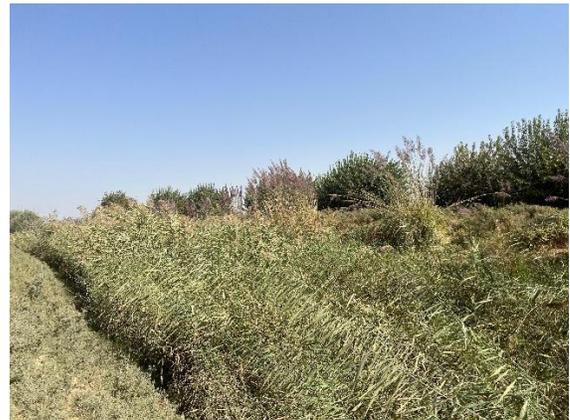
Figure 12: The irrigation drain is overgrown and filled with silt due to poor removal of excess water. This has caused widespread waterlogging, which undermines the stability of nearby roads.

- **Environmental and Climate Issues:** Persistent heat along the entire road corridor is a concern. Stakeholders believe that planting more trees and grass can help mitigate heat impacts and reduce carbon emissions. There is also potential to increase electric vehicle use if supporting infrastructure is developed.
- **Water Management:** Water scarcity is a challenge in several areas. Stakeholders recommend better use of water from road drainage and culverts, including artificial reservoirs and modern irrigation methods (e.g., drip irrigation, sprinklers), to support both agriculture and green corridors. Water logging is also an issue, related to intense and partly wasteful irrigation with a drainage system that is not maintained and hence does not remove water. The waterlogged situation affects the stability of the roads.
