Landslide Related Road Failures in Ethiopia

By: Kifle Woldearegay (PhD) (Mekelle University, Ethiopia)

(Modified after the presentation made at National Workshop on Natural Hazards Monitoring and Risk Management in Ethiopia; Nov. 06-07, 2014; IGSSA; AAU, Ethiopia)

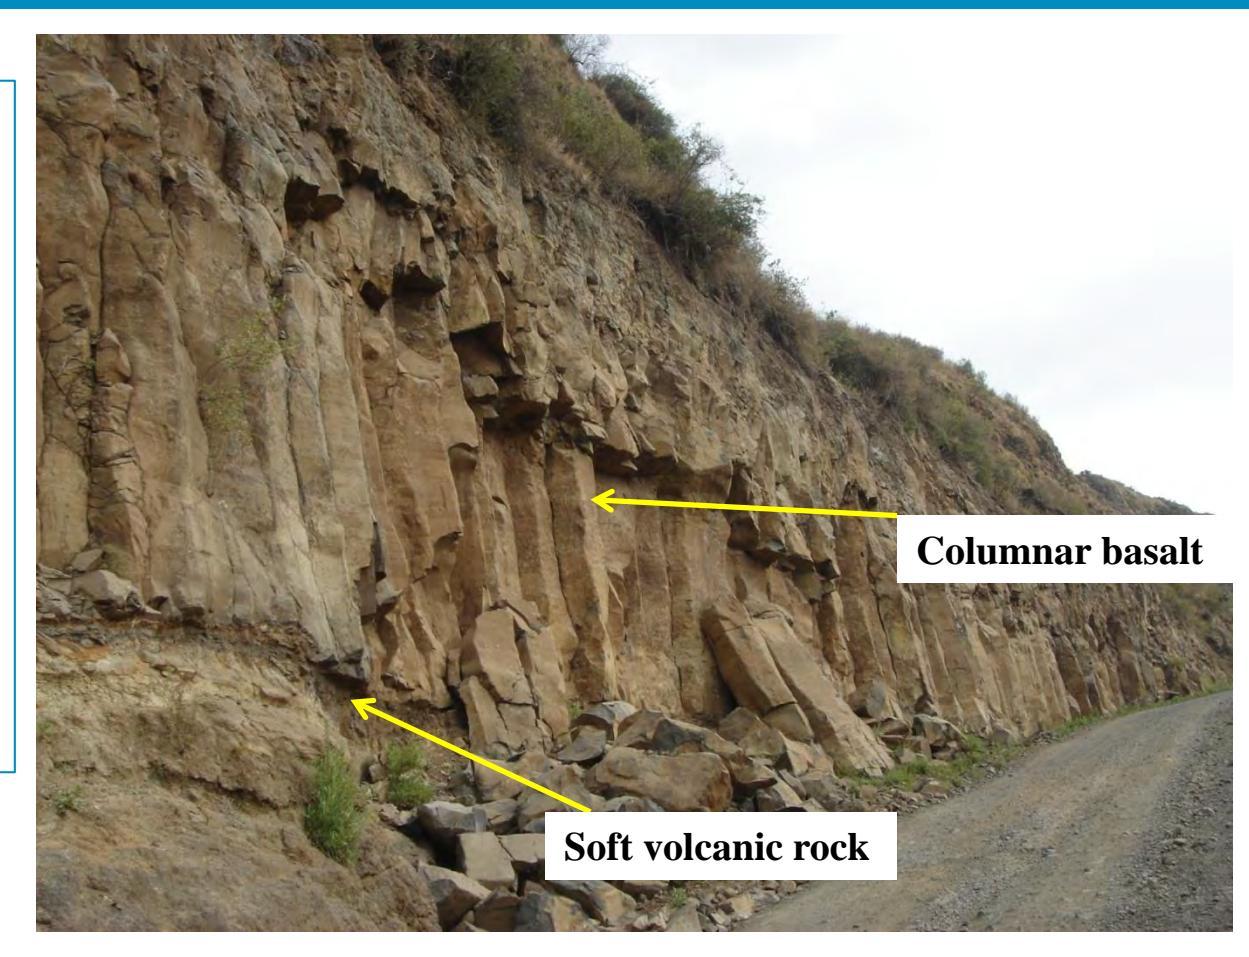
Along Lemi-Alem Ketema route

- On steep slopes: volcanic as well as sedimentary terrains.
- Presence of soft, erodible materials contributes to instability.

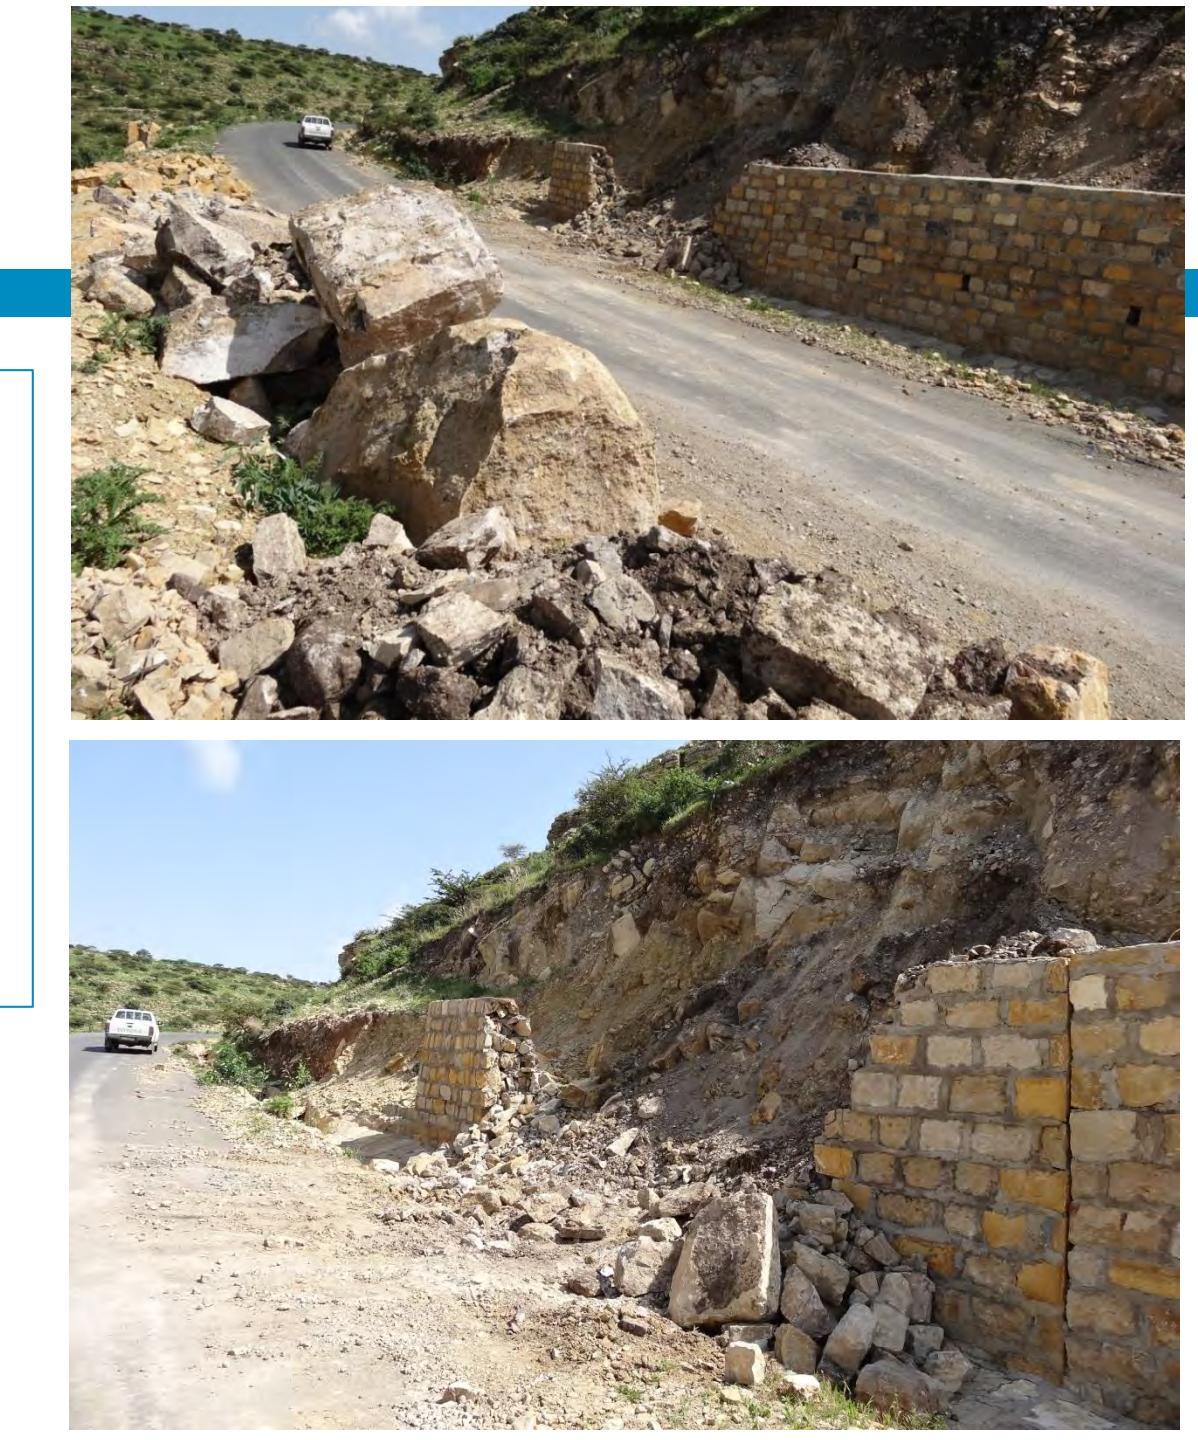
- Sliding of limestone and shale intercalating slope mass, leading to failure of retaining structure.
- Presence of shale material contributes to instability.

Rockslide controlled by discontinuities (that daylight on the slope), leading to failure of masonry retaining structure.

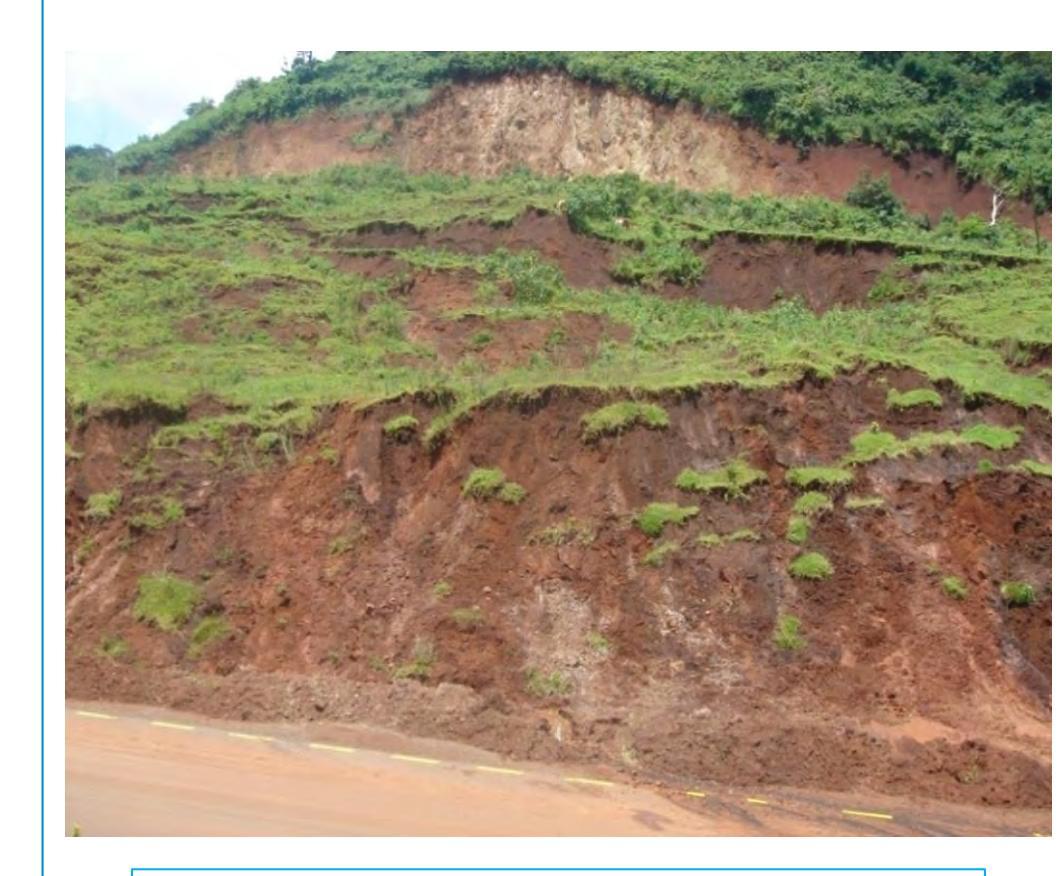
Earth slide along Jimma-Agaro road

Failure took place at the interface between soil (colluvial/earth material) and the underlying bedrock.

- Water pressure developed at the interface between soil and bedrock.
- Over 60% of the failures are associated with stream/river incisions or with gully development from water from culverts.
- Failure characteristics can be categorized into *four Models*.

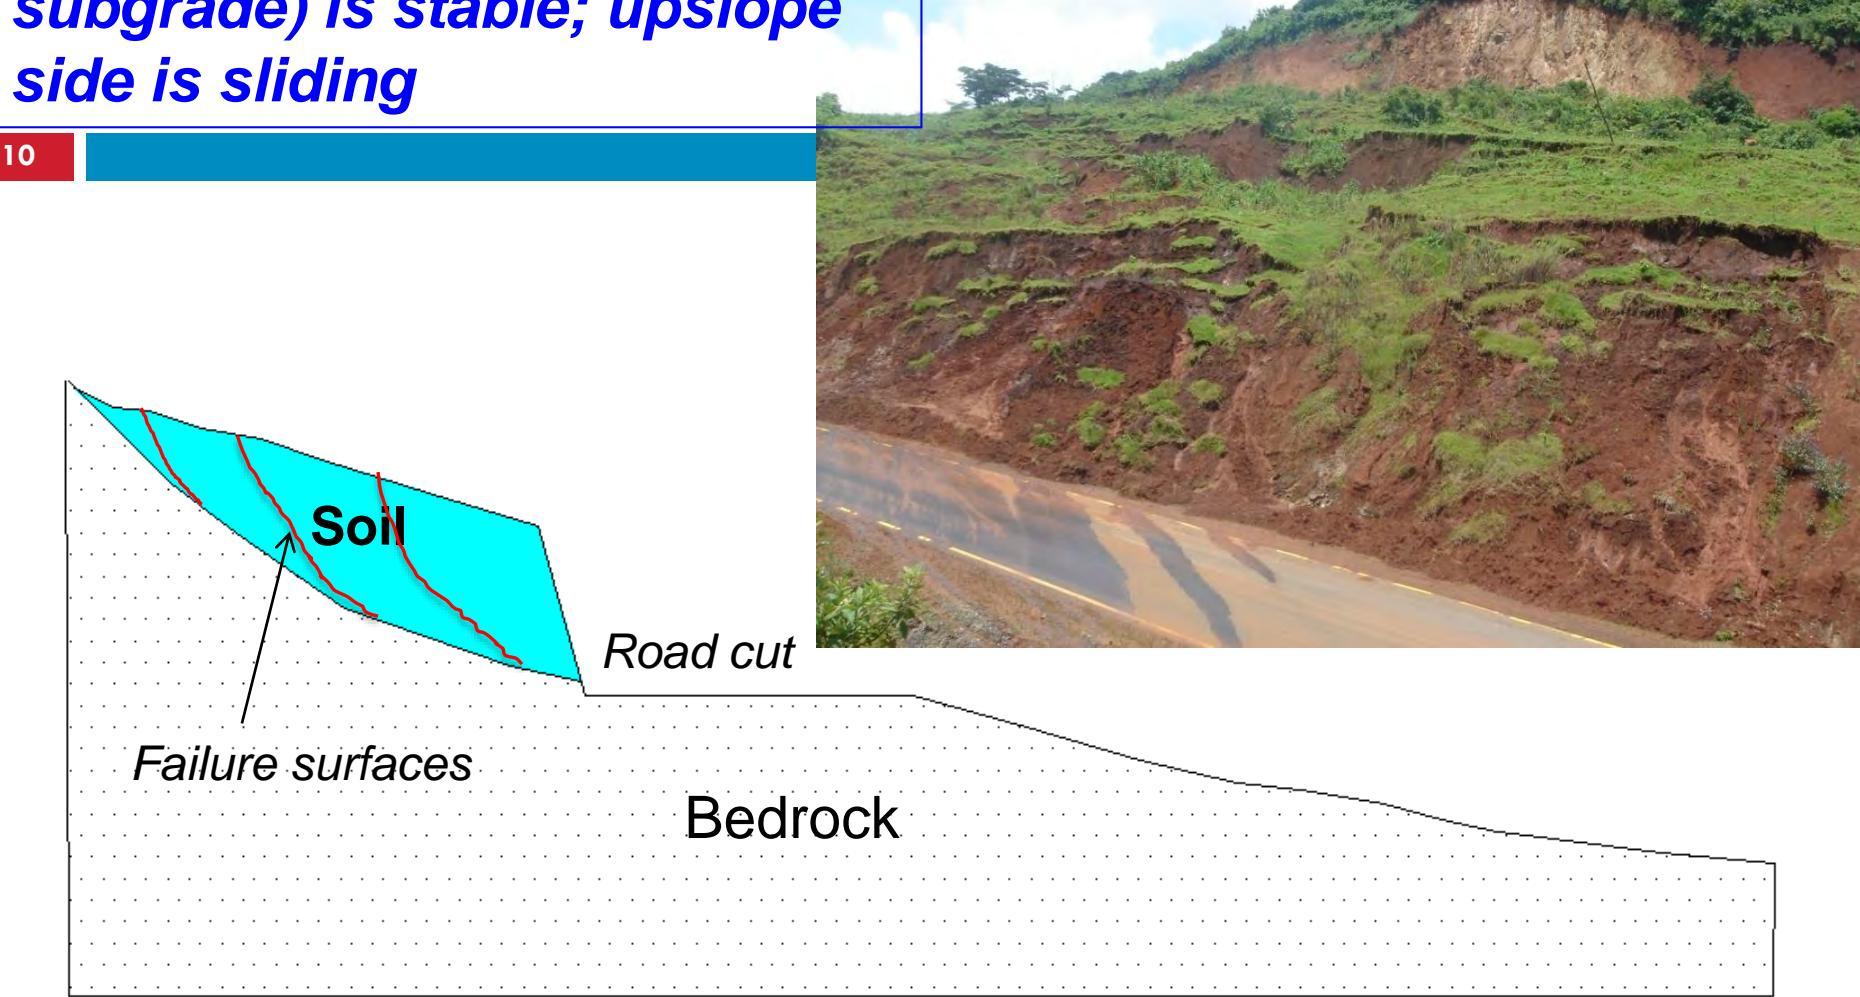
Model 1: Road (including subgrade) is stable; upslope side is sliding

- Removal of support due to road excavation has initiated instability of the upslope.
- Provision of proper retaining structure coupled with drainage systems (surface and sub-surface) is the solution.

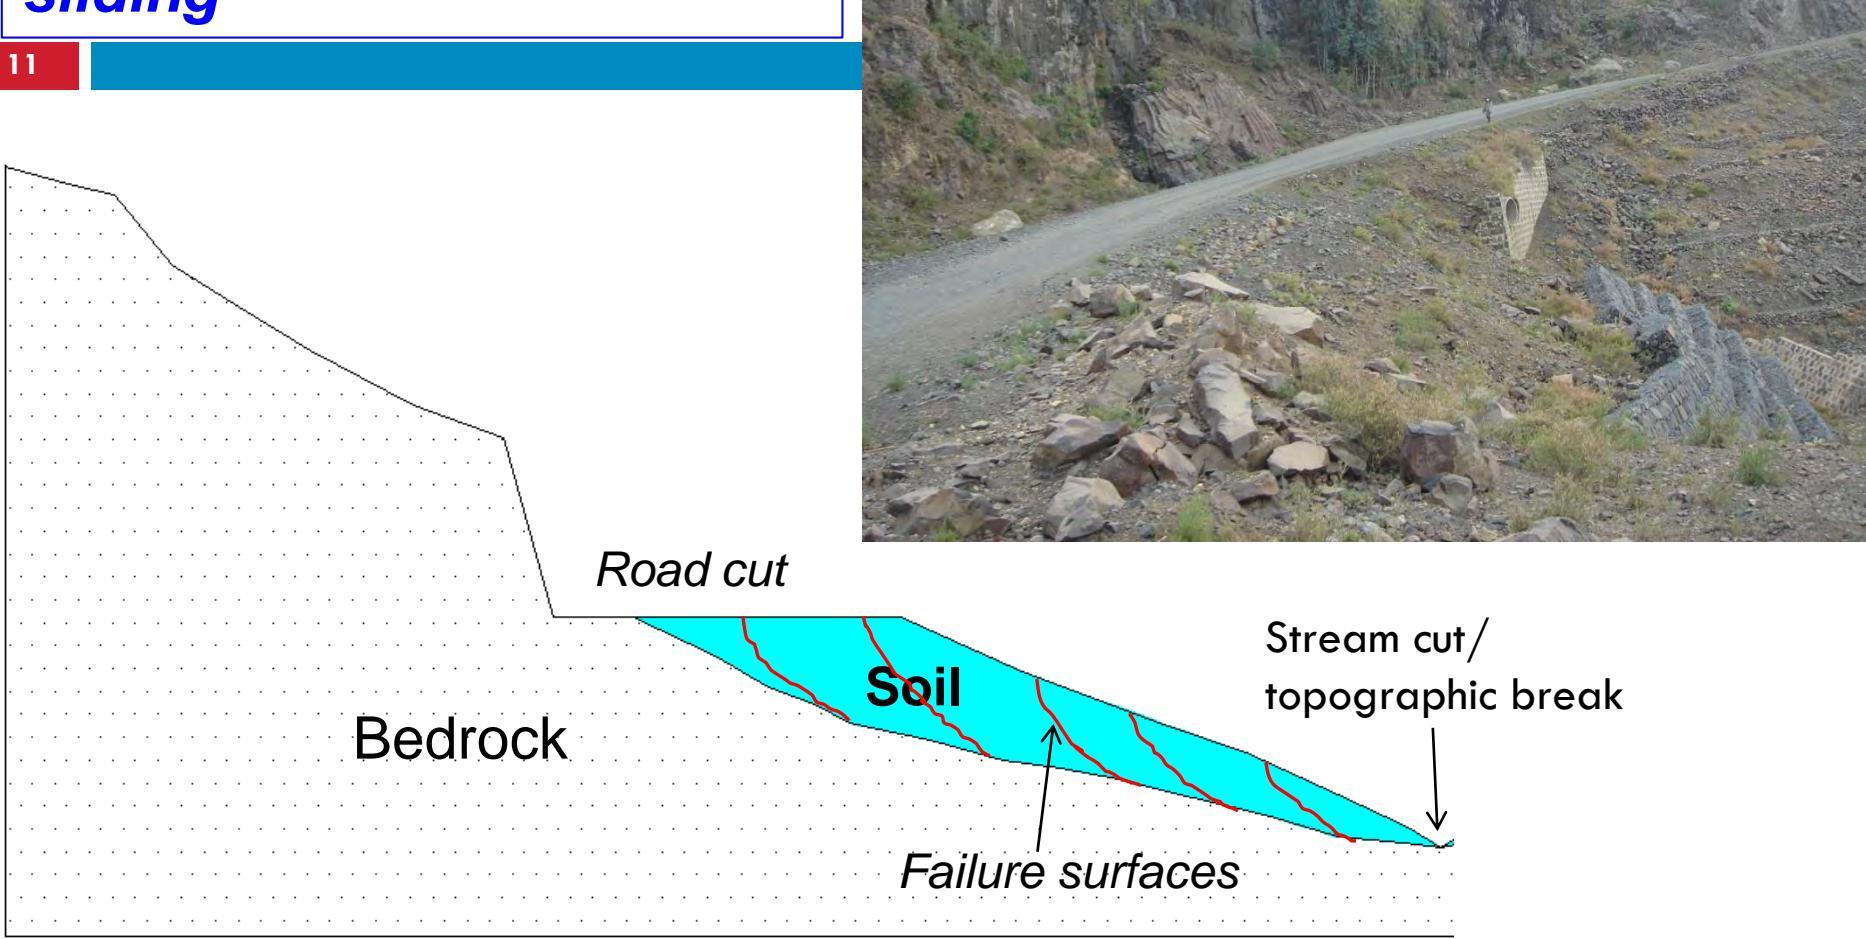
Model 2: Upslope side is stable; downslope side is sliding

Additional load (due to road construction) on a slope which was already unstable or on marginally stable state is initiating instability of slopes. Model 3: Placement of excavated material on marginally stable slope

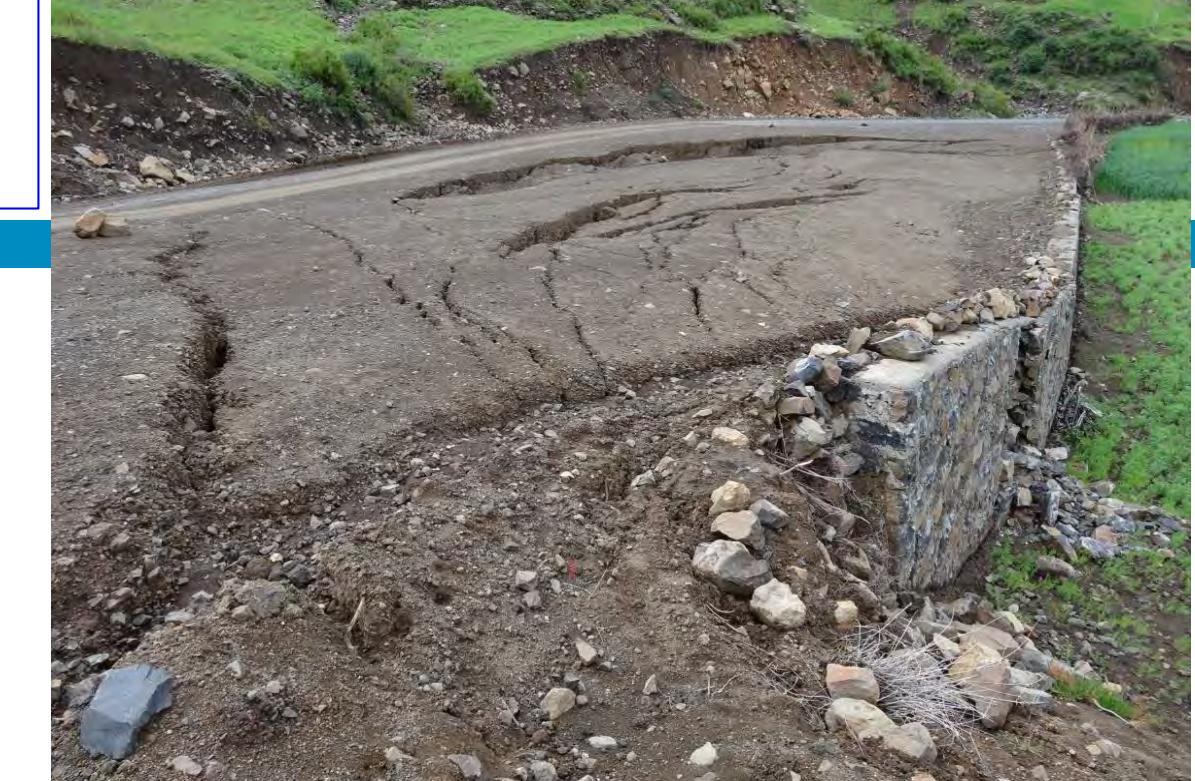
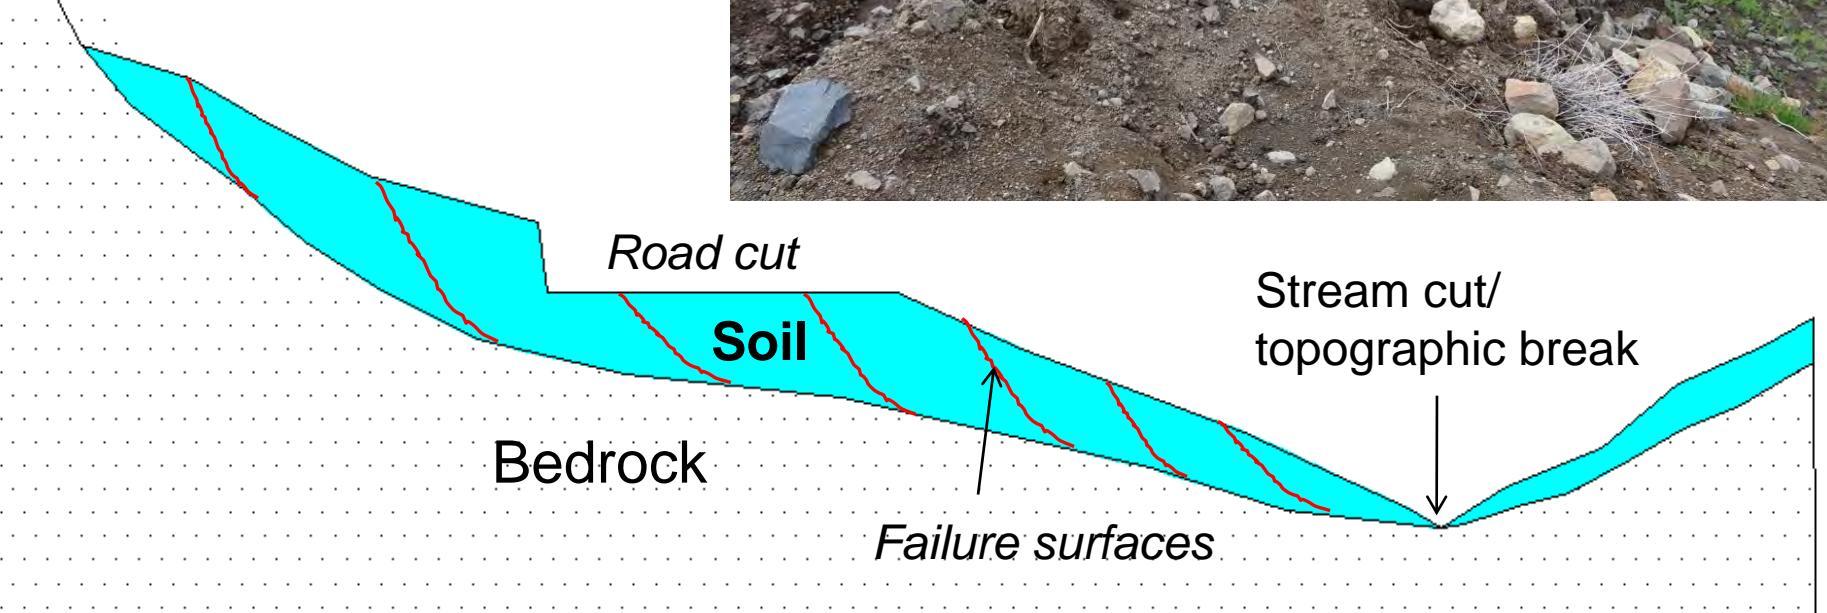
Model 4: Whole road section is on a sliding mass

Excavation and placement of additional load (road) on already unstable slope or on marginally stable slope is initiating instability of slopes.

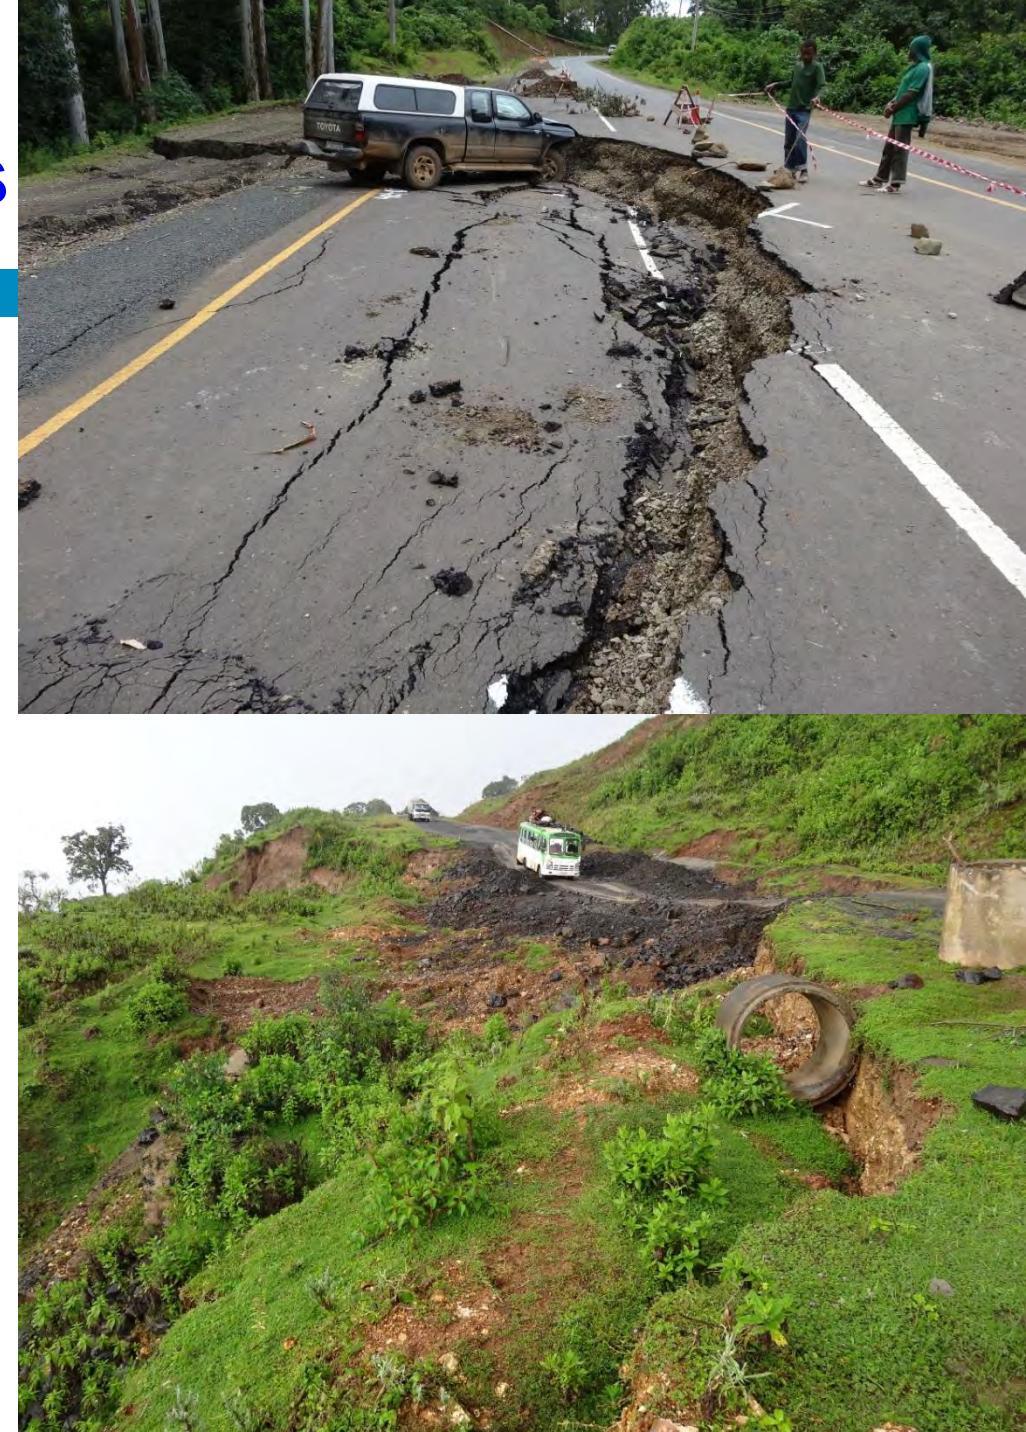
Damaged asphalt road in Tarmaber area

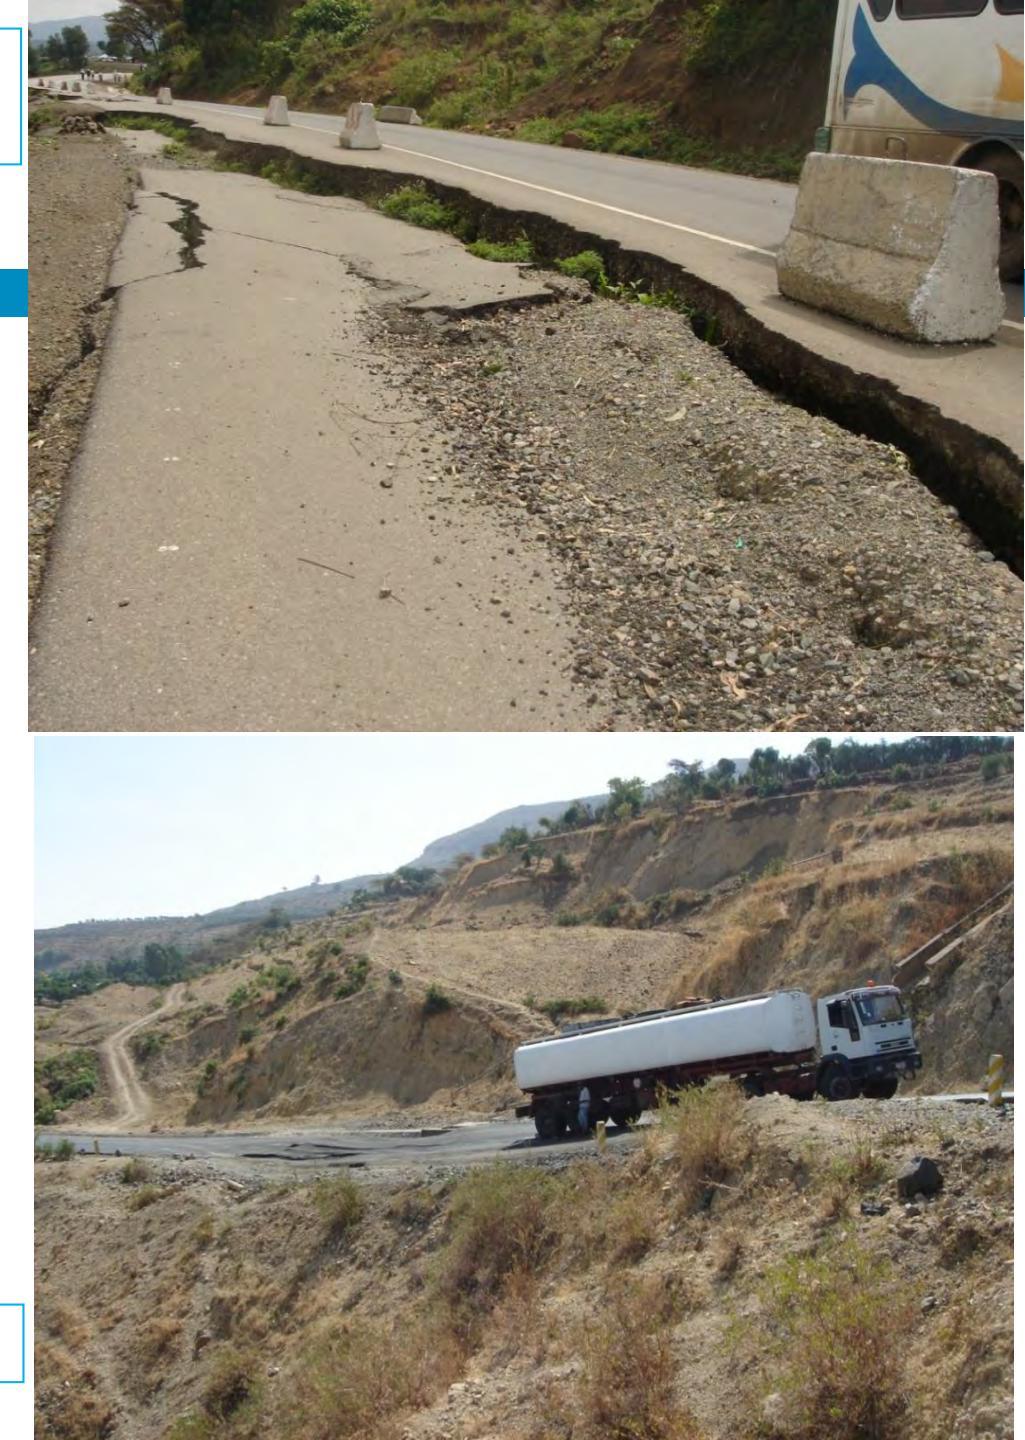
Landslide in Abay Gorge

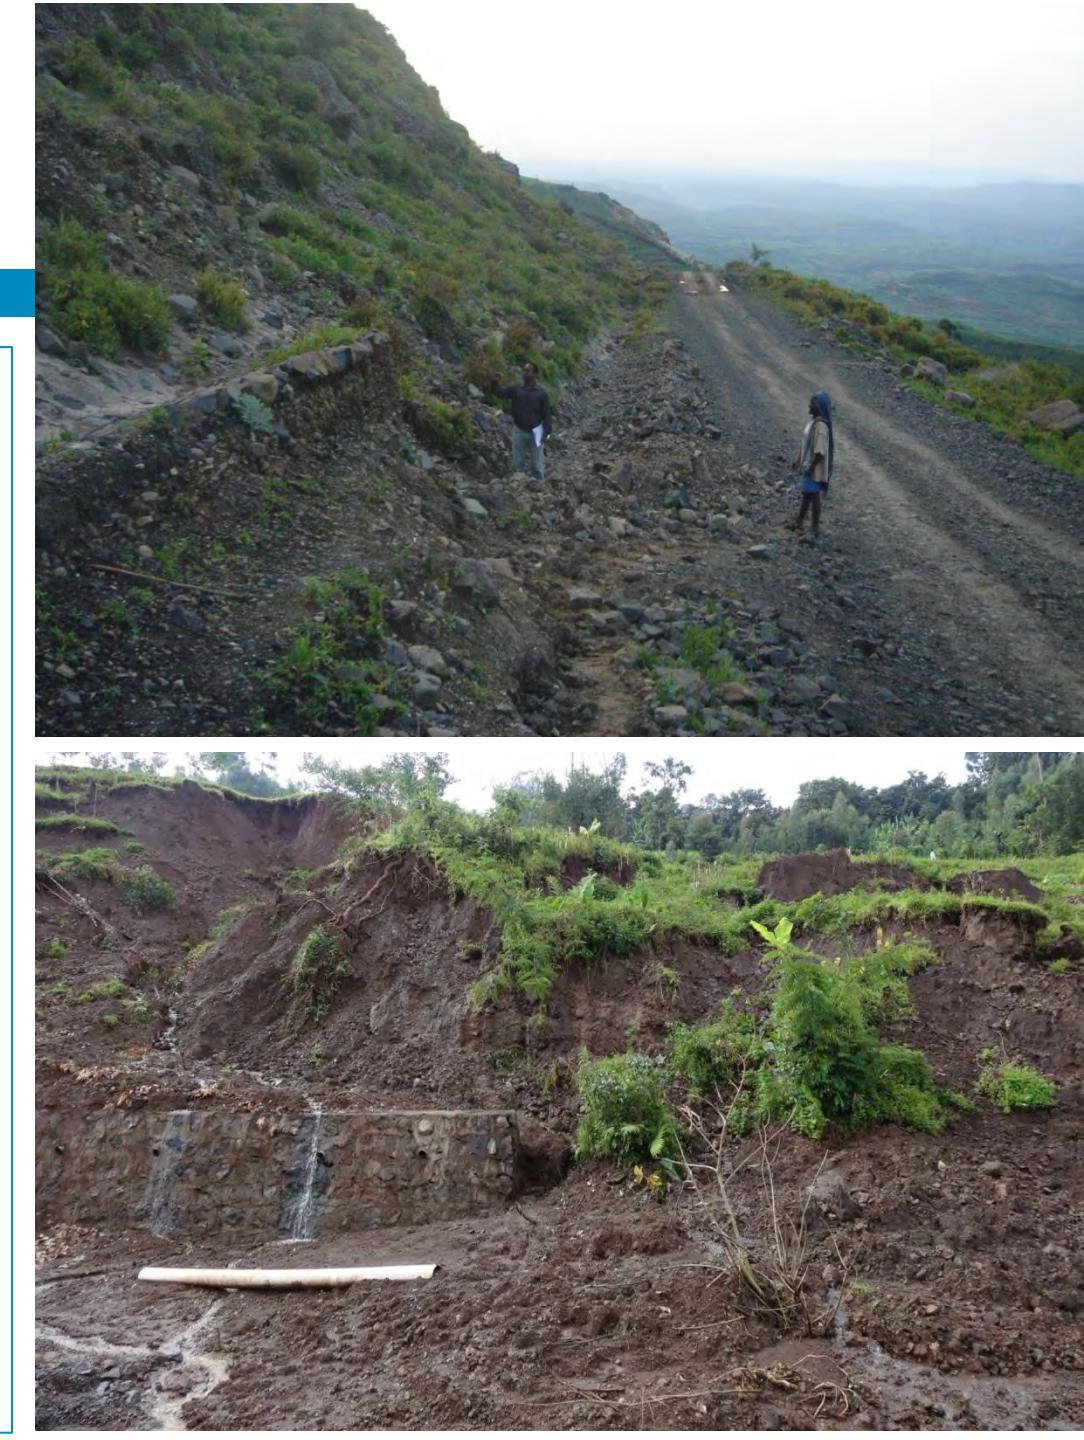
View of a large-scale landslide: affecting roads, power lines and farm lands along Bonga-Mizan road.

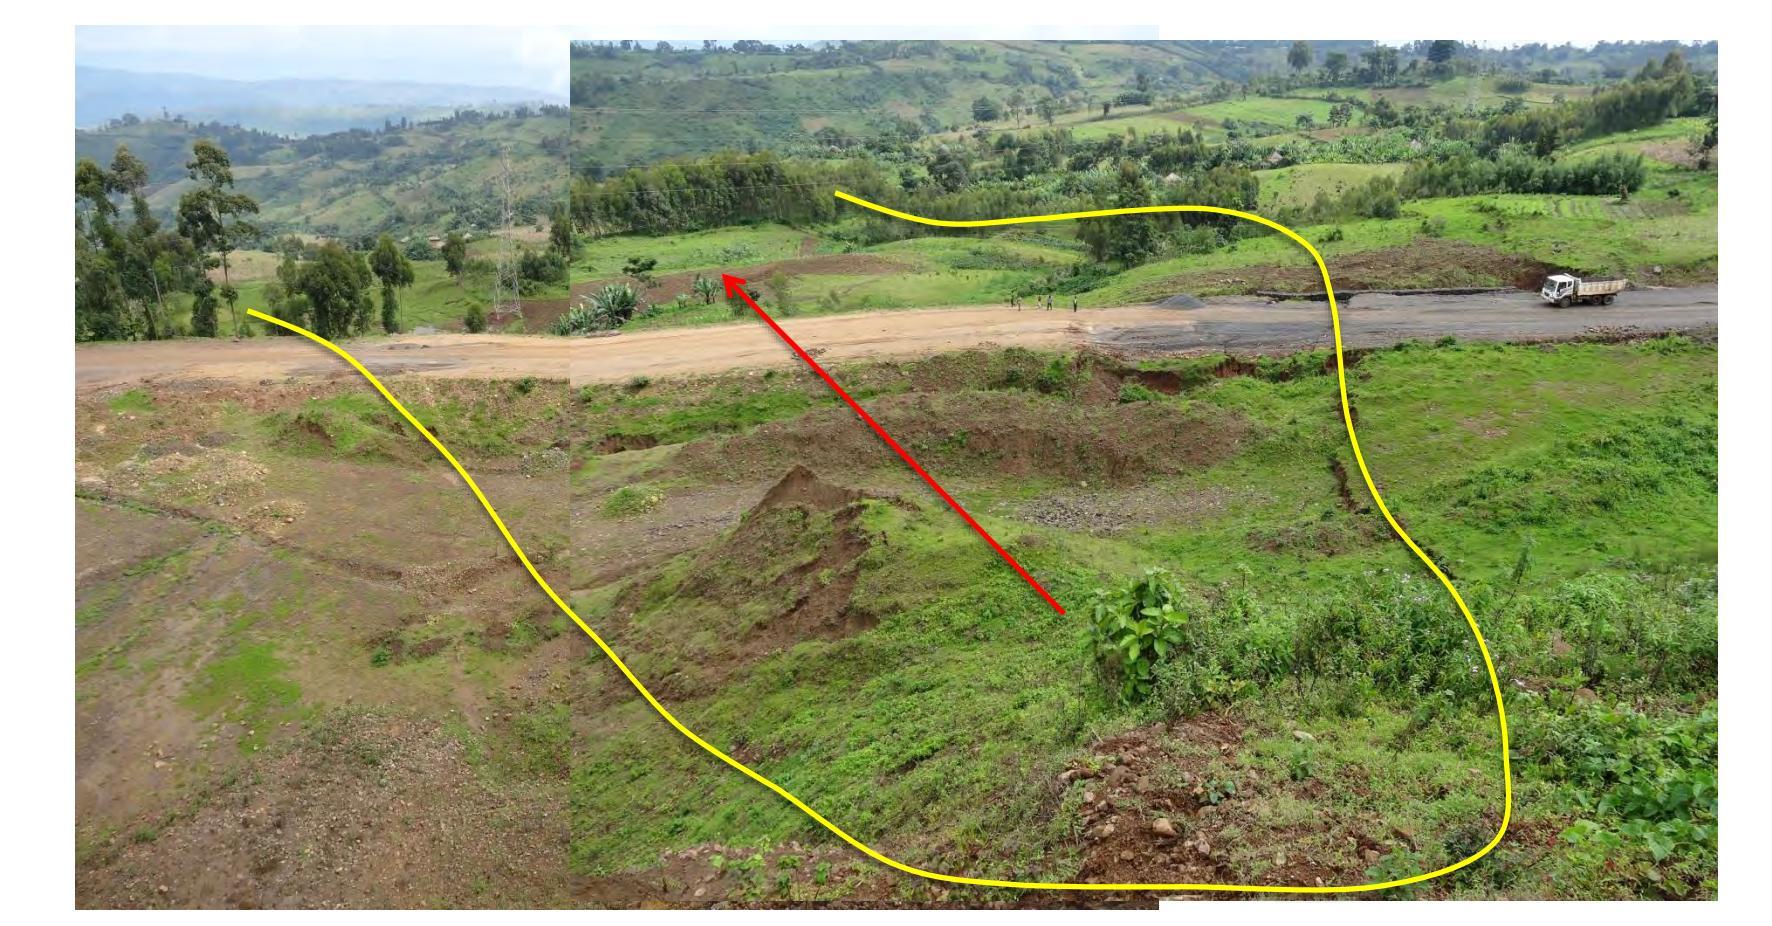
View of a large-scale landslide: affecting roads, power lines and farm lands along Bonga-Mizan road (arrow indicates direction of movement).

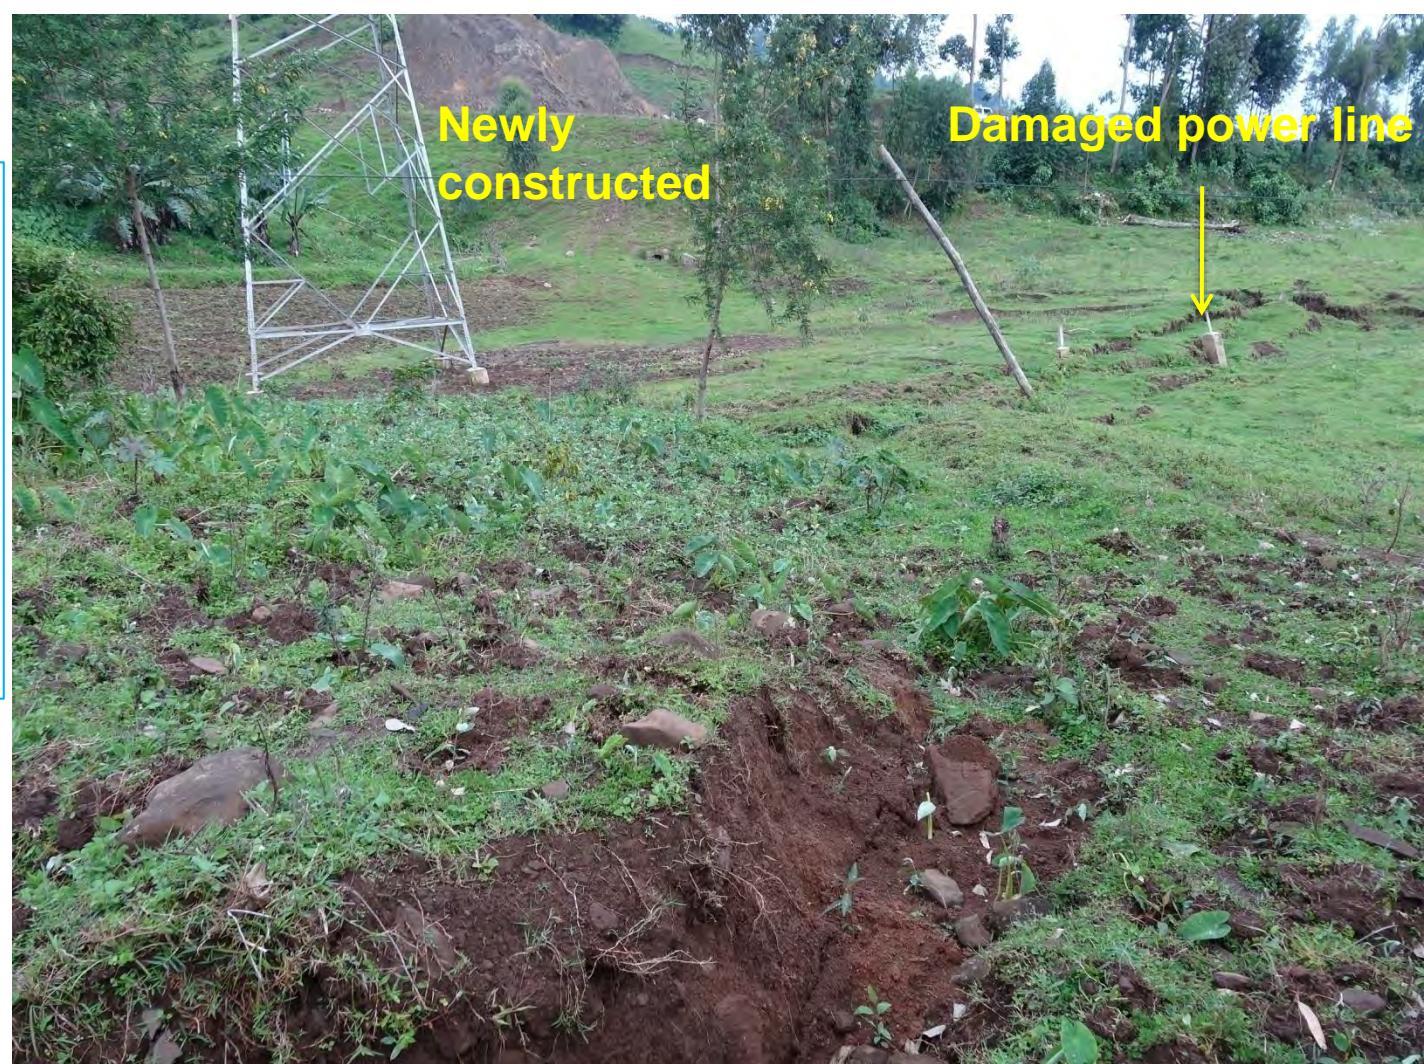
Main Power line damaged by a landslide is shifted but still endangered by the same landslide along Bonga-Mizan road

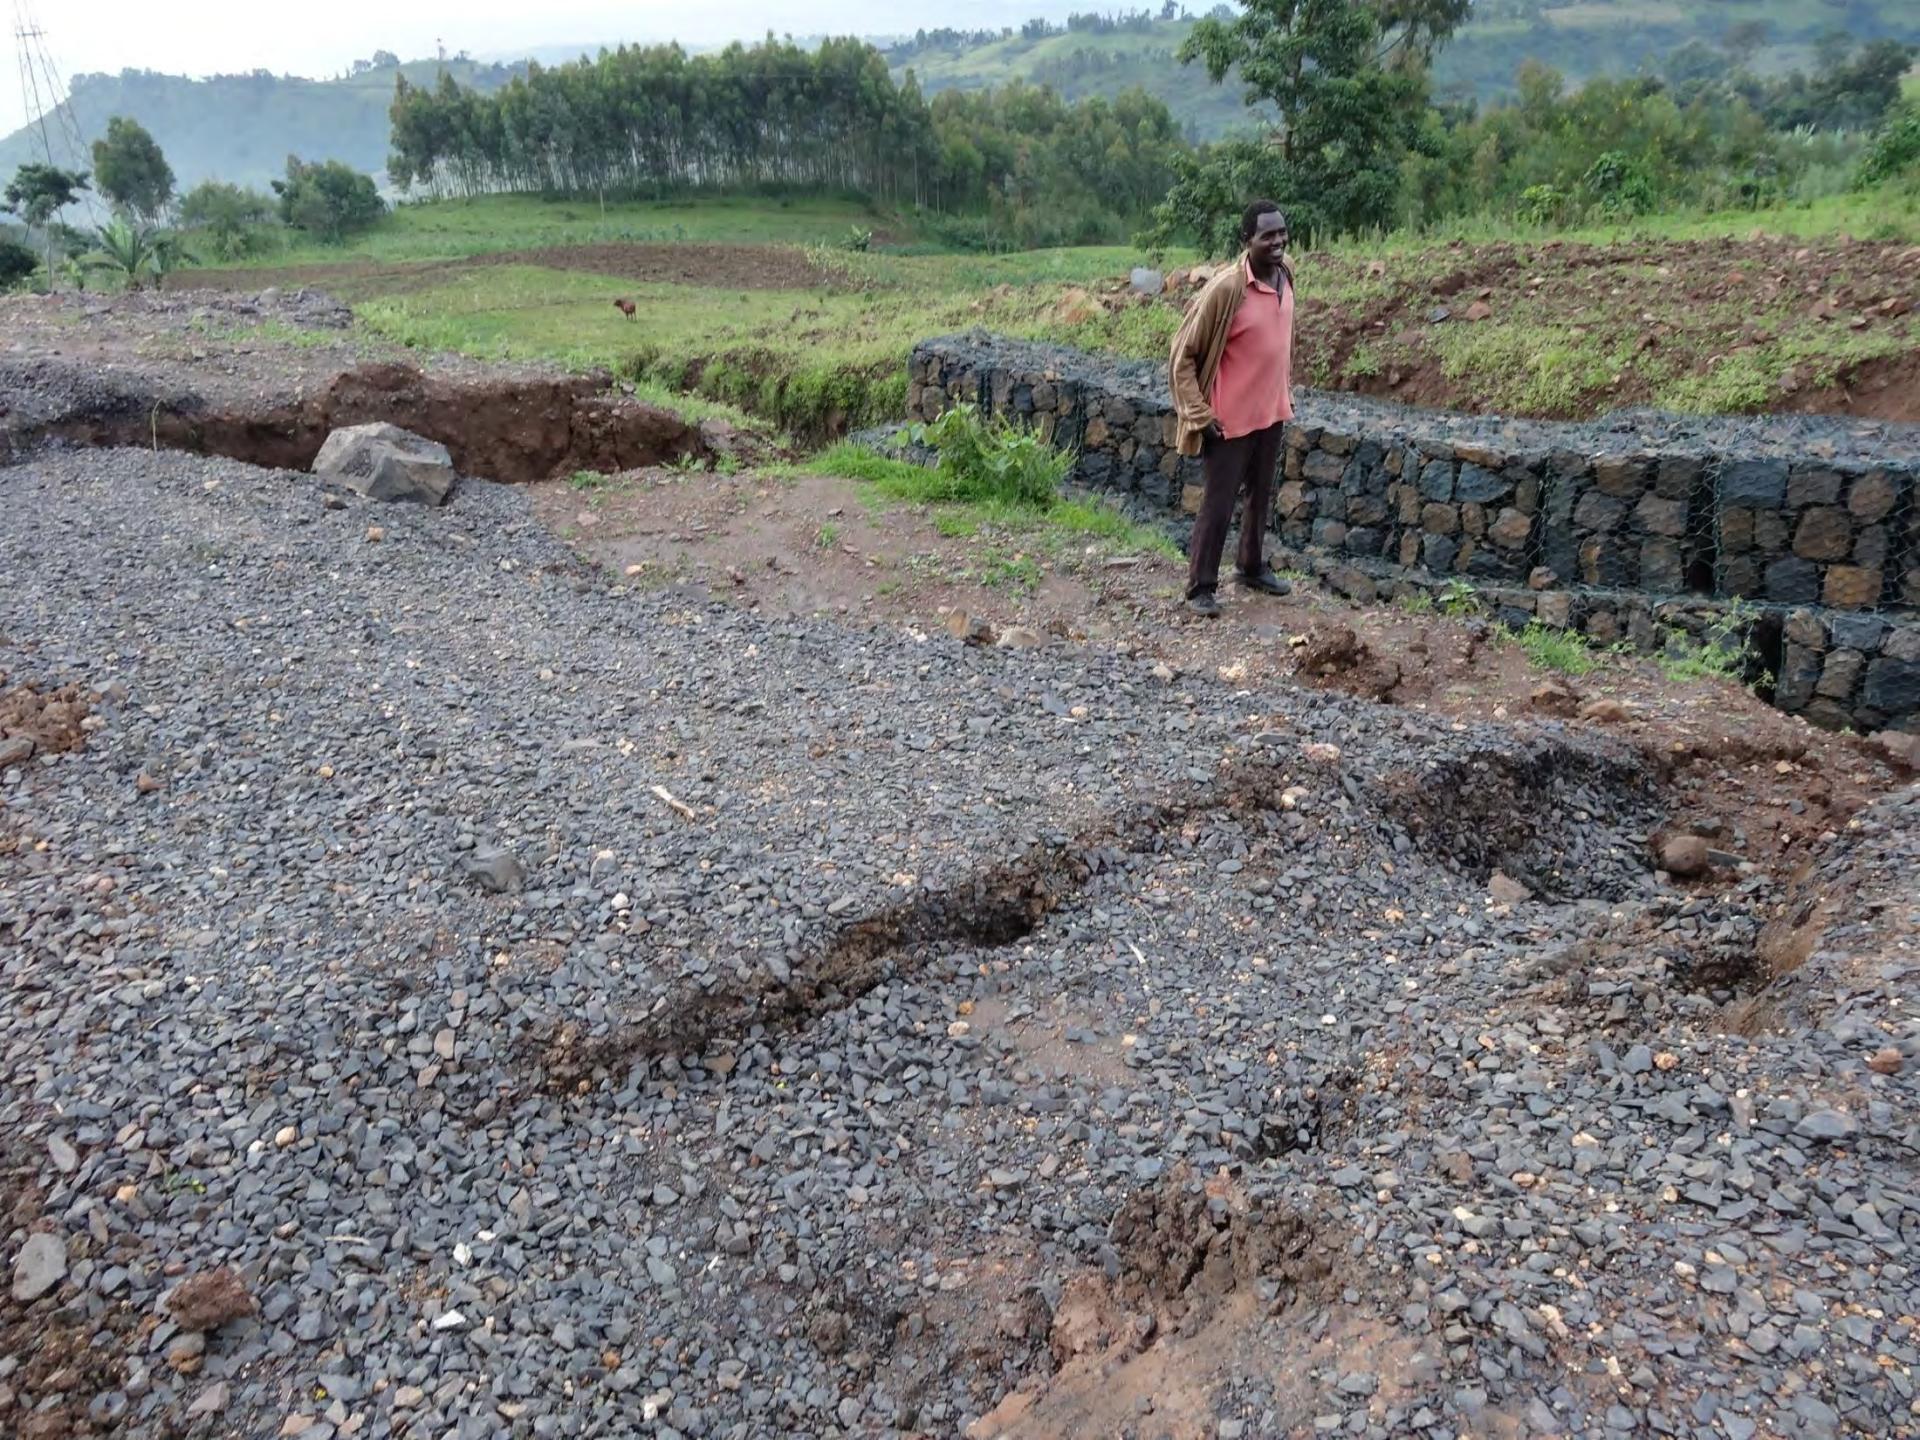
Landslide related road failure along Kombolcha area (head of the slide).

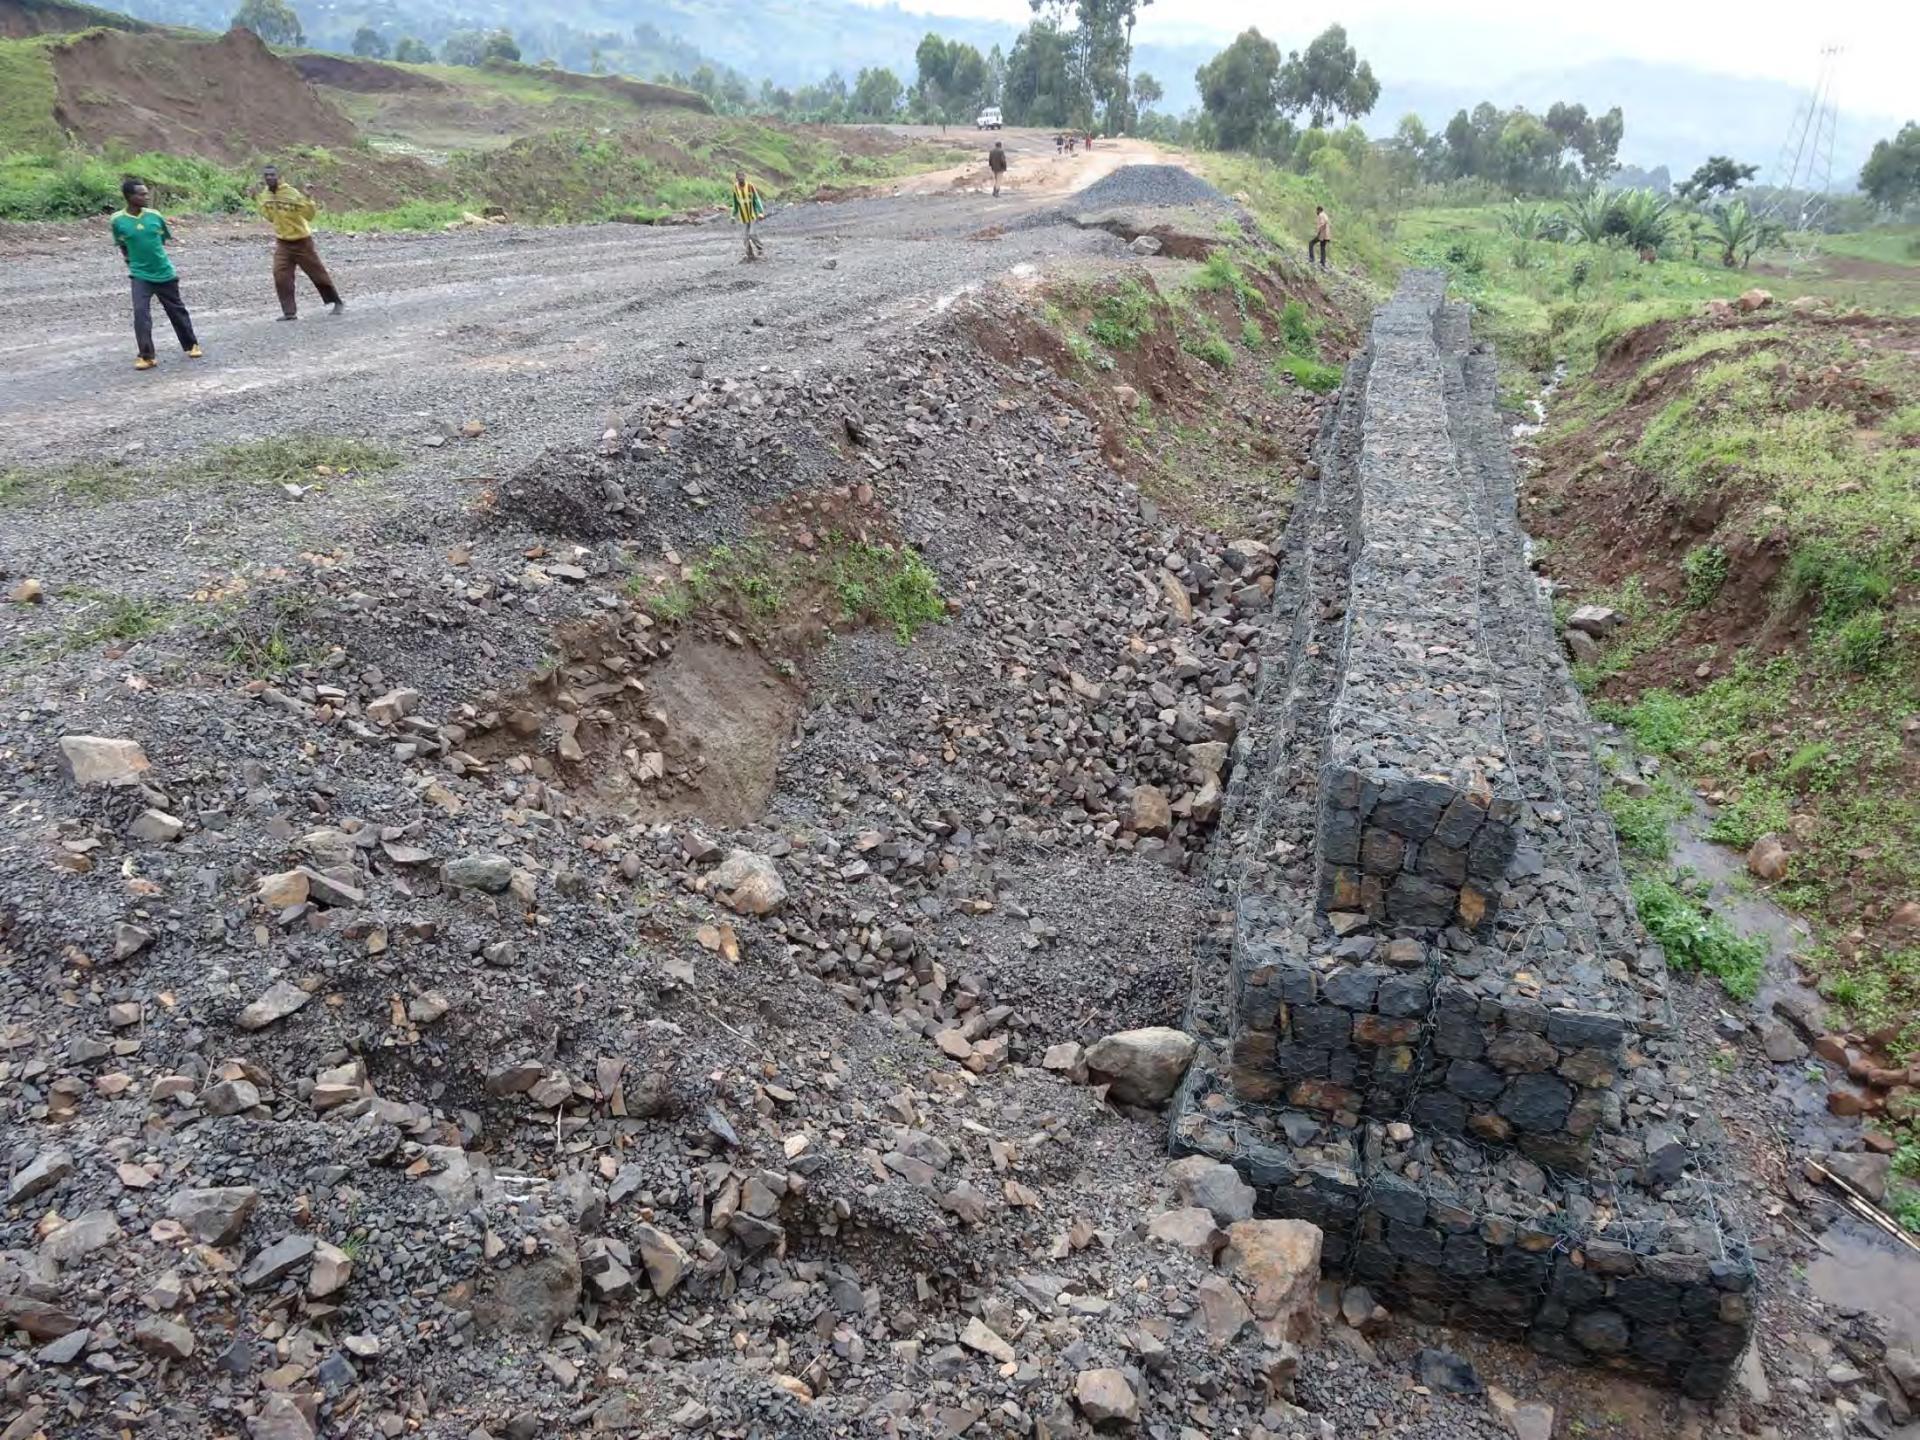
Backfilling and construction of retaining wall over a sliding mass.

Could this be effective while the landslide extends upto about 800m downstream?

Downslope view of the landslide along Kombolcha area.
