Landslide Related Road Failures in Ethiopia

By: Kifle Woldearegay (PhD) (Mekelle University, Ethiopia)

(Modified after the presentation made at National Workshop on Natural Hazards Monitoring and Risk Management in Ethiopia; Nov. 06-07, 2014; IGSSA; AAU, Ethiopia)

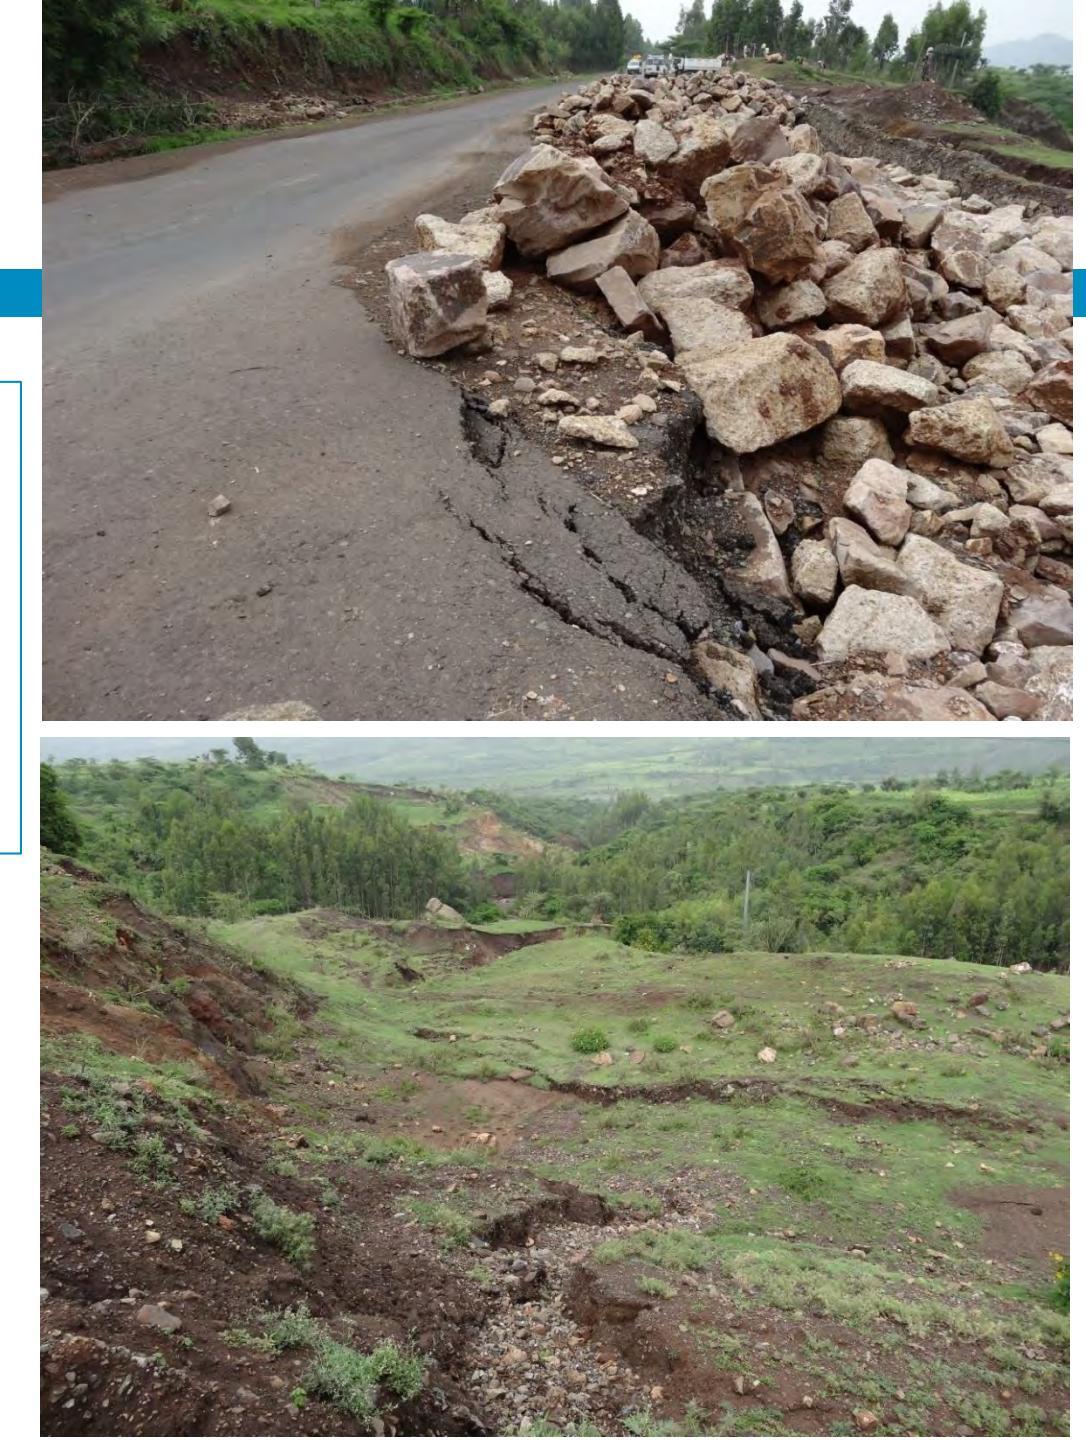
Landslide in Dessie town; affecting retaining structures.

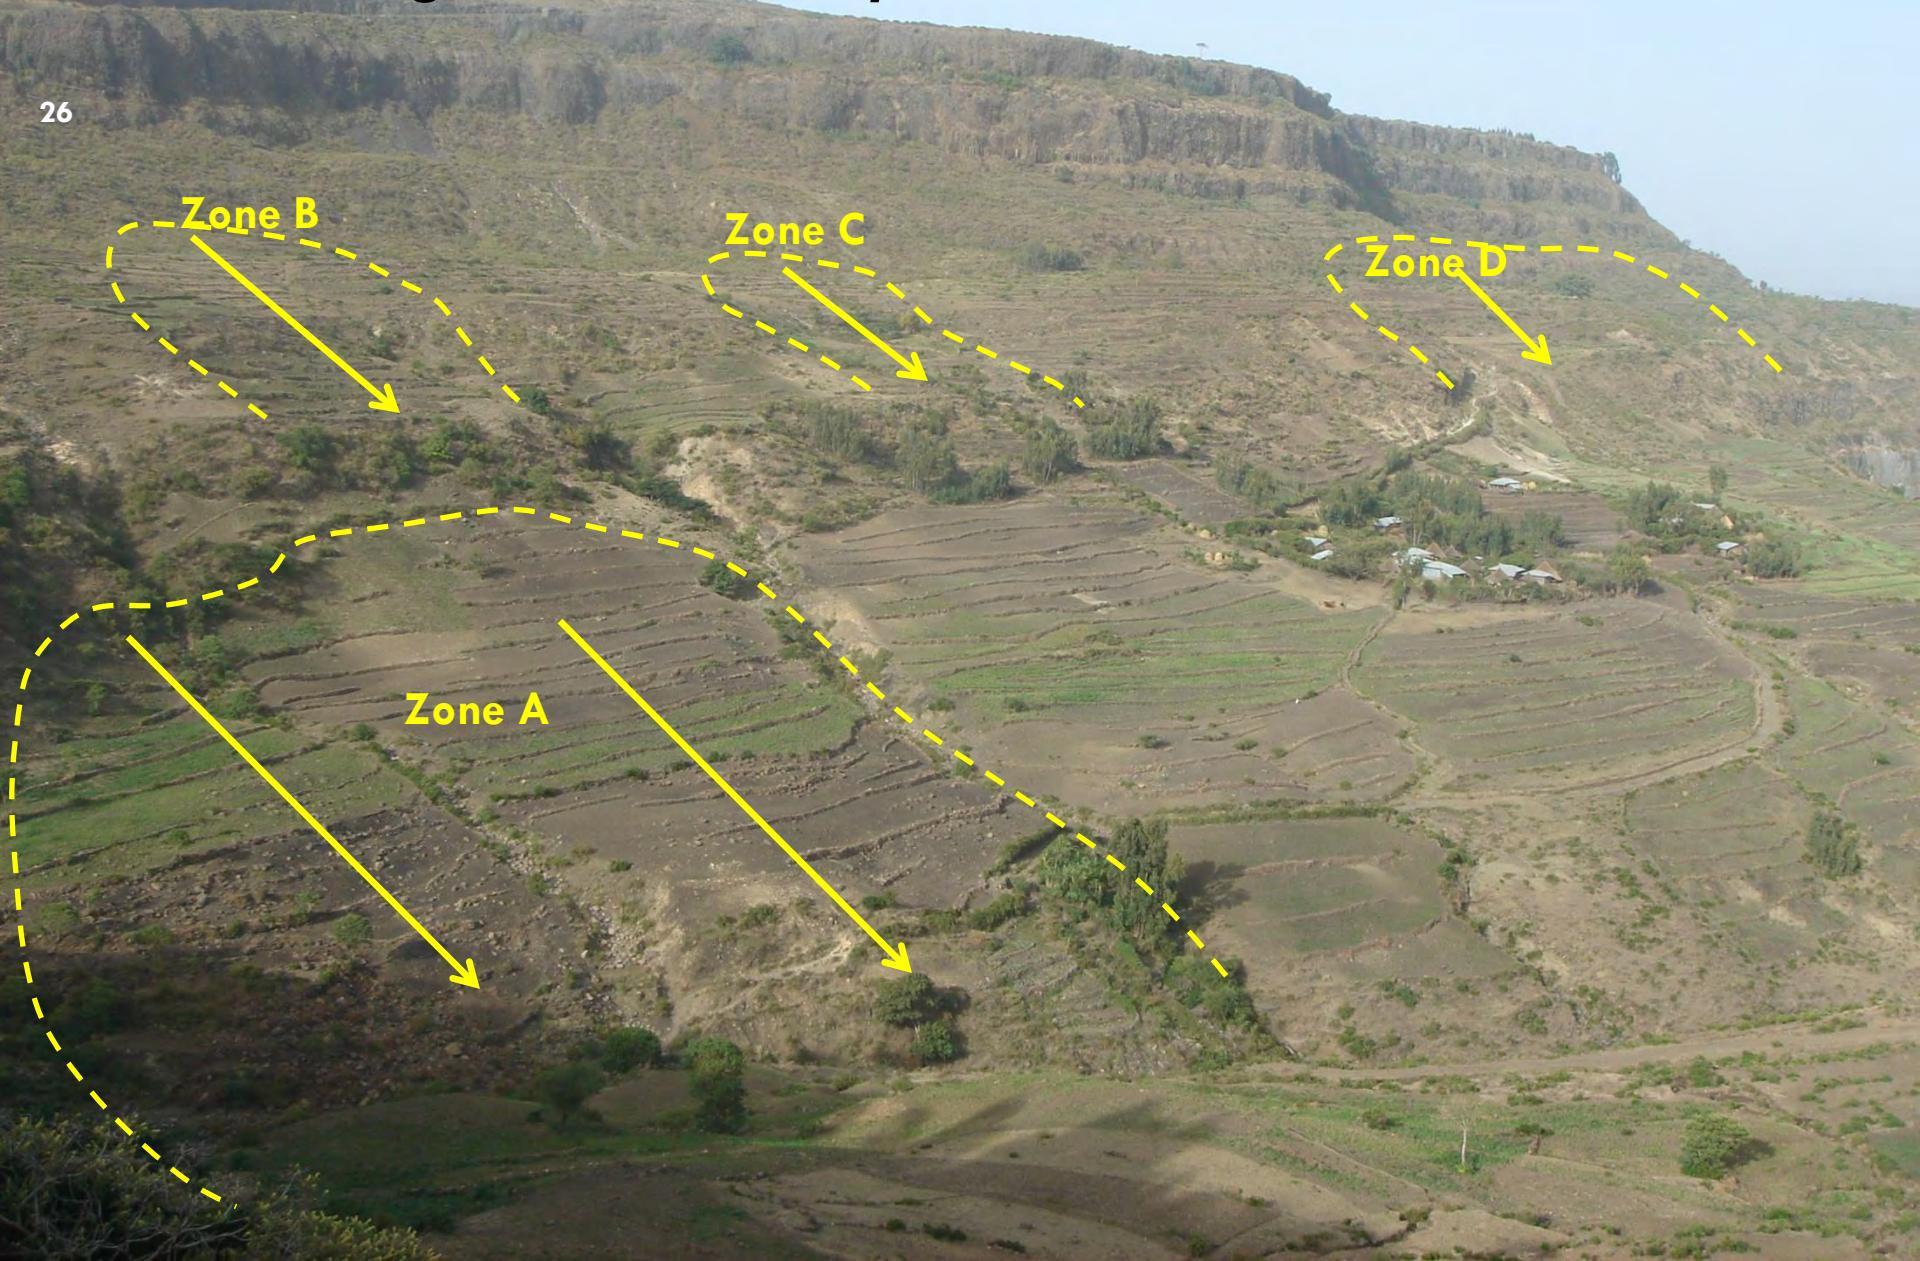
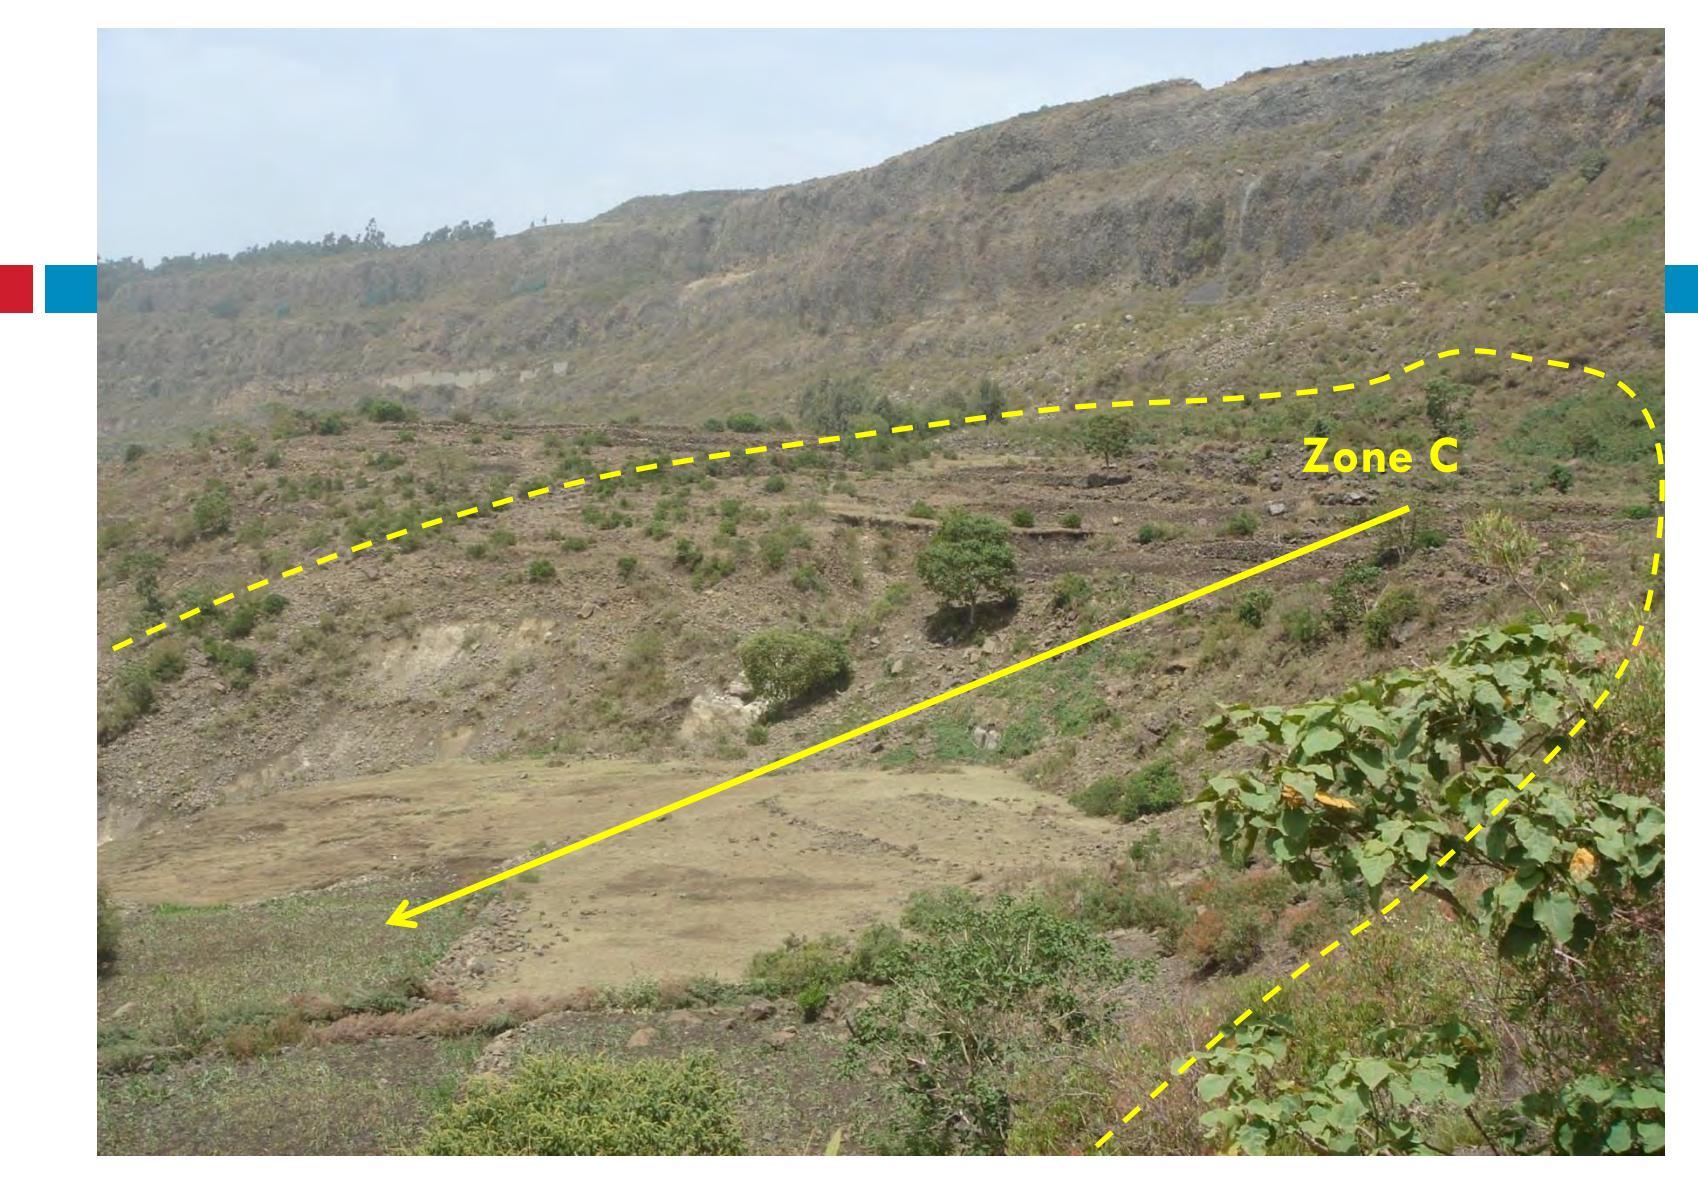
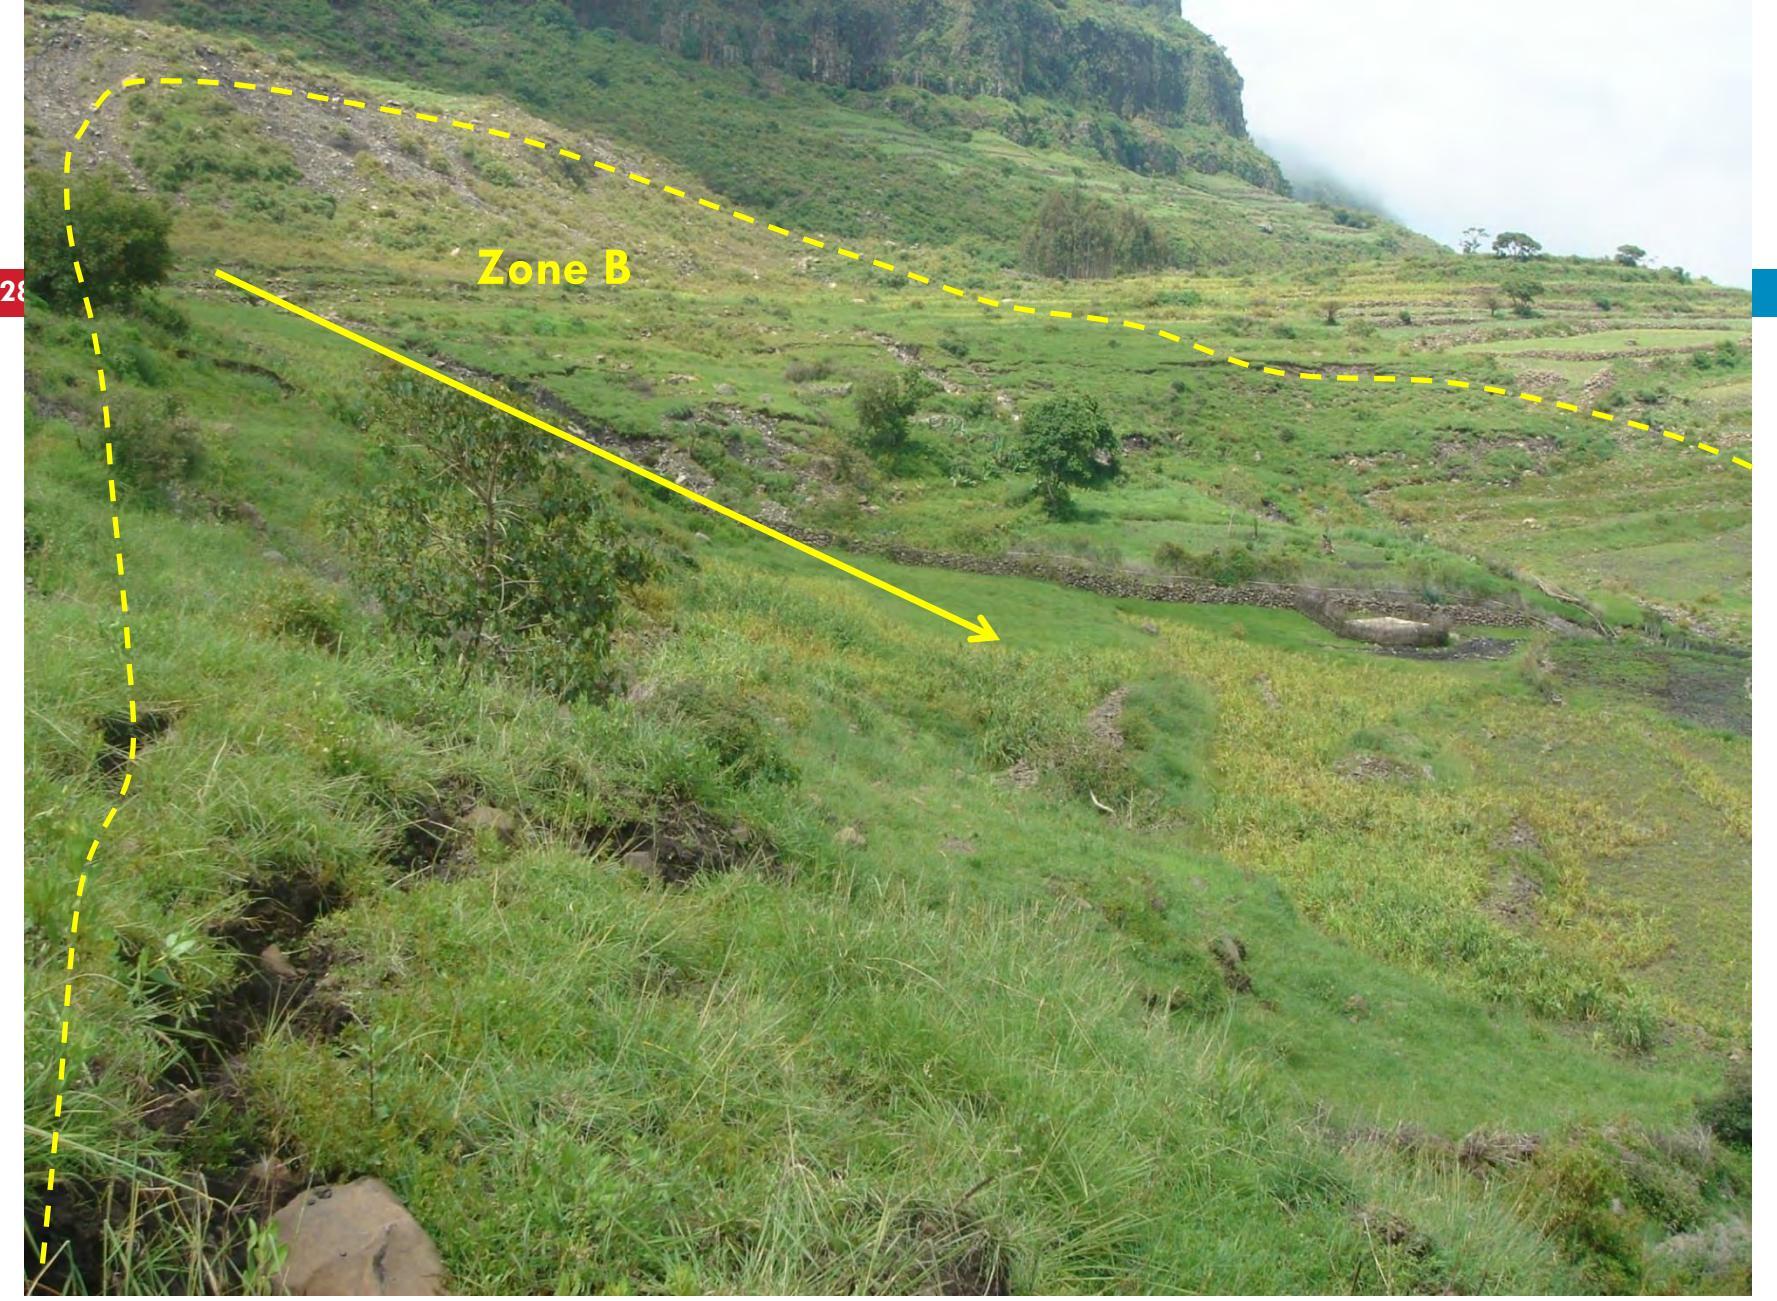
Challenges of road design and construction in Lemi area, central highlands of Ethiopia

Zone B: Debris/earth slide affecting farm land in Lemi area,
