SCOPING STUDY ON GREEN ROADS FOR WATER OPPORTUNITIES IN SEBEYA CATCHMENT

Integrating climate change adaptation and water management in the design, construction and rehabilitation of roads

Sebeya, Rwanda June, 2022

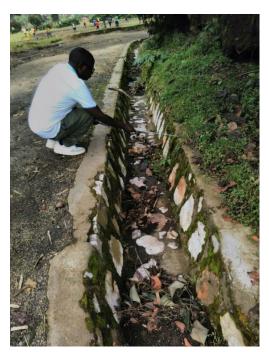
Figure 2: Taking the dimensions of existing structures on the pilot road

The identification of existing drainage structures and their locations, size was done from the site (Figure 2). From DEM 10x10m resolution, and with help of ArcGIS with arc hydro tools integrated, the drainage lines and their corresponding catchments were generated. The catchment characteristics like catchment area, mean slope, longest flow path were calculated. The runoff discharge for different return periods were calculated by rational method for the area below 5km² and Soil Conservation System-Curve Number (SCS-CN) method for the catchments area greater than 5km². The obtained discharges were compared with the hydraulic capacity of existing structure. In addition, some locations were recommended to add drainage structures.

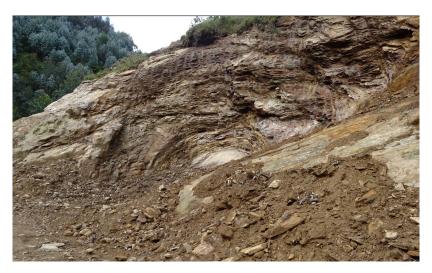
Figure 6: Highly folded, foliated and weathered gneissic road-side outcrop.

Previous studies on natural resources management and land restoration program give little emphasis to the geology of the catchment. However, geology and related processes are among the most determining factor in such catchments, with very rugged terrain and complex geological settings, like Sebeya. The bed-rock geology over which the roads are built, and their settings are the basis to choose appropriate GR4W measures. Geological map of the Sebeya Catchment, which was updated and prepared from the 1:250000 scale, Rwanda Carte Lithologique Du Rwanda (Institut Geographique de Belgique, 1981) shows three major rock units to exist in the Catchment (Figure 5). Multispectral Landsat 8 images are used for the update. The Crystalline Basement Rocks are the dominant geological units covering a total area of 28,397 hectares (77% of the catchment). These rocks form the highly dissected part of the catchment. It has a dominantly granitic composition with swarms of pegmatites. The Crystalline Basement rocks are highly weathered foliated and folded (Figure 6).

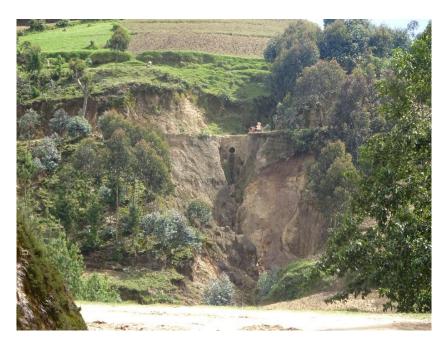
Figure 12: Erosion downstream of culvert in Sebeya catchment.

During the assessment survey in Sebeya catchment, varying degrees of water-related road damage have been observed along the roads. Gully development along roads that are lacking in water guidance structures and running across erosive thick soils, erosion downstream of drifts and culverts (Figure 12), and water-related slope failures are the most dominant forms of road damage.

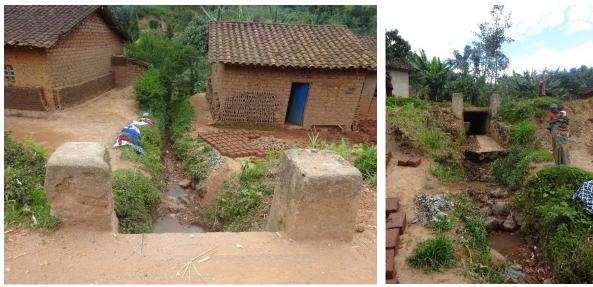
Figure 14: Road runoff crosses roadway posing risks to communities' buildings.

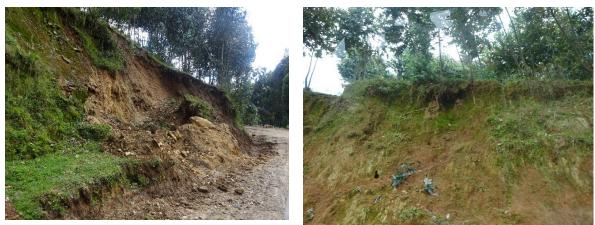
Figure 15: Road embarkment failure on feeder roads in Sebeya catchment.

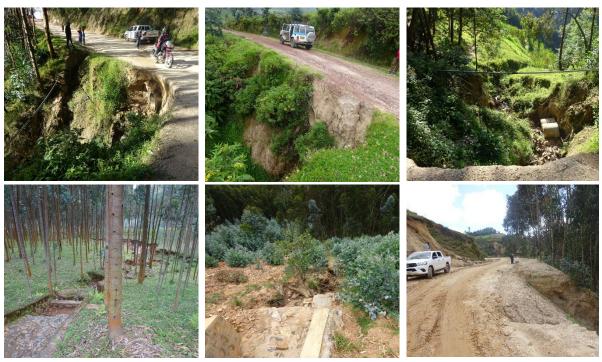
Figure 17: Road runoff causing erosion downstream of the culverts in Sebeya catchment.

Many culverts at the intersection of hills were observed channelling water from the hills towards the downstream areas. Unfortunately, most of the observed culverts were causing excessive erosion at their outlets. Some of the consequences observed were big gullies generated downstream wgich often go with massive landslides (Figure 17). The concentration of flow into a culvert significantly increases the erosive ability of the flowing water at the culvert outlet since the flow has been accelerated. The accelerated flow travels for quite some distance before it can fan out again over a wide area after it has passed through the culvert. As time elapses, erosion or gullying increases, and scour control becomes more difficult and expensive. Culverts need to be designed taking into consideration their

downstream impact. The cost of repairing the road due to erosion is often much higher than greening the drain.

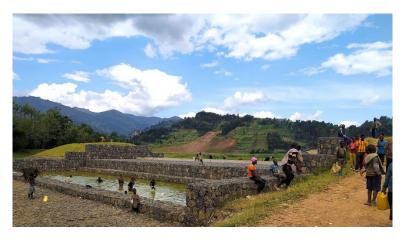
Figure 18: Dyke in Sebeya catchment. The construction of this dyke is part of the 'Embedding Integrated Water Resource Management in Rwanda (EWMR)' Project funded by the Embassy of the Kingdom of the Netherlands in Rwanda.

A dyke is a long wall or embankment constructed along a riverbank or coastal shoreline to prevent flooding in the land behind the dike. It is typically made of compacted earth and outfitted with flood boxes, gates and pumps to help regulate the water level on the landward side of the dyke. In the case of Sebeya, the dyke serves as a flood mitigation and protection structure on the Sebeya river to store part of the flood volume and have it released later a lower flow rate (Figure 18). The dyke constructed in Sebeya is expected to have an effect on floods generated on Sebeya upstream catchment and floods generated on Karambo catchment.

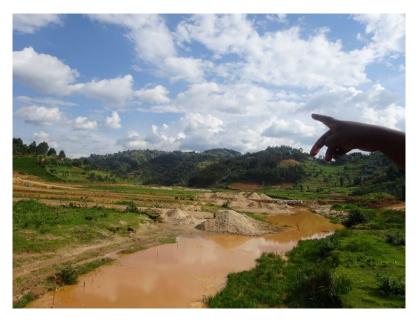
Figure 19: Dam under construction Sebeya catchment.

A dam is a structure built across a stream or river to hold water back and protect from flooding. A dam under construction was observed in Rubavu district, aiming to help curtail severe floods in Western Province by the Sebeya river (Figure 19).

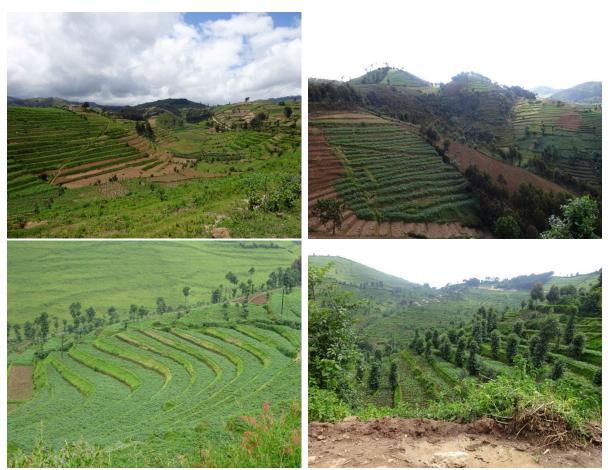
Figure 20: Terraces are quite widespread in Sebeya Catchment.

Terraces are pretty spread throughout Sebeya Catchment (Figure 20). Terraces are principal water and soil conservation measures for catchment restoration and protection. They consist of ridges and channels constructed across the slope to slow down the runoff velocity, store water in the soil profile (or replenish the groundwater), keep nutrients and soil particles from washing away from the field and prevent erosion.

- <u>Progressive terraces</u> are formed by establishing contour bunds with soil or stones in combination with ditches and vegetation as in the Fanyaa Juu. The progressive terraces are formed in time by the natural process of erosion and sedimentation. Contour bunds covered by nipia grass, a more passive and slower option are mostly preferred.
- <u>Radical terraces</u> are constructed on terrain with steeper slopes. Construction of the radical terraces is labor intensive and expensive. Terracing design takes in consideration the soil and subsoil. With a thin arable layer on rocky surface, it is not possible to build terraces. Radical

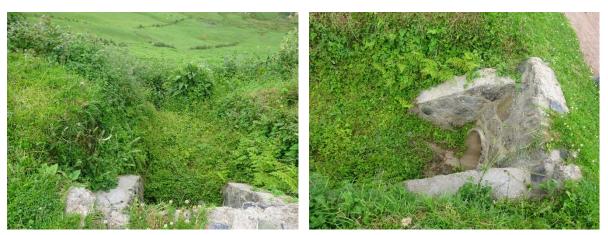
Figure 21: Grass vegetation at the culvert outlet protects the roadside environment from road-induced erosion.

Grass is an excellent choice for erosion control because it covers the soil thoroughly and its fibrous roots spread deep and quickly holding the soil very well. Field observations in the Sebeya catchment showed that grass combined with indigenous trees is remarkably reducing soil erosion and sediment transport rate despite the steep slope and high rainfall intensity (Figure 21). Lack of erosion signs on drains under grasses and indigenous trees indicated the positive effect of grass and indigenous trees, especially in the upland of the Sebeya Catchment in the Gishwati area (Figure 22).

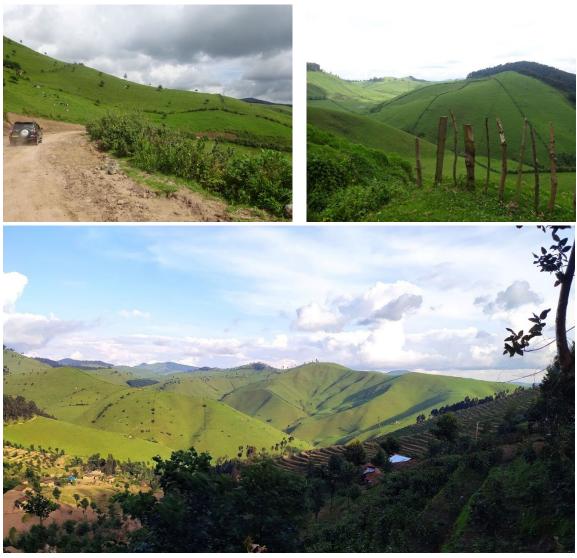
Figure 22: Grass vegetation at the high mountain of Gishwati is used to prevent soil erosion.

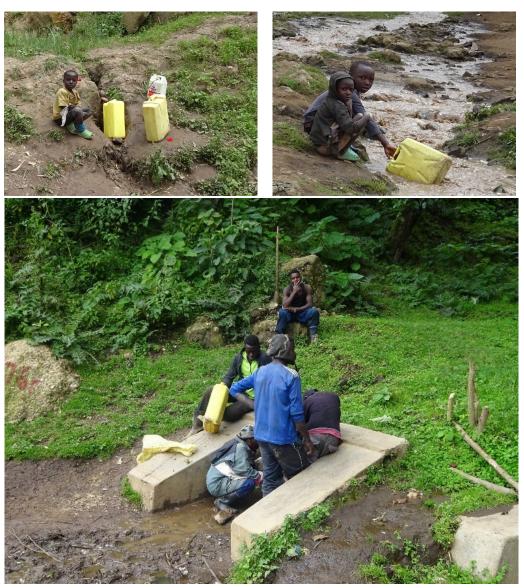
Figure 25: Domestic water supply in rural Sebeya Catchment: Community members fetching floodwater and water from road-side spring.

However, the team has observed inadequate water supply for human consumption. Long waiting to fill a jerrican from roadside springs and floodwater harvesting have been observed in different parts of the rural areas and small settlement areas (Figure 25). This observation was made during the rainy season when both the flood and spring are found, and it is evident that the problem will get more severe during dry seasons.

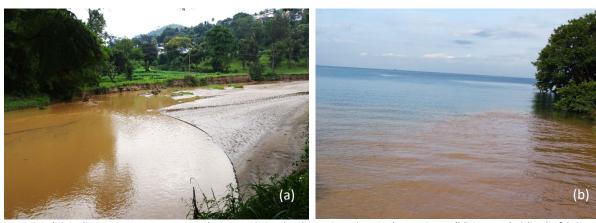
Figure 26: (a) Sediment transport, accumulation and riverbank erosion along Sebeya River. (b) Suspended load of Sebeya River entering Kivu Laker.

Sebeya catchment has multiple problems associated with catchment degradation emanating from its dominantly steep landscape, land use conversion, poor agricultural practices, mining and inappropriate road design. Issues related to road water are getting more intensified in recent decades following the construction of new roads. Soil Erosion (Figure 27), overflows that cause flooding in the northern part of the catchment along Sebeya river and sediment transport are among the good indicators of the degradation of the catchment (Figure 26).

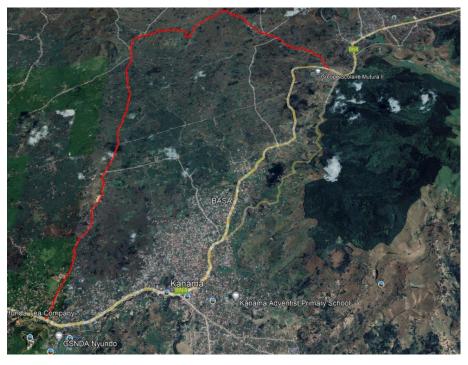
Figure 30: Selected pilot road on Google Earth.

The pilot road for implementing GR4W was selected based on its importance in regard to connectivity, the issues on its drainage system and its potential for GR4W interventions. Three different feeder roads were identified for piloting GR4W interventions during road rehabilitation, but this study focuses on one of the proposed pilot roads (Figure 32). The selected pilot road is close the most densely populated area of Sebeya (Figure 30 and Figure 31). This feeder road of 12.6 km is located in north part of Sebeya and crosses three sectors namely Rugerero, Nyakiriba and Cyanzarwe. It starts from Muhira Cell of Rugerero sector and takes end at Bazirete (Nyarushamba cell) of Nyakiriba sector. This road joins three small markets namely Muhira in Rugerero sector, Ryabizige in Cyanzarwe sector and Bazirete in Nyakiriba sector. This region is known to produce many agricultural products such as onions, cabbages, carrots and irish potatoes, so, this road is very important for transporting agricultural products to the markets.

The drainage problems observed on the selected pilot road were mainly due the improper maintenance (Table 18) and luck of hydraulic structures in some locations. The main drainage problems on the pilot road are listed below:

- Culverts are clogged fully or partially
- Many road sections (segment) do not have the side drain and some available side drains are not connected to the culverts or any other good location for runoff discharge
- · Water crosses roadway and goes to communities building
- The road banks are not protected, and this is probably one of the causes of their failures
- No maintenance is done on existing hydraulic structures
- Mass movement blocked culvert and changed the road grade, consequently it became the flood prone area
