# The Promises of Roads for Polder Water Management and Flood Protection

Opportunity Study

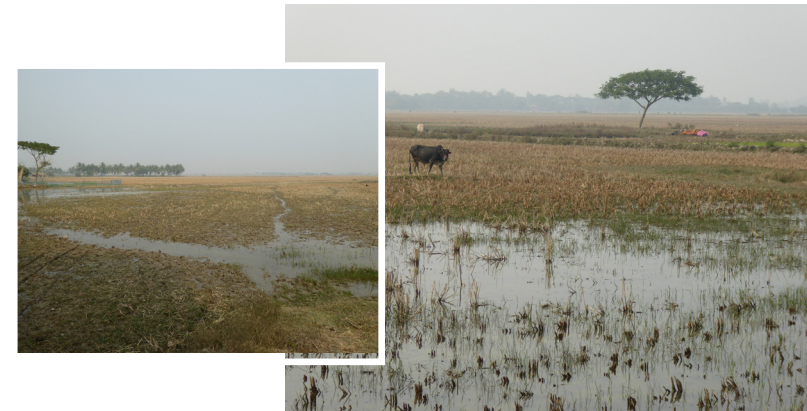
Figure 3: Waterlogged areas on the East of the main Union Road. These photos were taken in March 2017, during the dry season.

One is located at the intersection between Shaka Bai khal and the Union Road, the second is situated where the road intersects Kata khal (Figure 2). As a consequence of few water crossings, large areas of farmland on the East side of the main road are waterlogged (Figure 3).

Waterlogging impacts severely on farming, reducing its potential, and on other productive activities such as aquaculture. Household surveys reported direct crop damages and delayed farming activities leading to reduced yields and harvest losses. Crops are particularly vulnerable at the flowering stage, approaching maturity, and at the seed and seedling stages because water would wash the seeds away. Waterlogging also limits crop choices to few crops which tolerate better waterlogged conditions, and restricts vegetable farming.

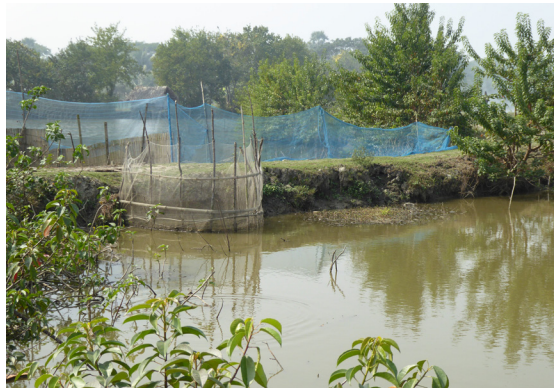
Figure 4: Earthen road constructed by local people across Ziler khal for communication for around 45 families. A culvert is needed to maintain the connectivity of this khal.

Roads are not only developed by LGED and UP. Earthen pathways are also constructed by people to restore communication across khals, often to be able to transport agricultural products from their fields to the nearest road (Figure 4). This unplanned construction of roads, however, encroaches on the

connectivity of the khal system and creates additional barriers to drainage flows.

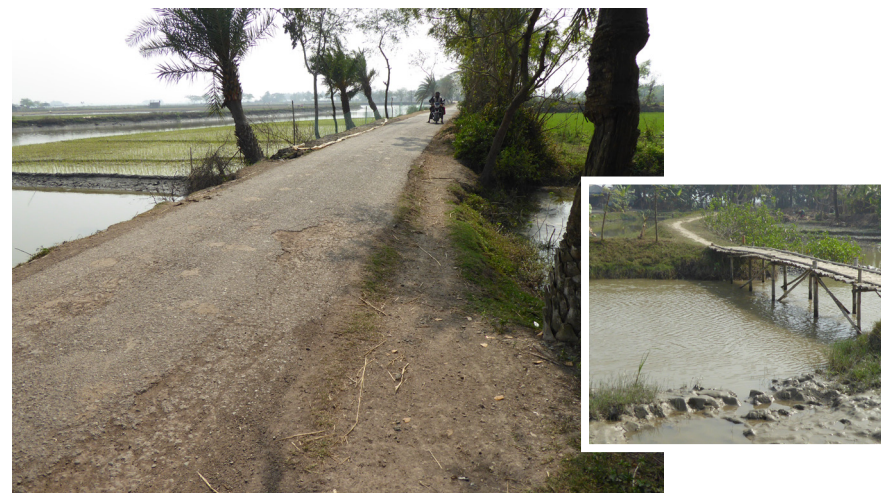
Figure 7: Main pucca Union Road cuts the Shaka Bai khal. Connectivity shall be restored by providing a large culvert on this road (left). A bridge is needed near Baloiyakhi Sluice. People use a bamboo bridge to transport goods (right).

Overall, at least 17 additional culverts and 1 bridge are needed and the size of 4 other culverts needs to be increased. Problematic locations where additional culverts or bridges are needed have been identified through physical survey and focus group discussions with UP and WMG members. Two examples are shown in Figure 7. This list has been confirmed and integrated during the validation workshop in Khulna on April 10, 2017 (see Annex I Overview of possible interventions).

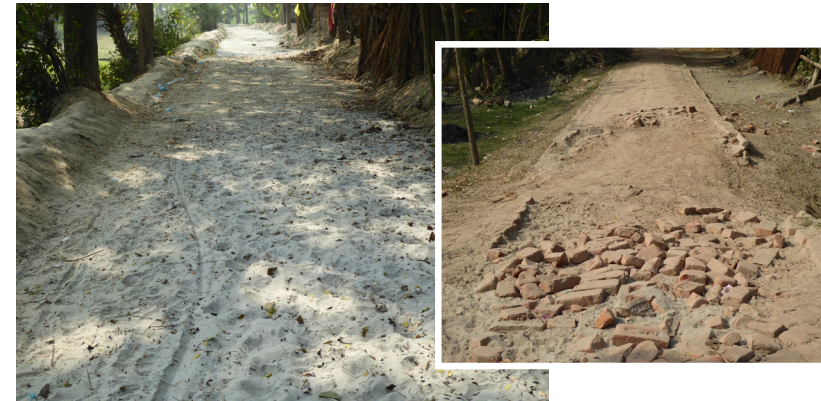
*Figure 10: Earth and brick roads deteriorate rapidly and create many challenges to communication and transport*

The quality of both internal and embankment roads is a challenge in Polder 26 and household surveys highlighted that the majority of the polder population is affected to some extent by poor road conditions, particularly during the rainy season. Many village roads are earthen or paved with bricks. During the rains, earthen roads become extremely muddy, slippery, and uneven under the pressure exercised by the wheels of motorized vehicles. Brick roads are frequently damaged with bricks being displaced and leaving behind large potholes, ruts, and portions of muddy soil (Figure 10). Tarmac roads also deteriorate due to the corrosive effect of water. Portions of the tarmac carpet detach from the subgrade leaving large holes and unpaved portions.

Current road conditions affect people's lives and livelihoods in a number of ways: the use of motorized vehicles is limited during the rainy season, riding bicycles causes waist pain because of the ruts and potholes, transport of goods, products, and household supplies to and from the market is

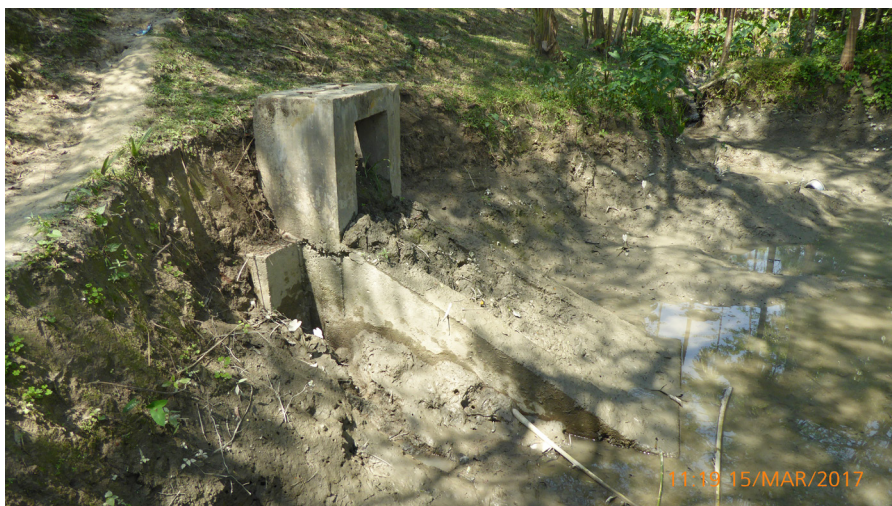
Figure 16: Inlet blocked by mud and devoid of vertical metal gate.

yet the provision of gates is responsibility of the Mechanical Engineering Department of BWDB. BG has plans to construct 4 new outlets in 2018. Out of 34 surveyed gated inlets/outlets along the embankments, 20 were found to be lacking the gate. Of the total 36 surveyed inlets and outlets, 23 were silted up or blocked by farmers with earth or bricks to control the water flow because still devoid of metal gates (Figure 16). Inlets and outlets are designed to pass water in one direction only, yet farmers usually use inlets also to drain out water, which damages the structure.

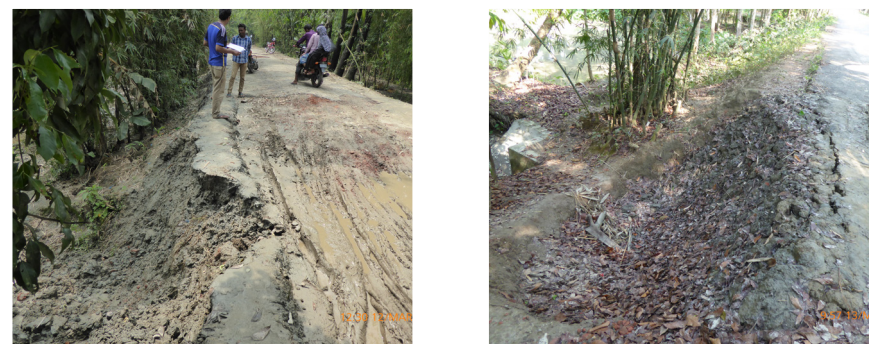
*Figure 18: Two examples of erosion and degradation of embankment roads in correspondence of inlets.*

The length of the pipe barrel of inlets and outlets along the embankment is a design characteristic that has a huge impact on the durability and stability of the portion of embankment or embankment roads above the structure. It has been observed that in several cases, the length of the inlet or outlet is smaller than the width of the embankment as often, the design length is not chosen in view of future widening of the embankment that accompanies the carpeting of an embankment road. Water entering or leaving the polder through the pipe gets in contact with the sides of the embankment and erodes them. This reduces the stability and height of the embankment and reduces flood protection (Figures 18 and 19).

This relatively easy to fix design detail has so much impact on the sustainability and flood protection function of embankments and on the sustainability of embankment roads. Thus, design of inlets and outlets should consider future widening of embankments in view of a potential development of an embankment road.

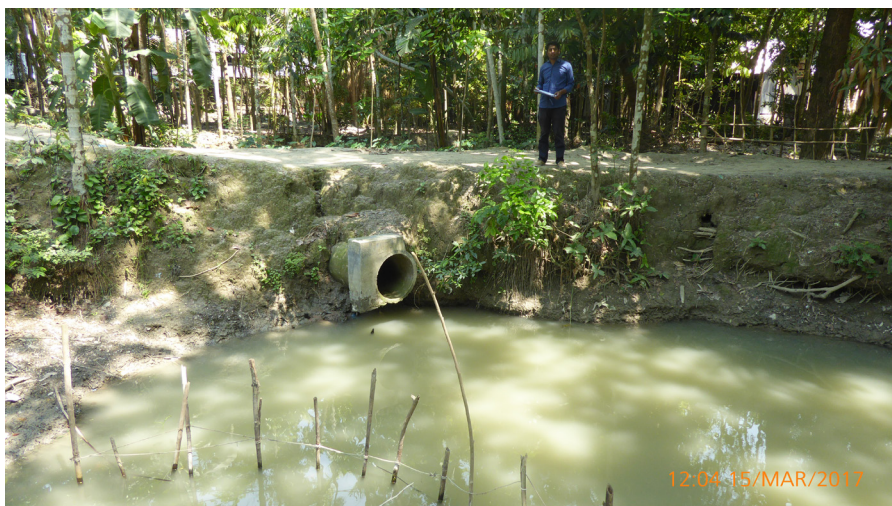
Figure 19: Erosion of an embankment section in correspondence of a pipe inlet.

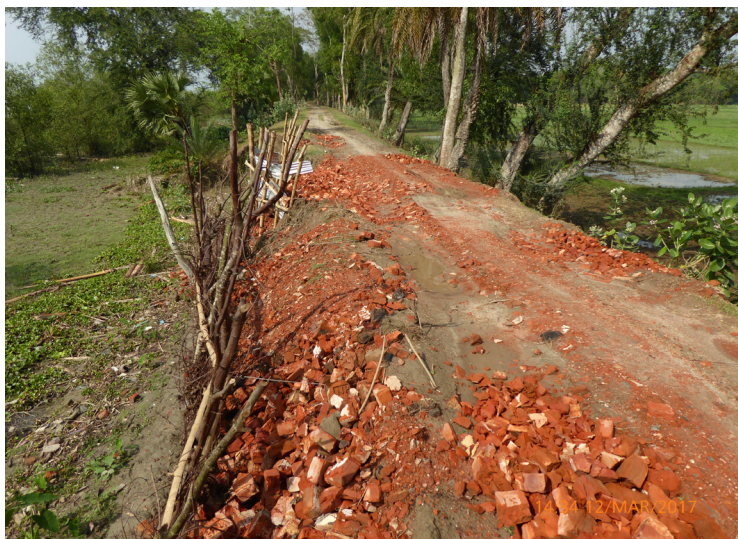
Figure 20: Low embankment section where carpeting has already started.

The risk of river flooding is higher in Polder 43 2F than in Polder 26 because the polder is surrounded by rivers, one being a very large one and very close to its embankment. The perception among the majority of household respondents, is that the embankments do not protect them sufficiently from river surges. It was observed in several cases that the carpeting of an embankment affects the height of the embankment and reduces thus flood protection. In 4 of the 5 carpeted embankment sections surveyed, the height of the embankment was found to be lower than the other embankment sections (Figure 20).

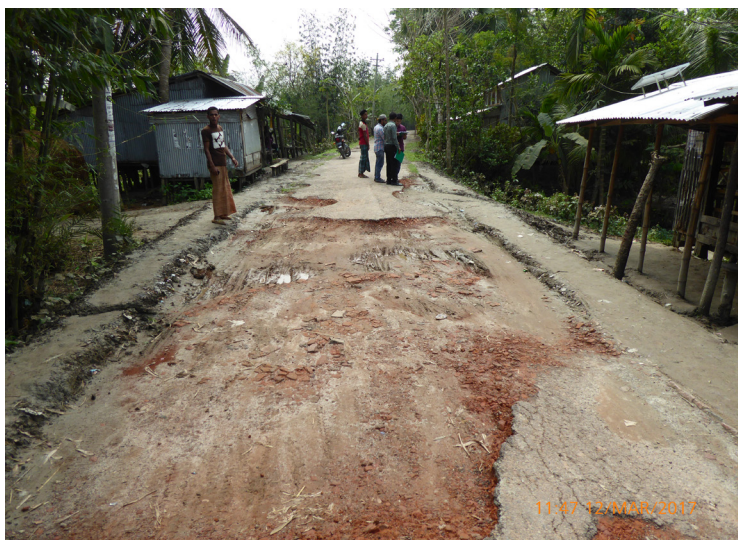
Figure 21: Poor quality embankment road.

In many cases, a lack of coordination and cooperation between BWDB and LGED and long time needed by BWDB to approve LGED's plans for developing an embankment road lead to premature carpeting of an embankment, before it is raised up to safe standard levels. Moreover, the quality of carpeting of embankment roads is not good enough for reasons similar to those already mentioned for internal roads. This results in rapid degradation of the road (Figure 21), which, in turns, also leads to the deterioration of the embankment.

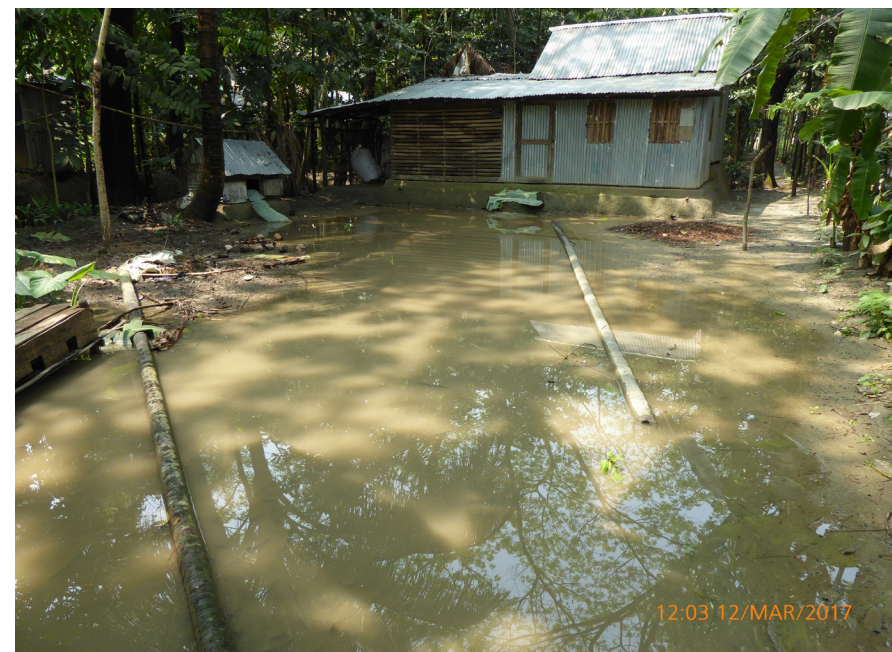
Figure 22: Drainage congestion around a house. This photo was taken in March 2017 during the dry season, 2-3 days after a rain event.

Despite the large number of water-crossing structures, sluice gates, and the extensive khal system, a large number of respondents are affected by waterlogging. Waterlogging occurs in patchwork manner in low lying lands and around homesteads (Figure 22). A large number of respondents reported to have abandoned some land because of waterlogging.
